FIGURE 43.—Modified Mercalli intensity distribution in Guatemala from the main event. Circle indicates epicenter location of the February 4 earthquake; dashed line indicates approximate isoseismal. (Base map modified from Guatemala Instituto Geográfico Nacional, 1974, 1:500,000.)

#### INTENSITIES IN GUATEMALA CITY

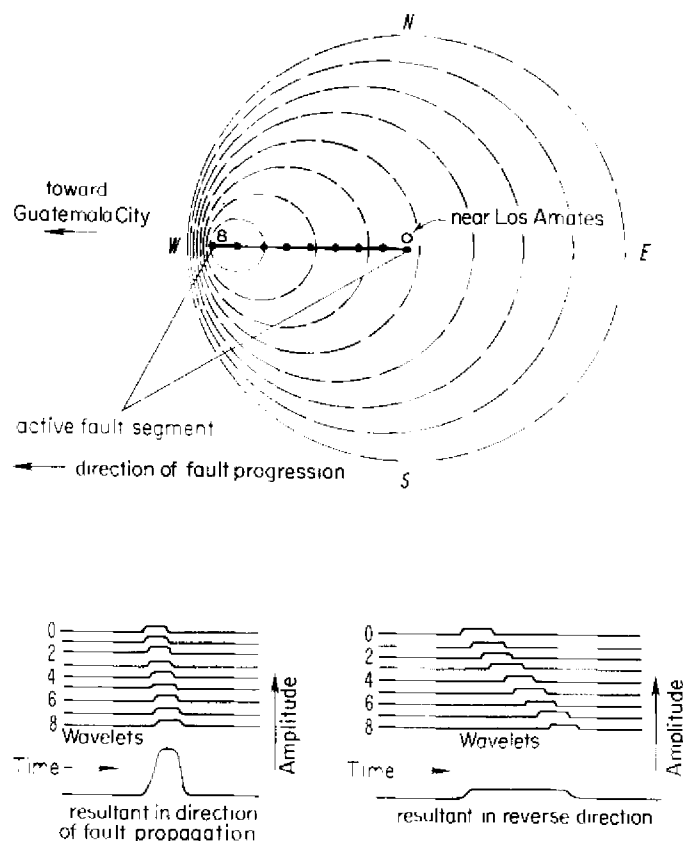
FIGURE 44.—Schematic of slip progression and its effect on wave amplitudes and shapes due to a moving source (modified from Benioff, 1955). Fault propagation from east, near Los Amates, to west, toward Guatemala City.

The pattern of adobe damage (fig. 45) is similar to the intensity distribution shown in figure 43. The similarity suggests that more energy was released to the west than to the east. It also suggests that seismic energy was released along and near the known fault zone of the Motagua fault. The maximum concentration of damage, mostly in the Department of Chimaltenango, is suggestive of a constructive interference of seismic waves due to a moving dislocation.

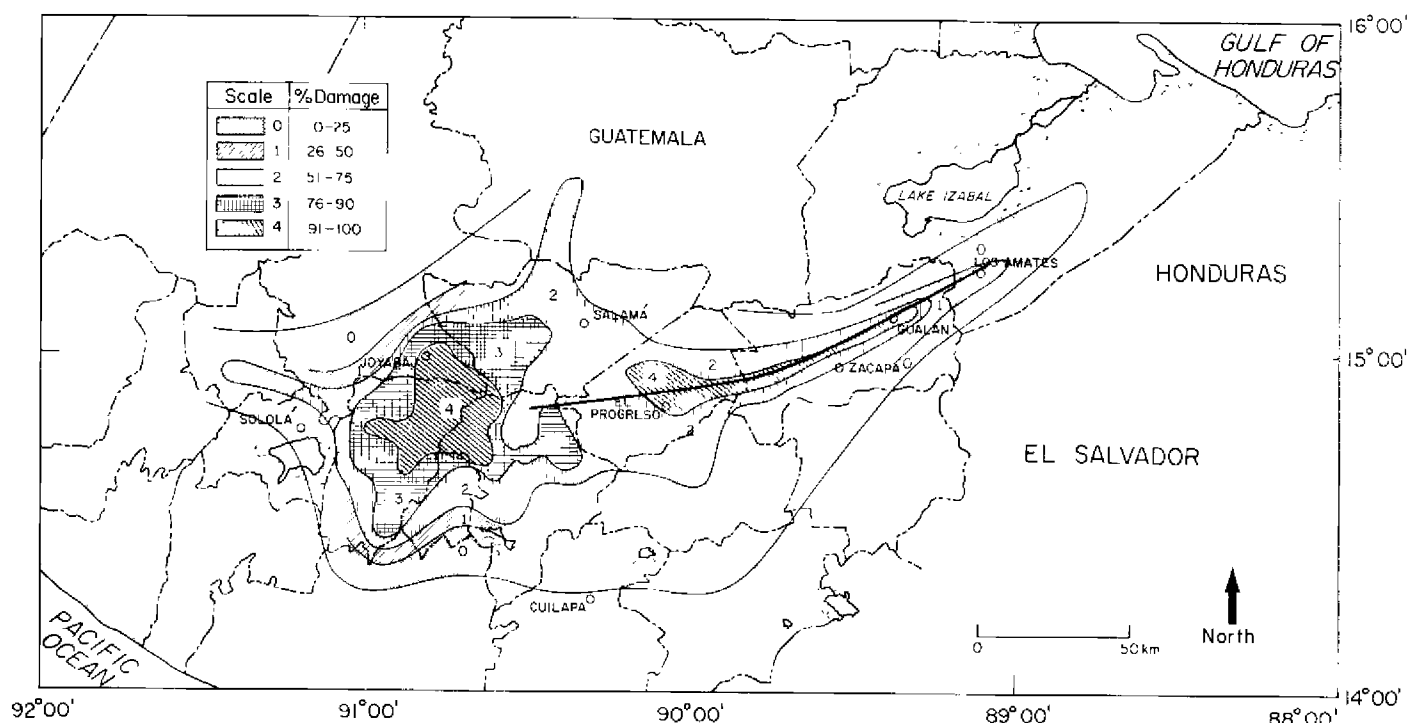
the Departments of Chimaltenango, Guatemala, and lower Quiché. These regions of the country are the highlands of Guatemala. The affected region of 51- to 100-percent damage covers a surface area of approximately 8,725 km<sup>2</sup>. There are two well-defined areas of maximum damage; one follows a trend parallel to the Motagua fault located in the Departments of Izabal, Zacapa, and El Progreso. A gap is found between the 4 and 2 contours for nearly 40 km. Within the next 35 km there is another concentration of high damage (fig. 45). The damage pattern diminished rapidly to the west into the state of Totonicapán.

the Mixco area. Damage decreases more rapidly to the east than to the west of the zone of strongest shaking. The areas damaged for different percentiles of collapsed adobe houses are given in table 11.

FIGURE 45.— Contour map showing damage to adobe-type structures in Guatemala owing to the February 4 earthquake. See figure 1 for Department names. (Base map modified from Guatemala Instituto Geográfico Nacional, 1974, 1:500,000.)
