## DAMAGE AND ENGINEERING IMPLICATIONS

By RAUL HUSID, ALVARO F. ESPINOSA, and ANTONIO QUESADA <sup>5</sup>

### INTRODUCTION

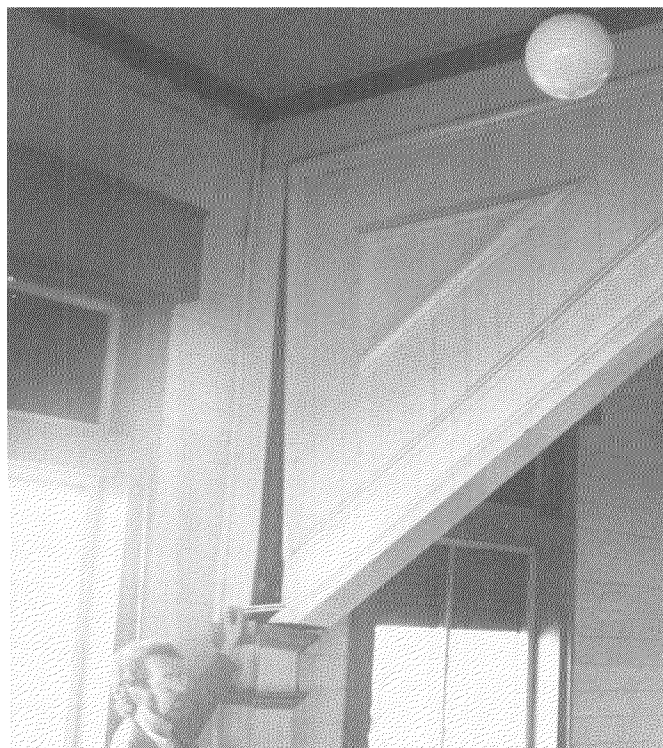
FIGURE 51.—Damage to a wooden structure in Puerto Barrios, caused in part by ground compaction. Note the large offset of 11 cm shown in the photograph.

heavy damage that has been observed after many previous earthquakes in other countries (Husid and Gajardo, 1970; Eisenberg and others, 1972; Husid and Espinosa, 1975; Espinosa and others, 1975). Wooden construction withstood damage well even when extensive damage was caused by ground compaction (Ray Wilson, oral commun., 1976) beneath the building (fig. 51).

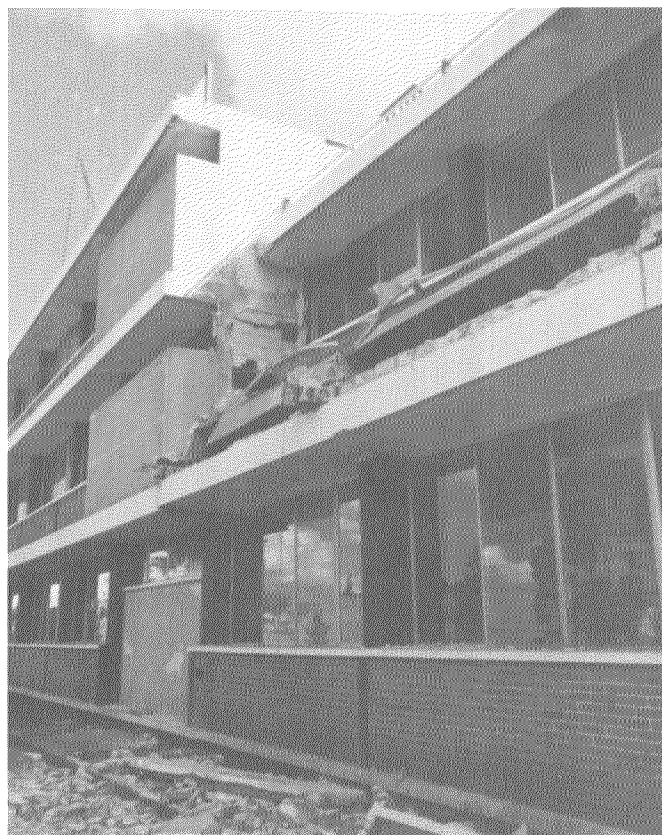
Many school buildings were severely damaged by this earthquake, and, if the earthquake had occurred during class time, the death toll would have been larger. The second story of a three-story reinforced-concrete frame structure with masonry walls at the Colegio San Javier collapsed (fig. 52). In the same school complex, a second building, next to the one that partially collapsed, was extensively damaged. There was no available information about the lateral loads used in the design of the school structures.

FIGURE 52.—Collapse of the second story of a building at the Colegio San Javier (Zone 12), Guatemala City.
