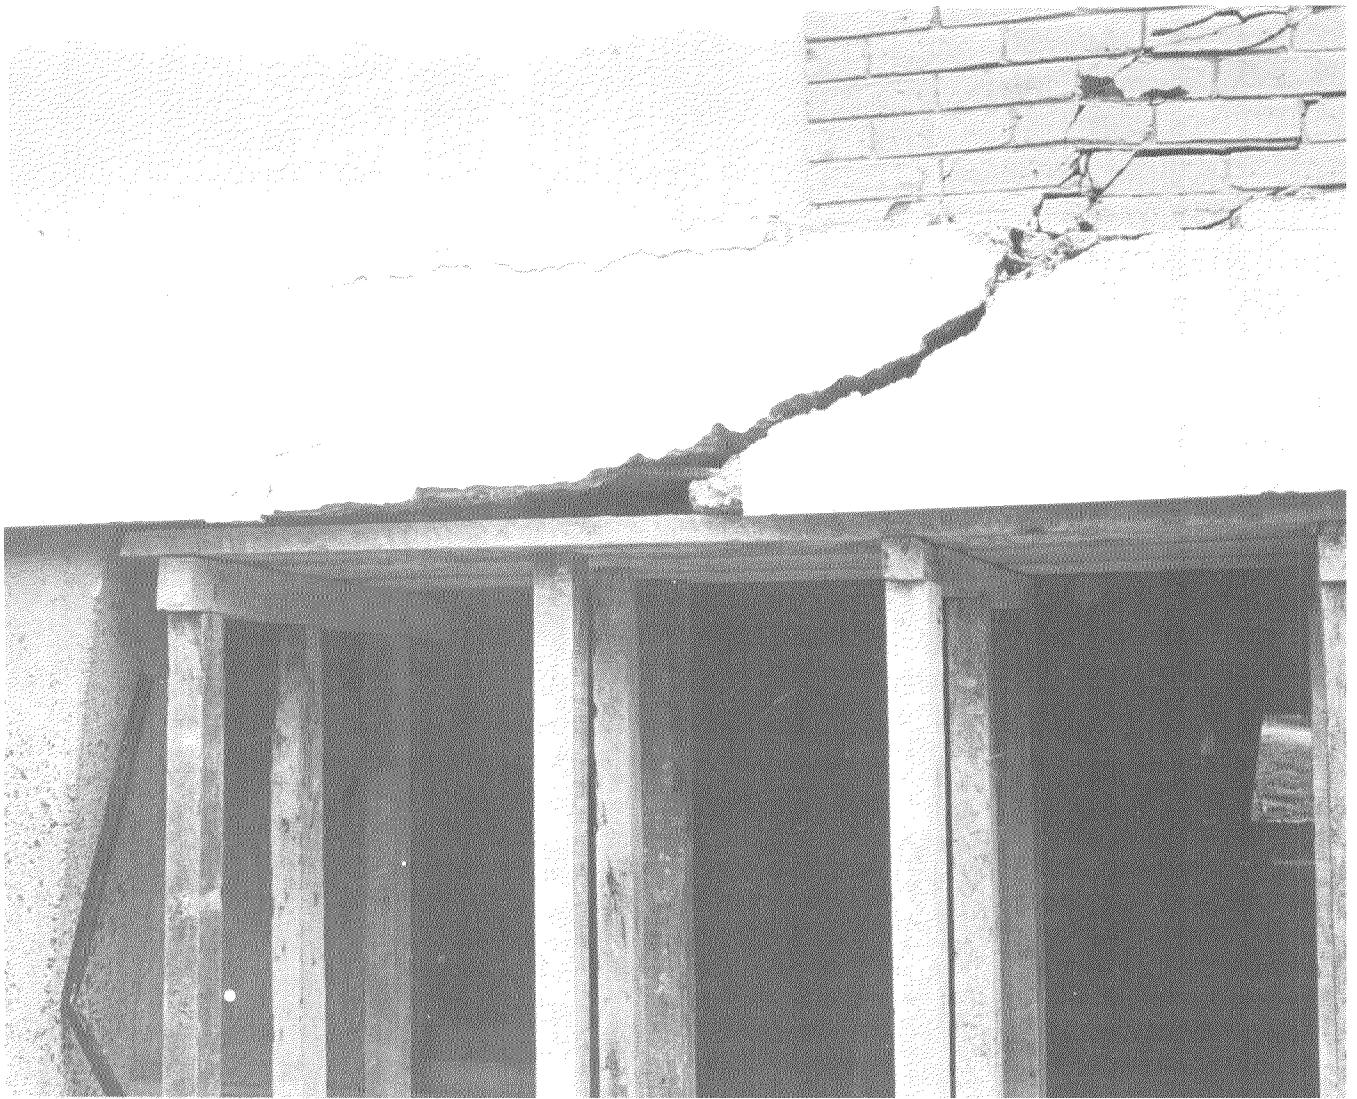
FIGURE 70.—Severe damage to flat beams and slab in the five-story reinforced-concrete Edificio ELGIN, in Guatemala City (Zone 14).
