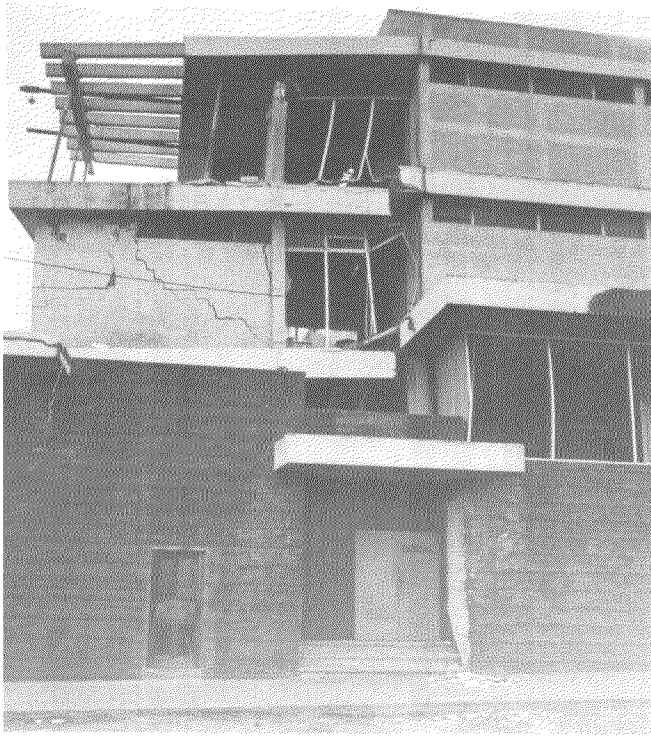
FIGURE 53.—Partial collapse of a three-story reinforced-concrete structure due to failure of columns in its second floor (Zone 12), Guatemala City.
