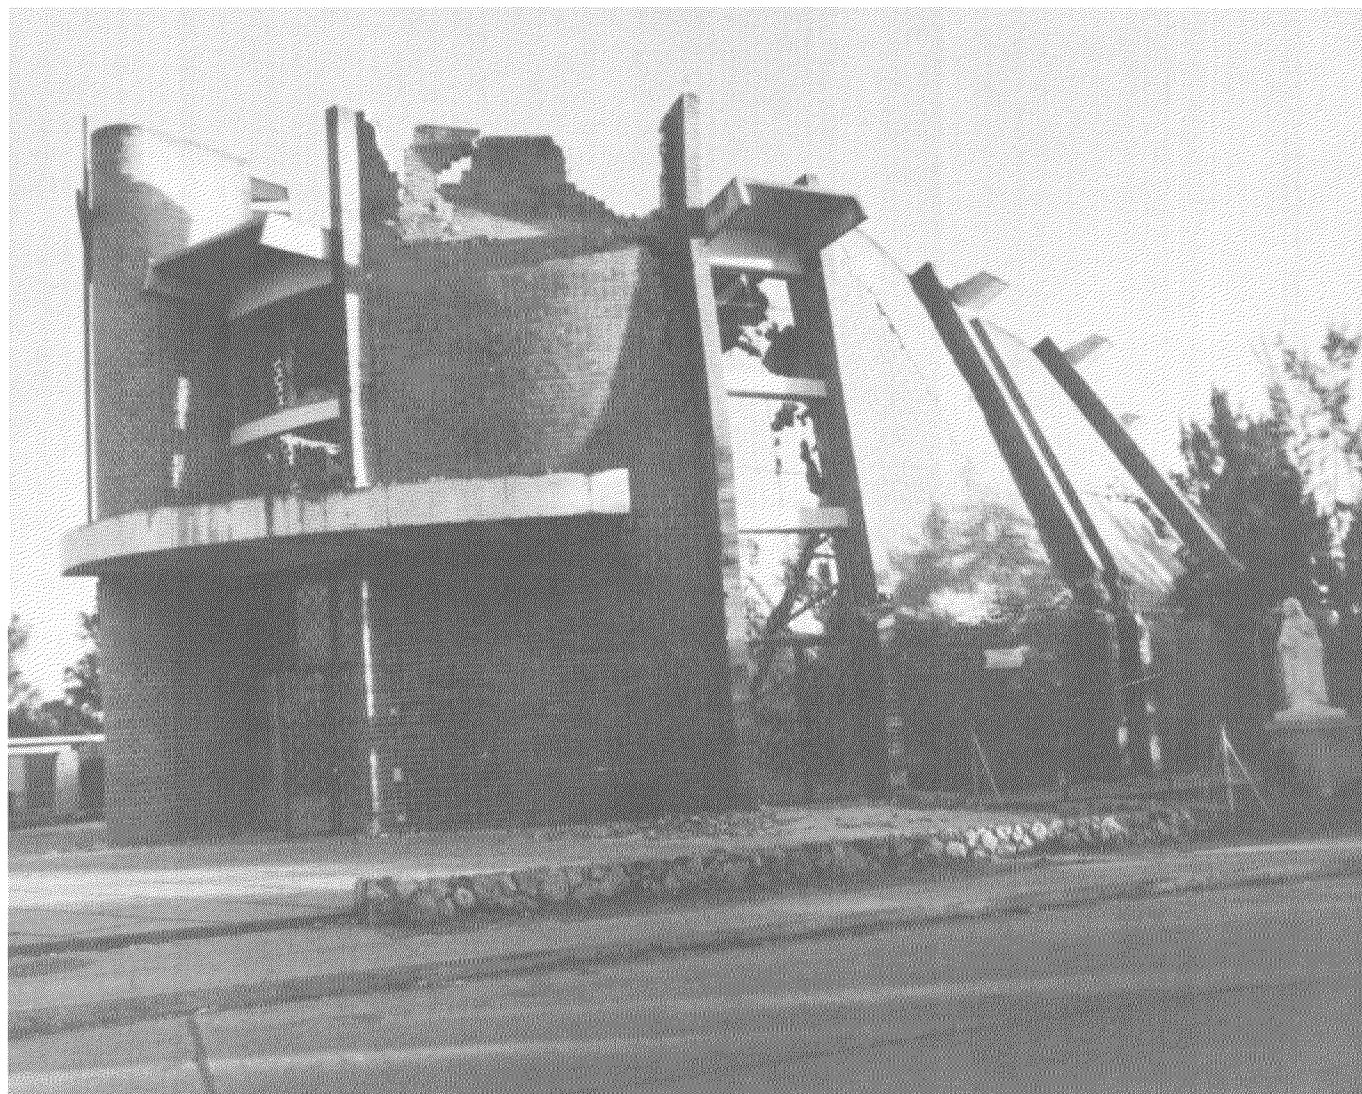
FIGURE 54.—Collapse of a new church, Iglesia del Divino Redentor, Guatemala City (Zone 11).
