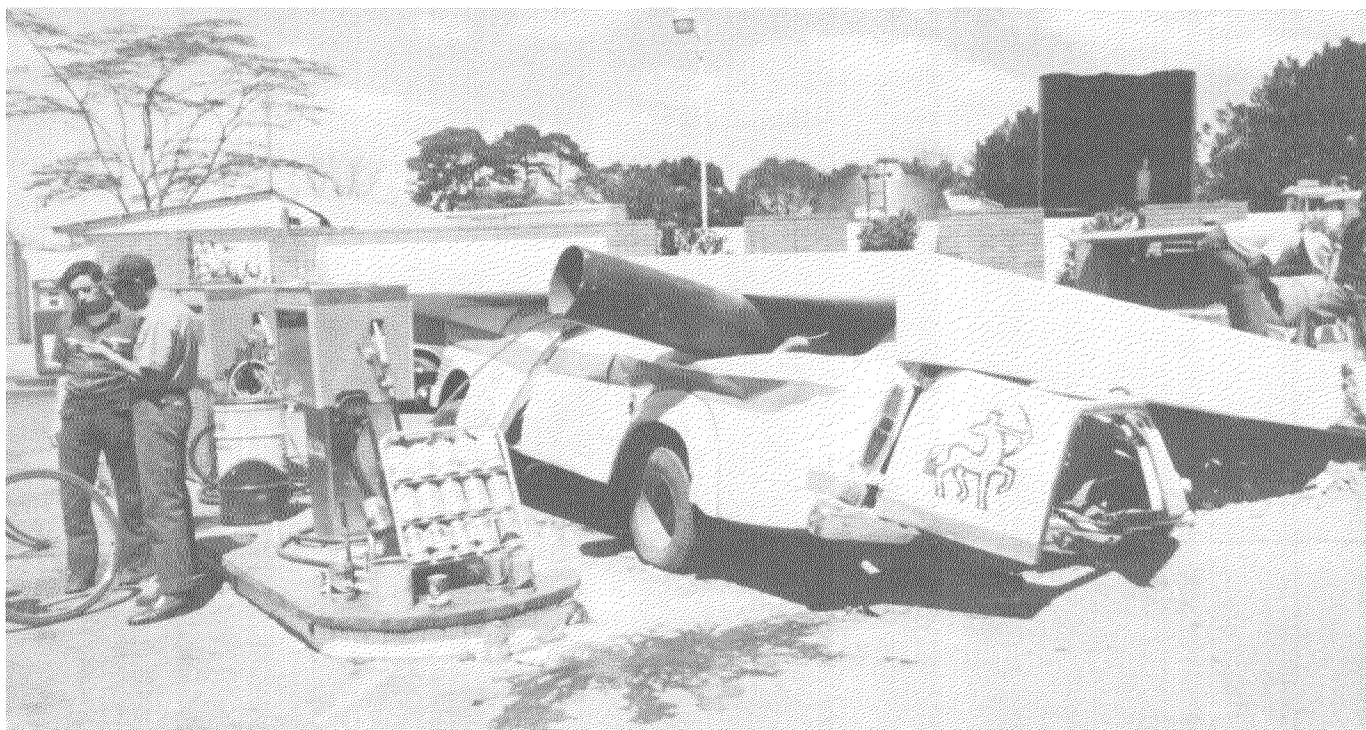
FIGURE 56.—Collapse of inverted-pendulum gas-station structure, Guatemala City (Zone 7).
