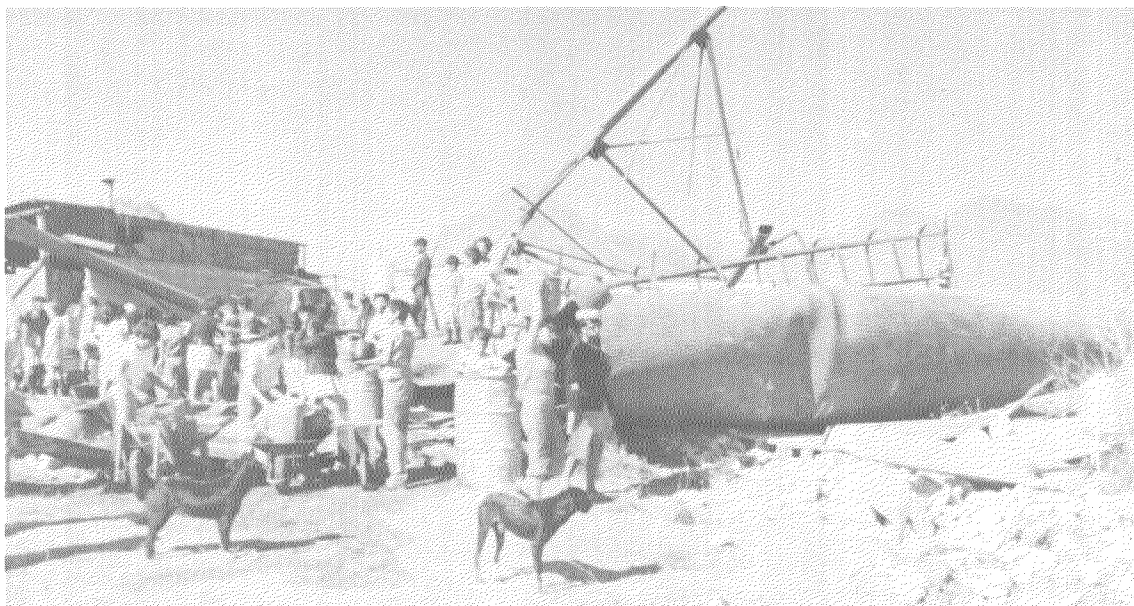
FIGURE 59.—Collapse of an elevated steel water tank in Villanueva, Colonia de los Planes, 22 km south of Guatemala City.

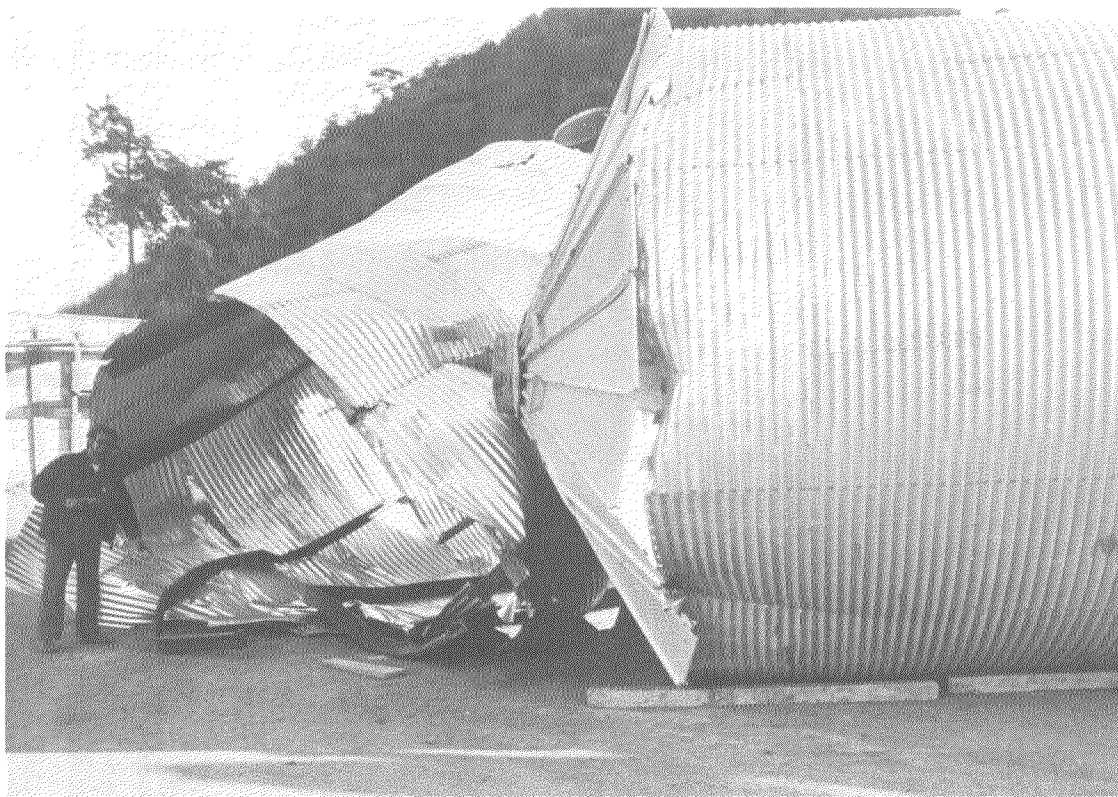
FIGURE 60.—Collapse of a corrugated-steel grain silo in Villalobos, 5 km southeast of Guatemala City

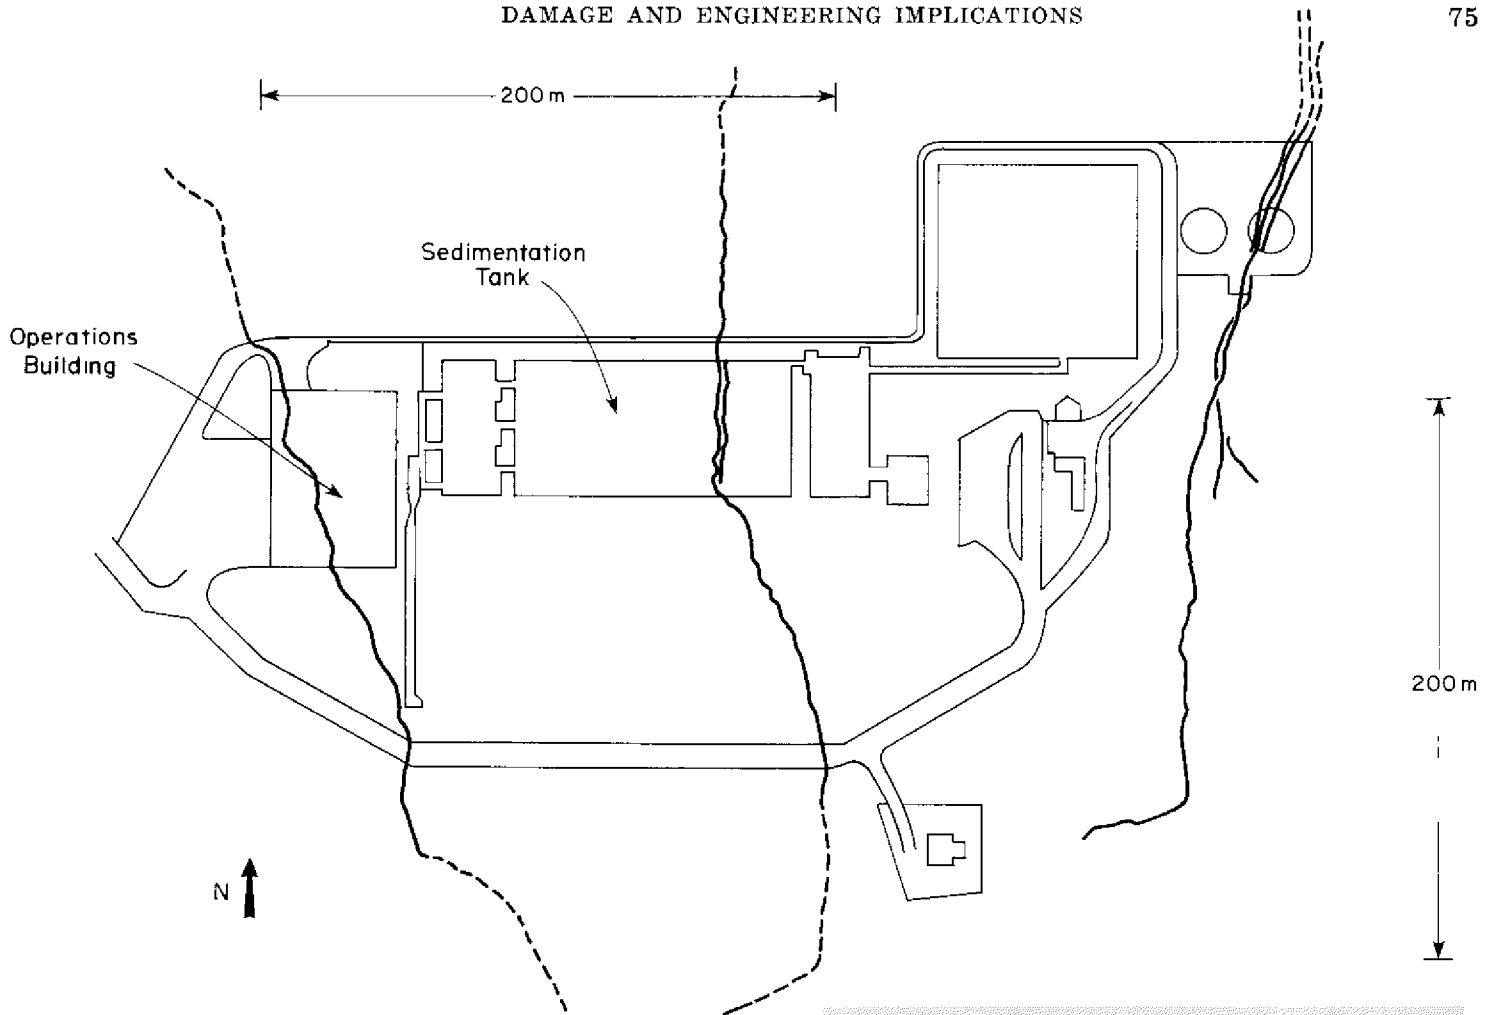
FIGURE 61.—Plan of sedimentation tank and Plant Lo de Coy of the XAYA-PIXCAYA project and cracks (heavy lines) running under and across the sedimentation tank.

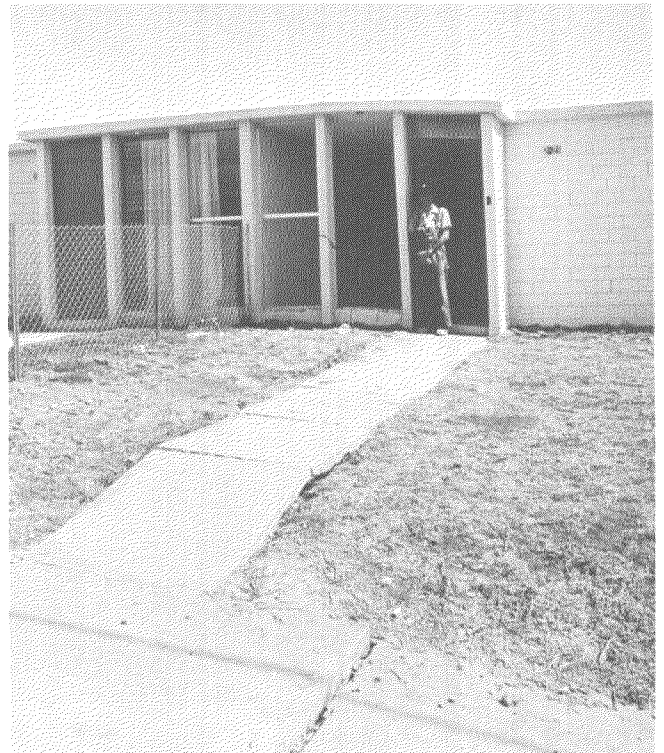
FIGURE 62.—Severe damage to reinforced-masonry construction caused by secondary faulting in Colonia San Francisco (Zone 19). The fault strikes north to northeast.
