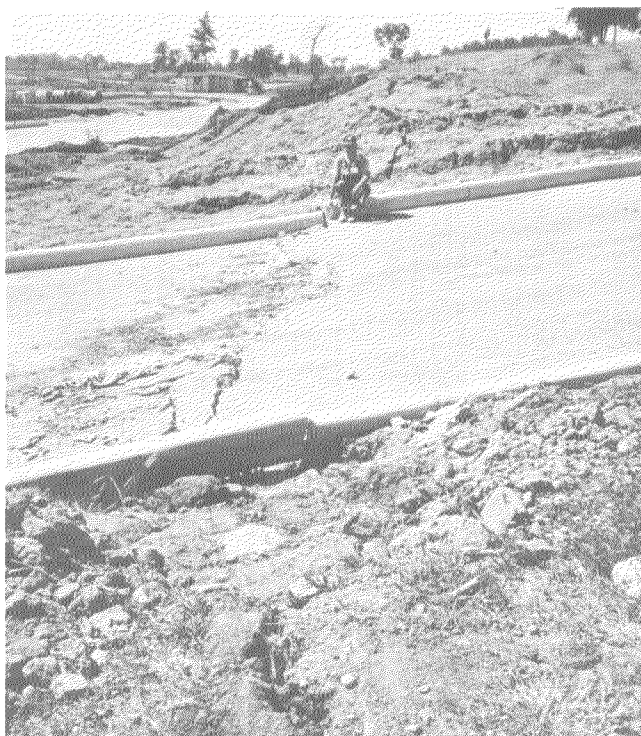
FIGURE 63.—Rupture across the San José Rosario subdivision Fault with 13 cm vertical and 5 cm right-lateral displacements (Zone 19)

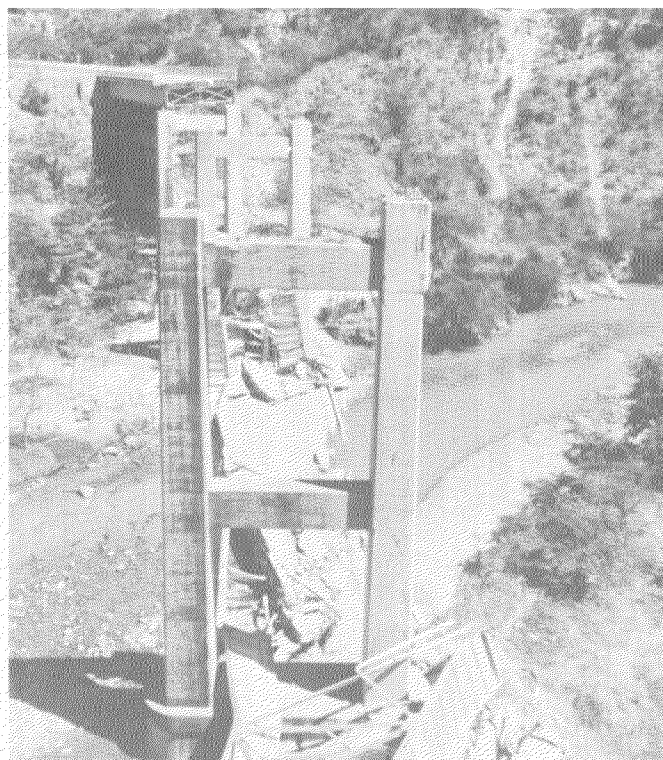
FIGURE 64.—Collapse of three central spans of the Agua Caliente Bridge, Kilometre 36 on the road to the Atlantic Ocean. This bridge was constructed in 1959

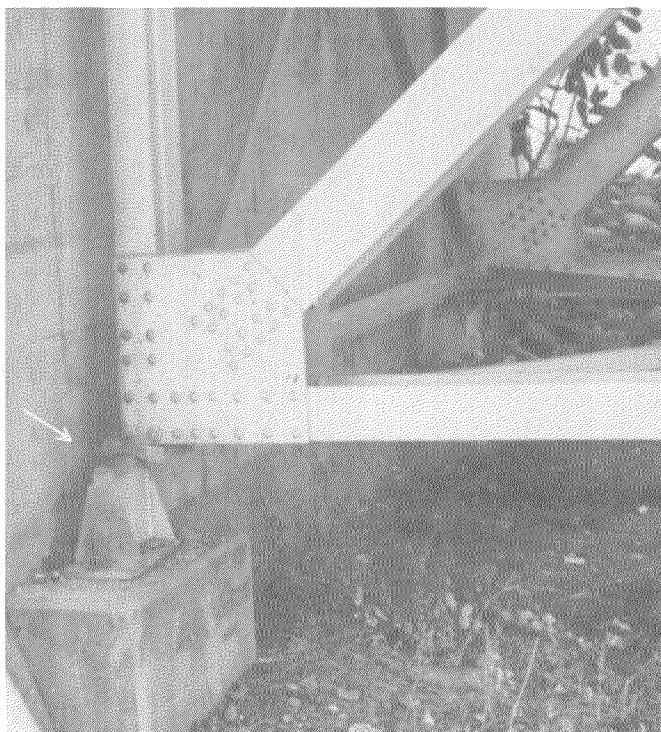
FIGURE 65.—Benque Viejo Bridge, on the verge of collapse after failure of supports, shown by arrow.

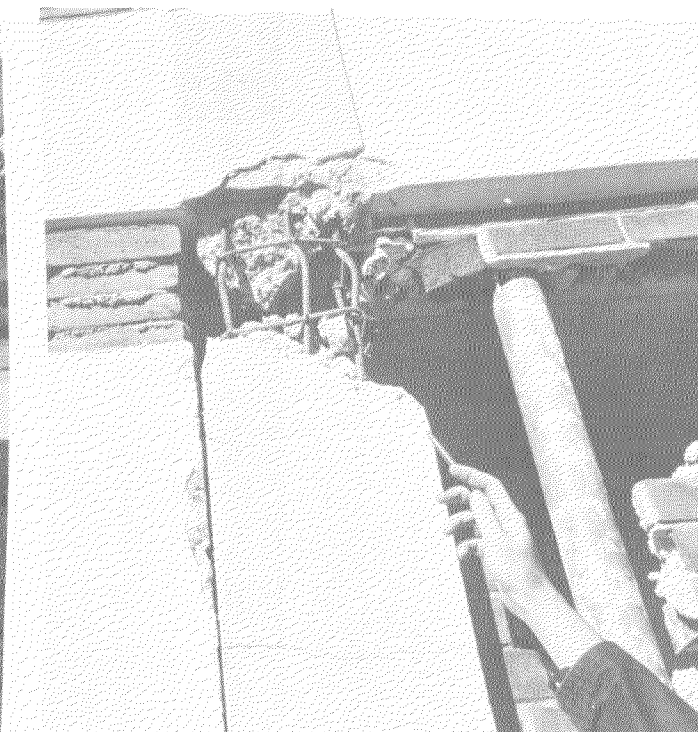
FIGURE 66.—Failure of short column in three-story framed reinforced-concrete structure in Guatemala City (Zone 7).
