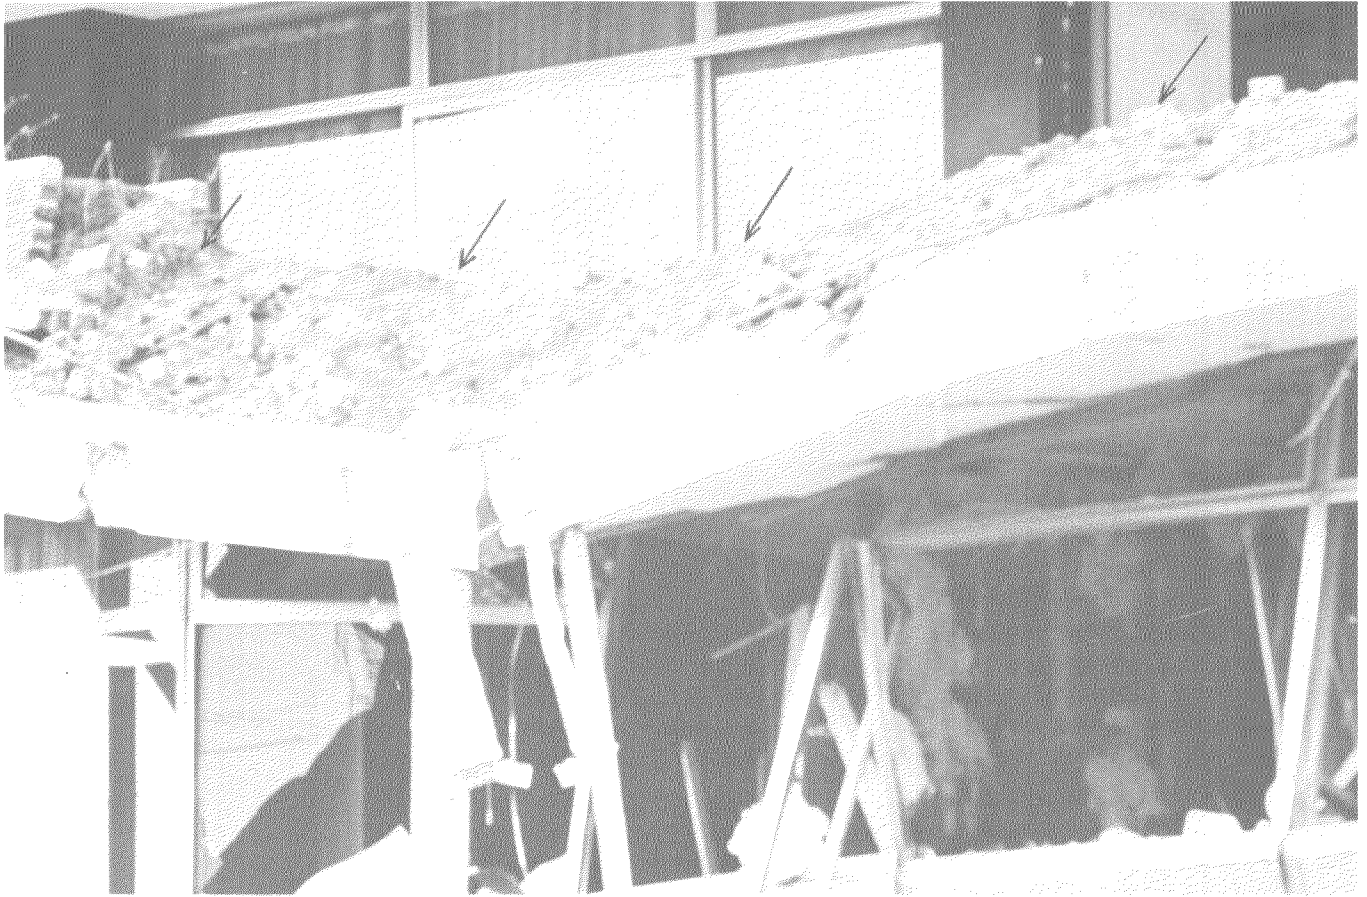
FIGURE 67.—Partial collapse of protruding first-story structure of the Cruz Azul 11-story reinforced-concrete building caused by falling (shown by arrows) of masonry walls from the two topmost stories, in Guatemala City (Zone 1).

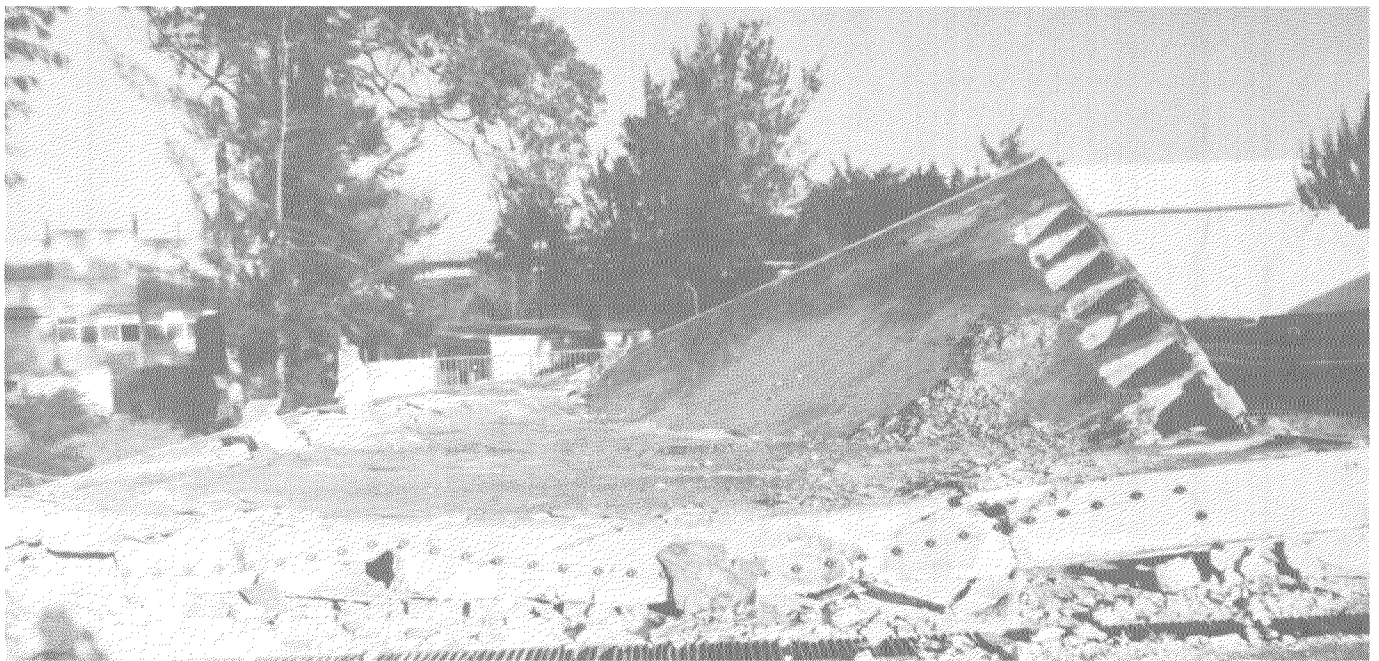
FIGURE 68.—Collapse of one-story reinforced-concrete framed structure in the Licorera Mixco, Mixco.
