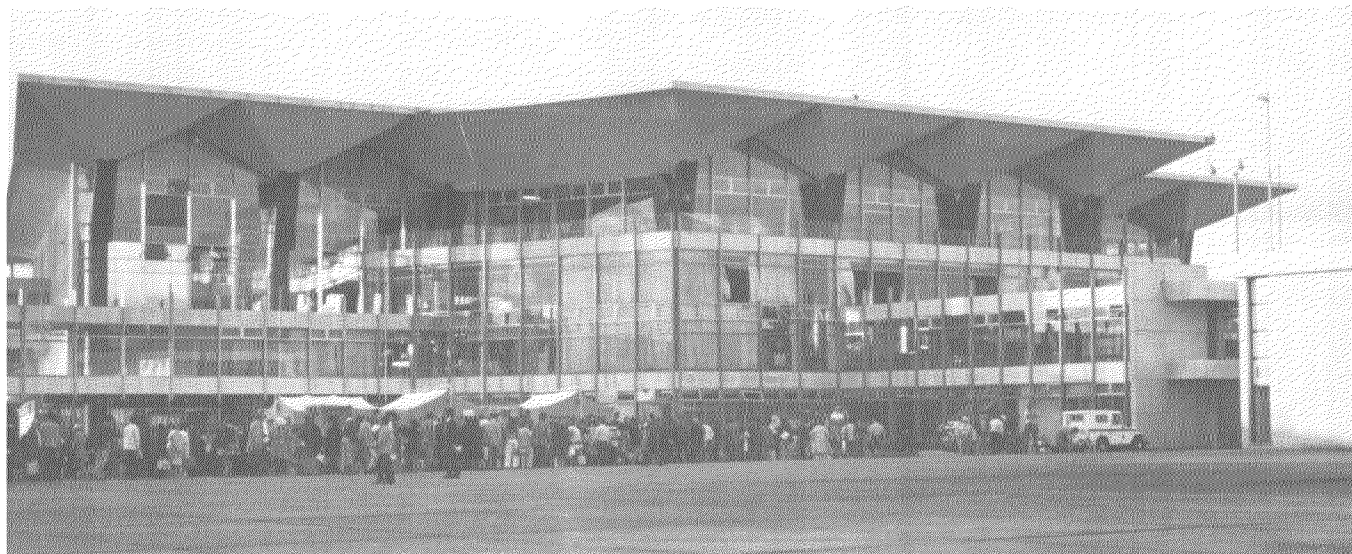
FIGURE 72.—International Airport at Guatemala City. Note that some windows are broken.

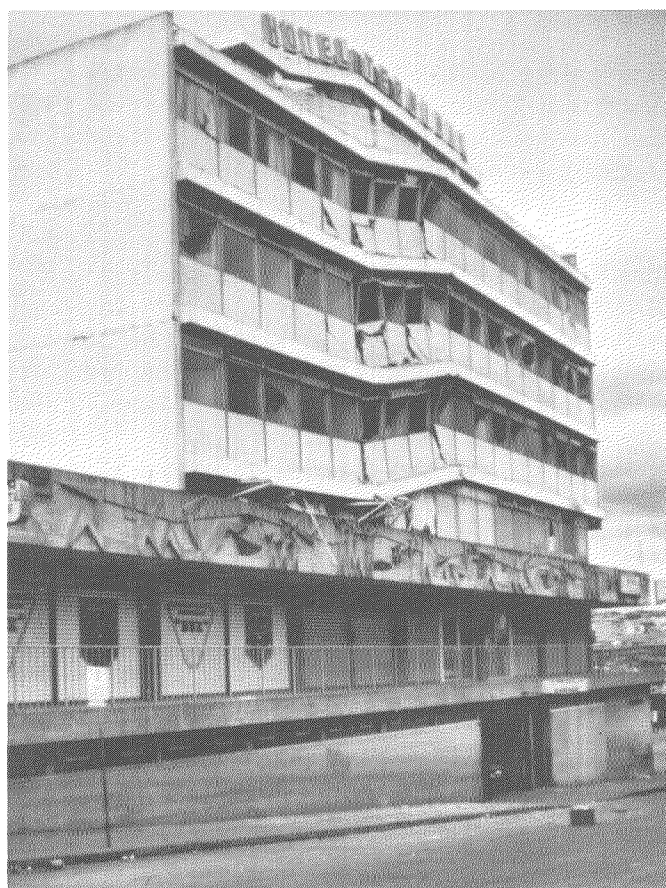
FIGURE 73.—Hotel Terminal in Guatemala City. Columns in third story collapsed.

In general, building performance ranged from good to excellent, but several spectacular failures occurred. For example, in the Hotel Terminal (fig. 73), columns failed in the third story (fig. 74). Another example is the dormitory-classroom unit of the Catholic Boys School (Colegio San Javier), which collapsed owing to failure of its second-story columns (fig. 75). Figure 76 shows a collapsed column at the second floor of this unit. The time of night at which this earthquake occurred prevented major life loss in this building, since the first and second floors are used as classrooms.
