2 Site Observations

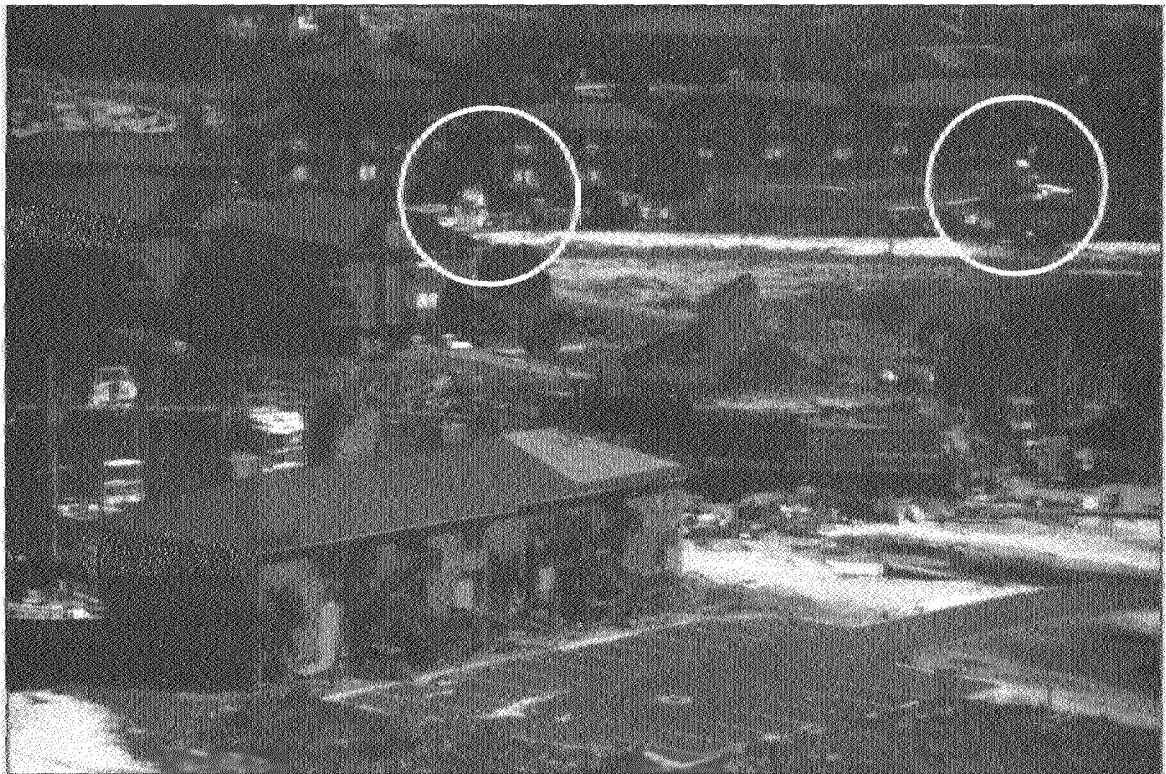
Figure 2-1 Debris washed inland as a result of surge action from Hurricane Opal (note circled boats).

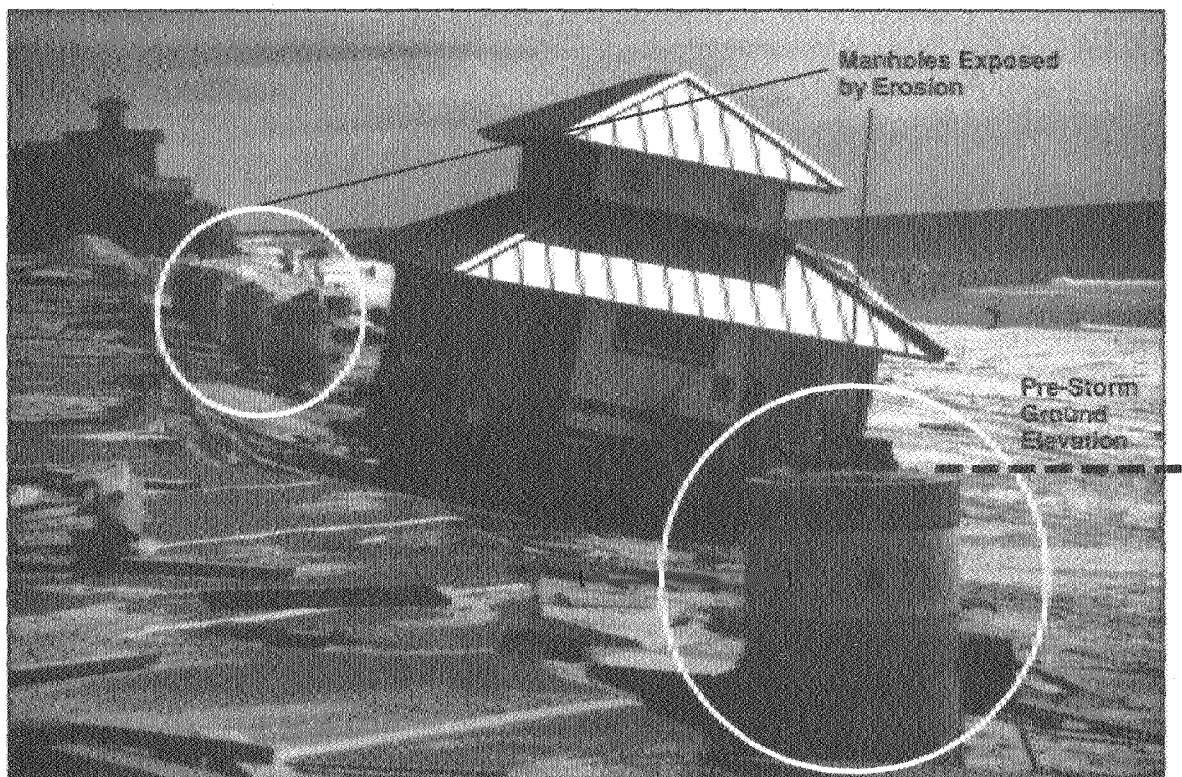
Figure 2-2 Beach erosion caused major damage to structures, as well as roads and utilities.
