### **2.3.1 EROSION AND SCOUR**

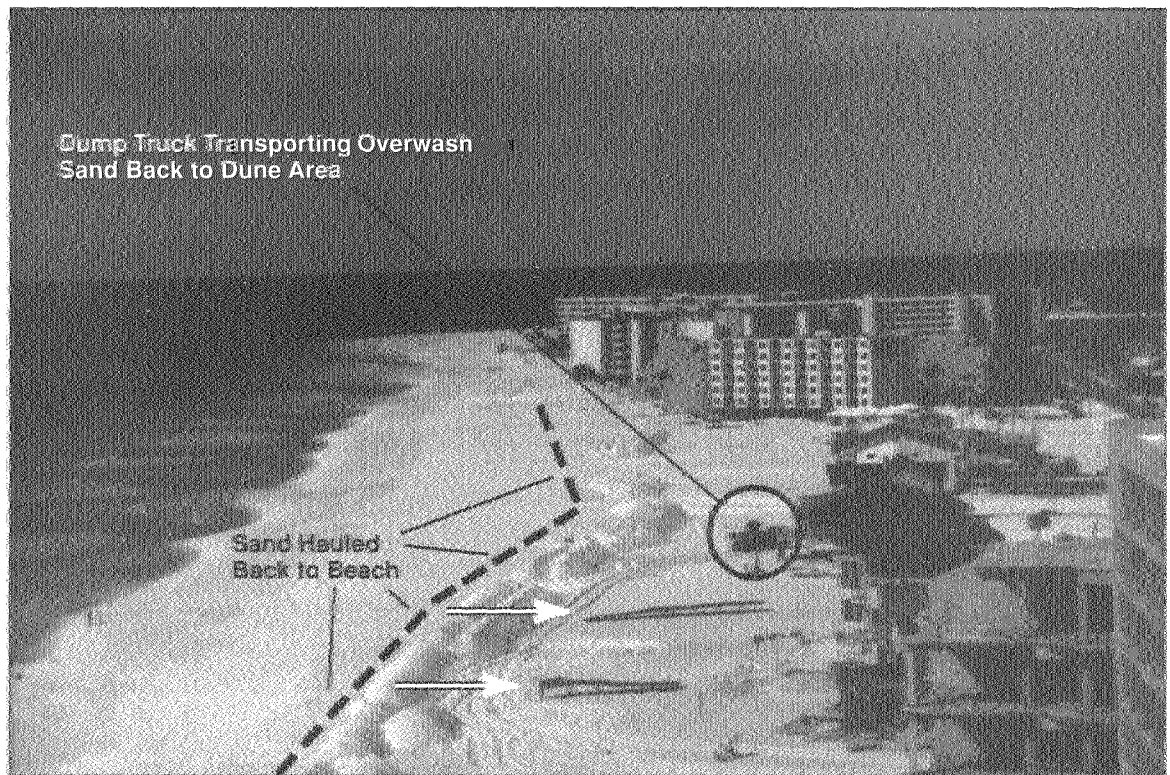
Where sand dunes existed before Hurricane Opal, significant loss of dune height and width was observed. Many dunes were breached or flattened (see Figure 2-3). Those that remained after the storm were scarped and weakened. Duneface retreat of 75 feet to 100 feet was observed in several locations. Overwash of eroded dune sediments was common, sometimes extending over 500 feet inland and causing burial of roads and at-grade construction by 1 to 4 feet of sand.

Figure 2-3 Beach erosion eliminated protection for structures. It is important that the beach and dunes be rebuilt as soon as possible. Arrows point to walkways used to traverse dune that has been washed away.

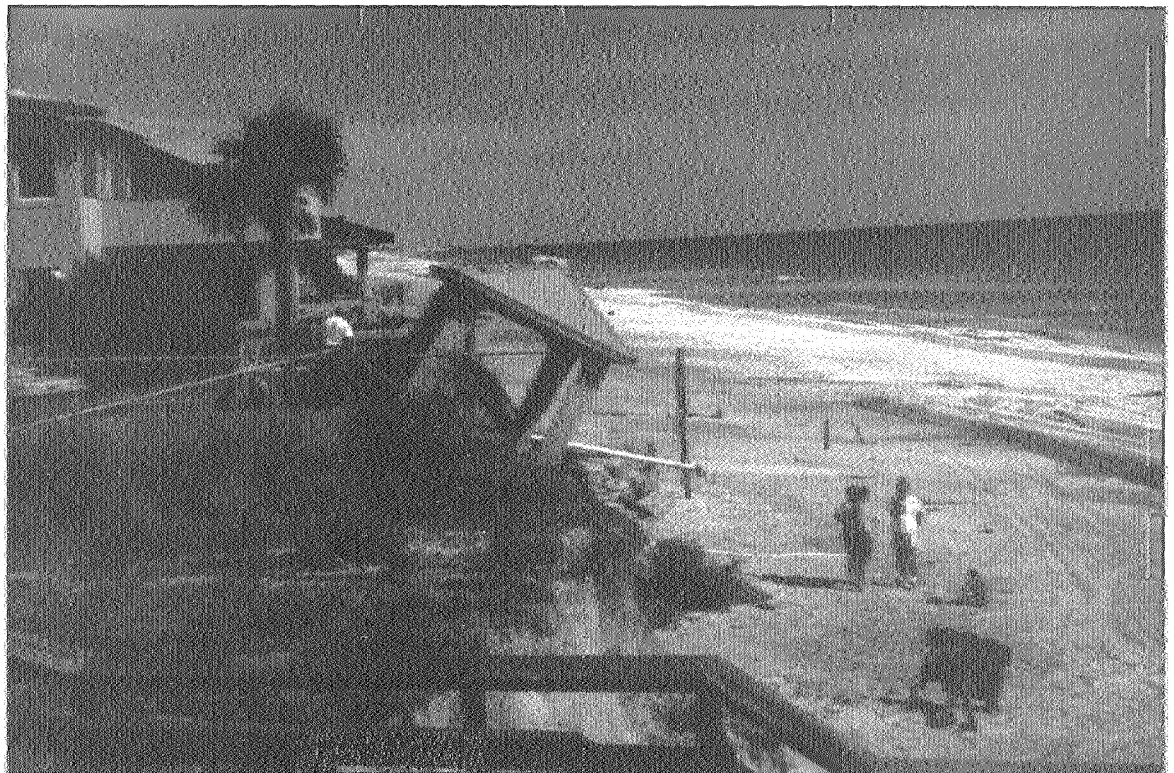
In some cases, an estimated 10 to 20 feet of vertical relief was lost at the seaward edge of high dune and bluff areas. Many structures atop high dunes or bluffs collapsed because of a loss of support, either from the undermining of slab foundations or from inadequate pile embedment (see Figure 2-4).

Figure 2-4 Erosion such as this took place along the gulf coast, causing structures to be undermined and resulting in damage.
