2.3.4 PILE AND PIER FOUNDATIONS

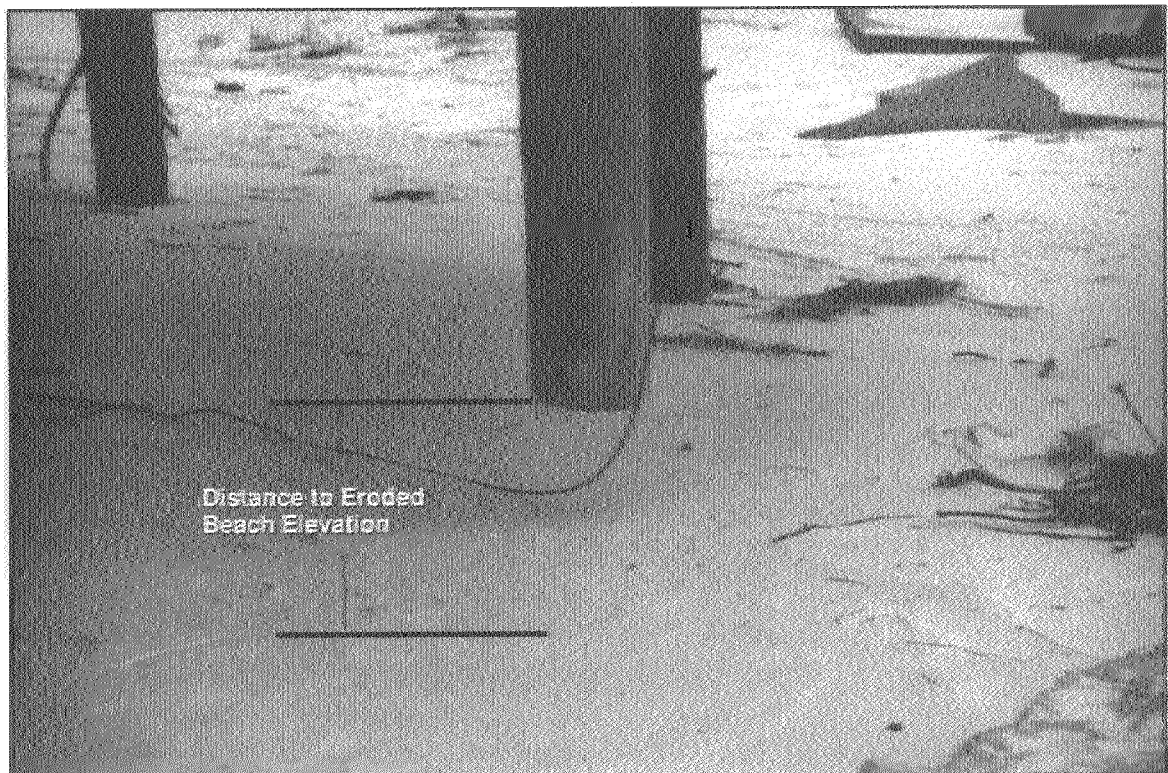
Three to seven feet of vertical erosion at the seaward row of piles was common (see Figure 2-7). This erosion, coupled with insufficient penetration of the piles on many structures, led to structural damage to or collapse of primarily pre-FIRM structures. Undersized piles (6-inch diameter timber in some instances) were not sufficient to resist storm forces; they generally failed and resulted in structural damage or collapse. Piers constructed of concrete blocks on shallow footings frequently collapsed as a result of erosion. Well-designed and well-constructed pile and pier foundations withstood the forces exerted by the storm. Use of splicing techniques was also observed on some eroded piles (see Figure 2-8). Although the splicing of piles placed these structures at increased risk of failure, no failures related to spliced piles were observed.

Figure 2-7 These piles were not embedded deep enough to survive the erosion of the sand. As a result, there is now a large gap between the bottoms of the pilings and the ground surface.
