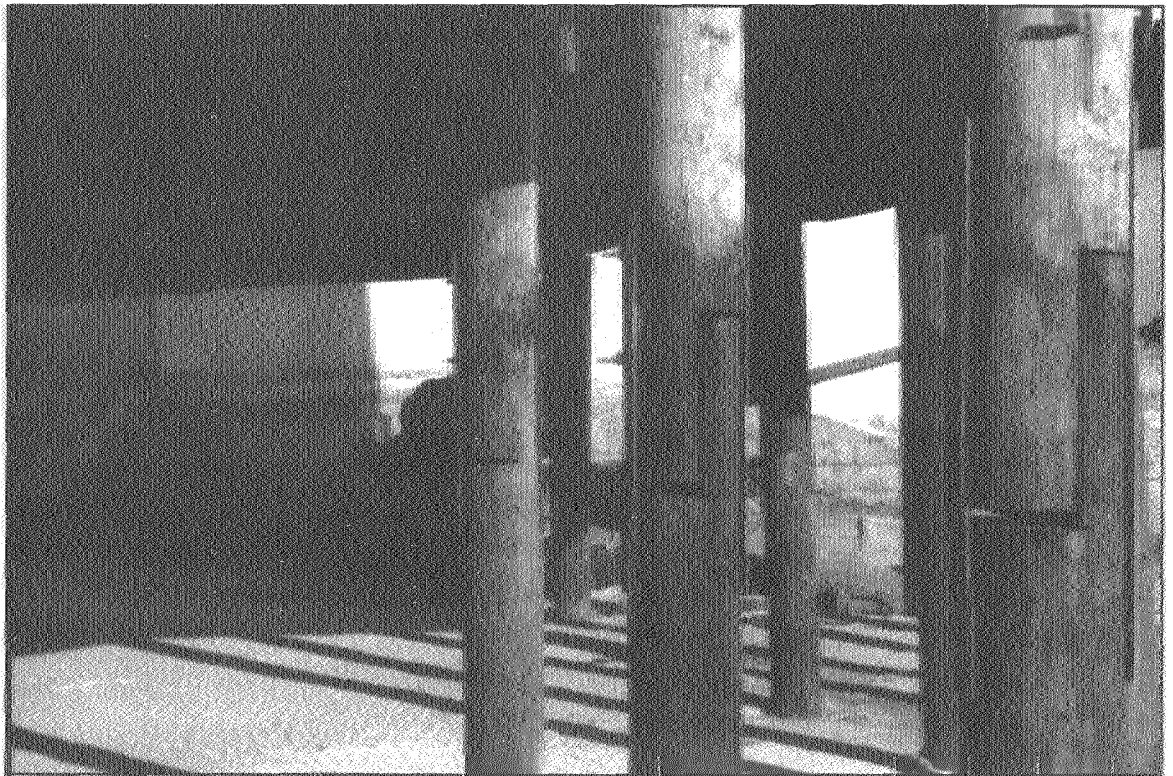
Figure 2-8 These piles were not long enough and were spliced to add depth. The splicing was exposed by storm-induced erosion.
