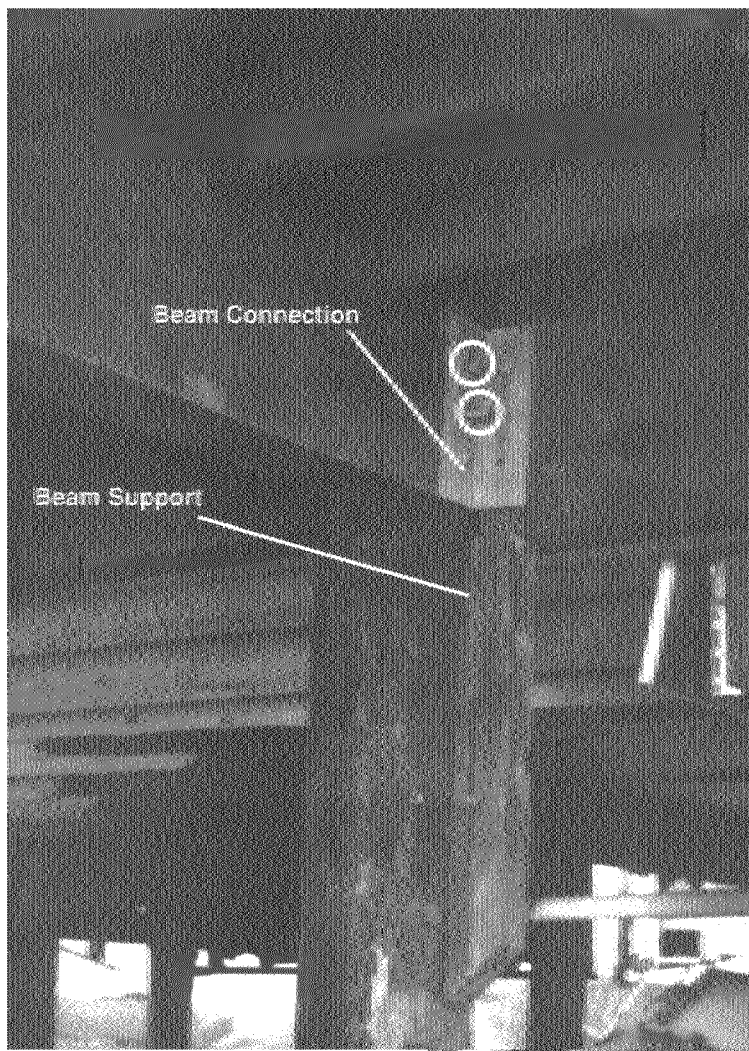
*Figure 2-9*

*The floor beam connection and beam support shown here illustrate the lack of design and proper construction observed on many damaged structures. Note the bolt pullouts (circled). Also, the beam support is attached to the pile with lag bolts rather than bolts that extend through the pile.*

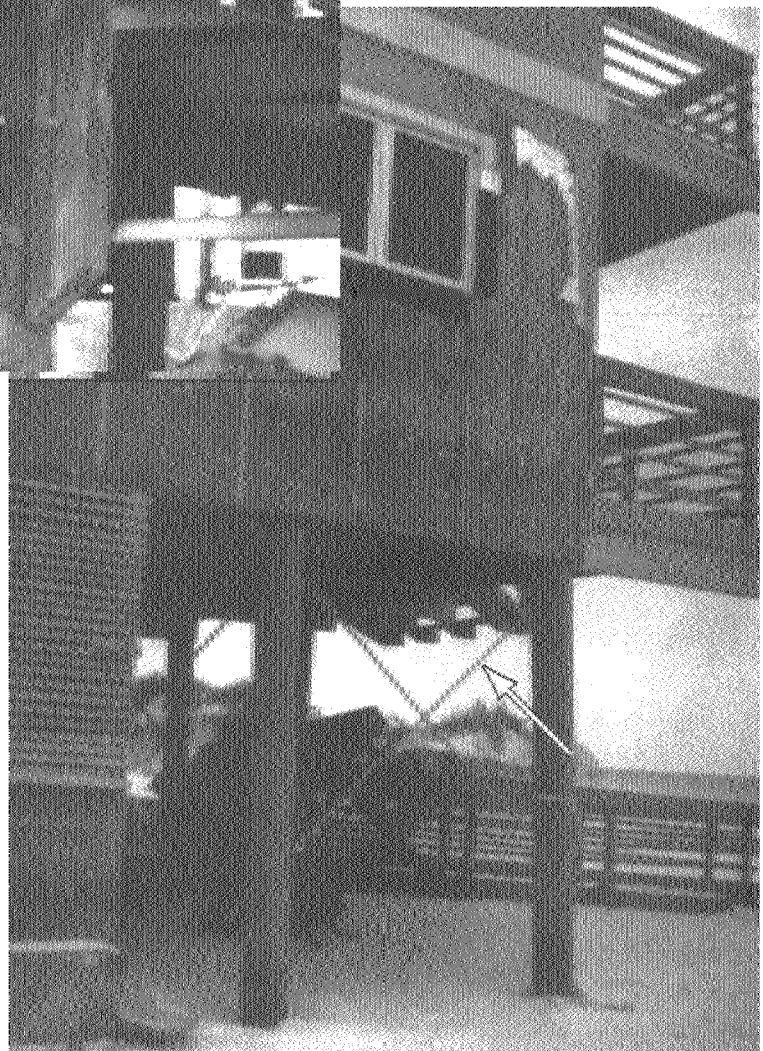
*Figure 2-10*

*This undamaged threaded rod & turnbuckle (arrow) cross-bracing continues to provide additional support as designed.*
