### 2.3.11 SEAWALLS

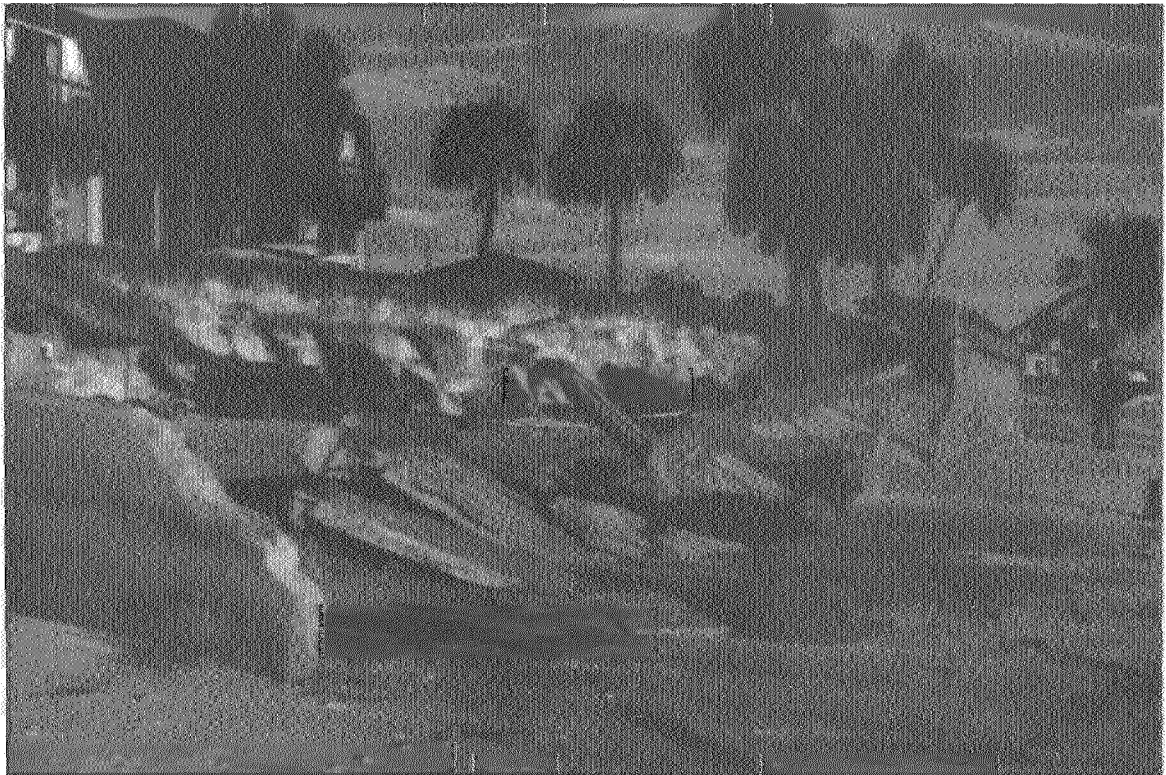
The BPAT observed widespread failure of seawalls and bulkheads along the Gulf of Mexico shoreline (see Figure 2-15). Damage figures from the State of Florida revealed that over 3 miles of seawalls and bulkheads were destroyed by Hurricane Opal, including 1.3 miles of concrete walls, 1.0 mile of concrete block walls, and 0.8 mile of timber walls (FDEP 1995). Failed walls contributed to damage of buildings, pools, and other structures, due to loss of backfill and generation of debris.

Many walls appeared to have failed because wing walls or return walls were flanked by erosion and scour. Many seawall returns flanked by erosion and scour were no more than 20 to 30 feet long, although some longer returns (50 feet to 75 feet) were also flanked.

Seawalls were usually destroyed when backfill was washed from behind the walls because of overtopping, insufficient wall embedment, or return wall flanking. Habitable structures founded on slabs or shallow foundations, swimming pools, and other structures that relied on seawalls to retain supporting soil, were frequently undermined and destroyed when seawalls failed.

*Figure 2-15 Fractured seawall, damaged by storm forces. Note the erosion of the bank behind the wall*
