## **3 Assessment and Characterization of Damages**

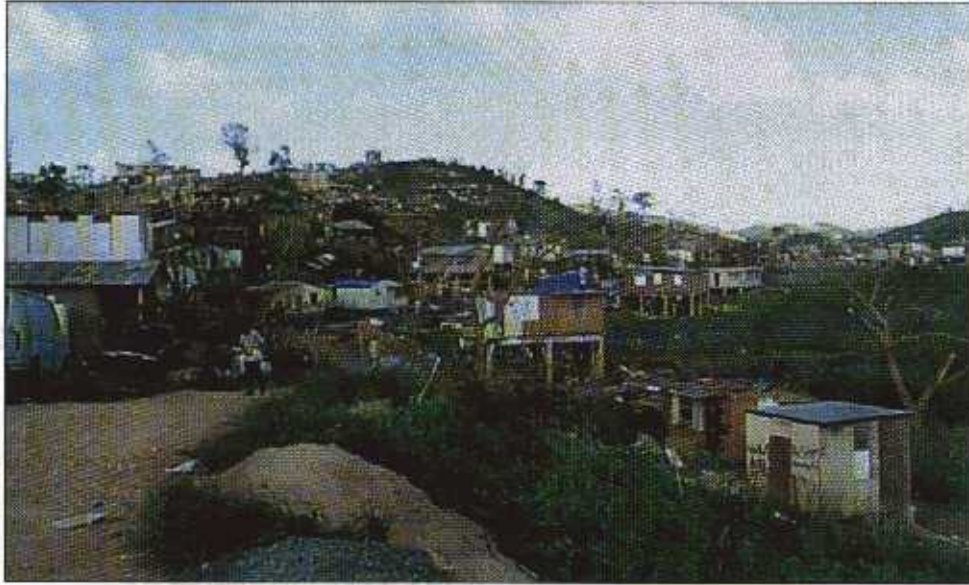
The siting of structures affected the wind forces that acted upon the building. Lower areas were sometimes shielded from winds by hills or mountains. Buildings on high exposed slopes appeared to receive higher wind speeds because of the speedup of the wind up the slopes of the hills or mountains (due to topographic effects and described in ASCE 7-95) (Figures 3-1 and 3-2). The significance of these topographical effects is not recognized in Planning Regulation 7, but is accounted for in the newly adopted 1997 UBC. The 1997 UBC references ASCE 7-95 for the determination of wind speeds. These wind speeds may be adjusted to incorporate topographic effects on wind speeds.

**FIGURE 3-1** The abrupt change in topography in this community outside Loiza caused a speedup in the wind that flows over and around the buildings located on the hill beyond. The wind load provisions of Planning Regulation 7 did not account for wind speedup caused by abrupt changes in topography, and therefore underestimated wind loads on buildings situated on hills, mountains, or escarpments.

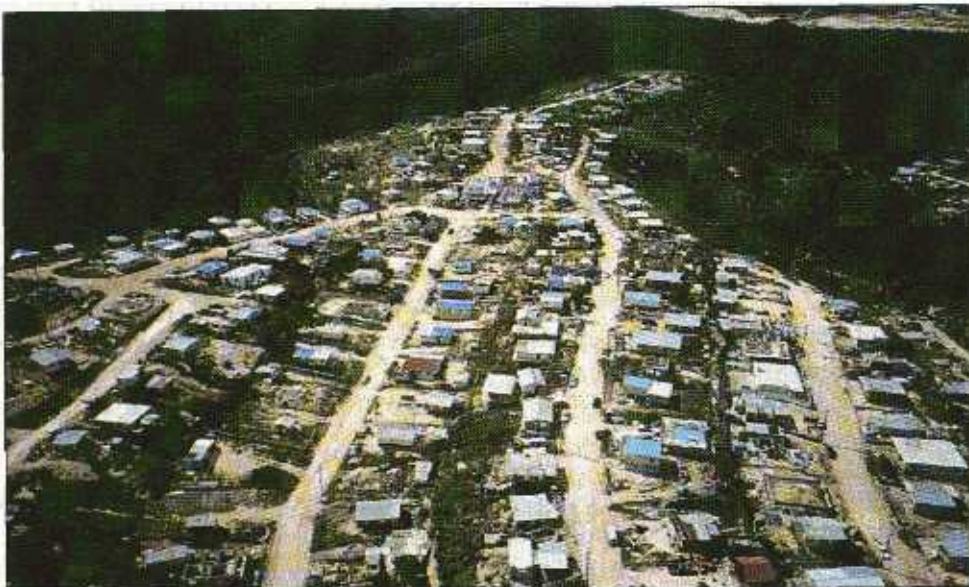
**FIGURE 3-2** Wind damage from Hurricane Georges to residential buildings in Puerto Rico. Blue FEMA tarps have been placed on many of the roofs that sustained damage.

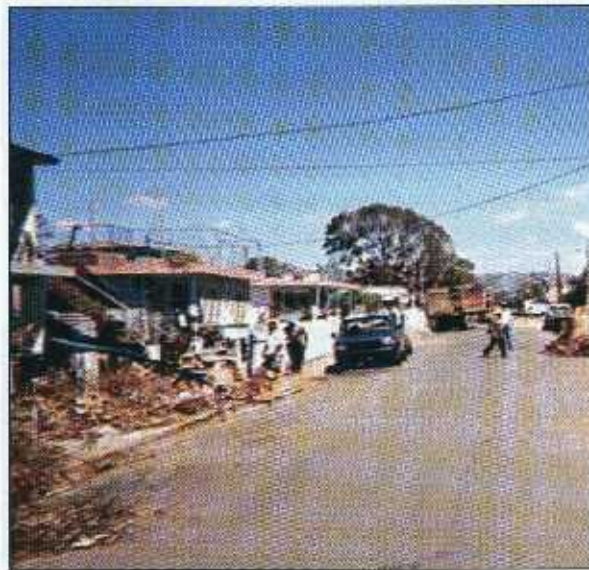
**FIGURE 3-3** Typical non-elevated structures in a community located entirely in an SFHA.

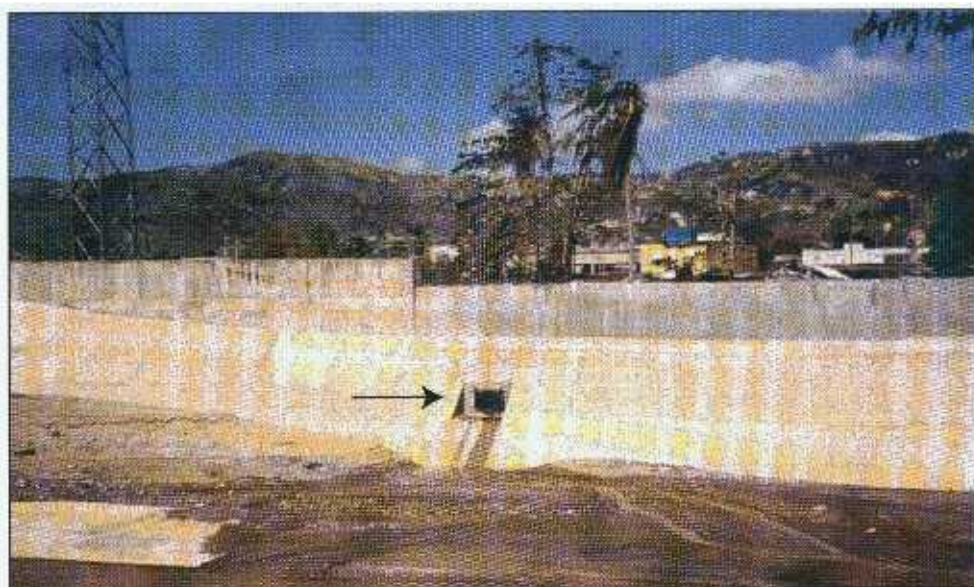
**FIGURE 3-4** This flood gate located in Adjuntas prevented backwater from flooding homes located behind it; however, the wall contributed to flooding in the community located on the opposite side of the river, as shown in Figure 3-5.

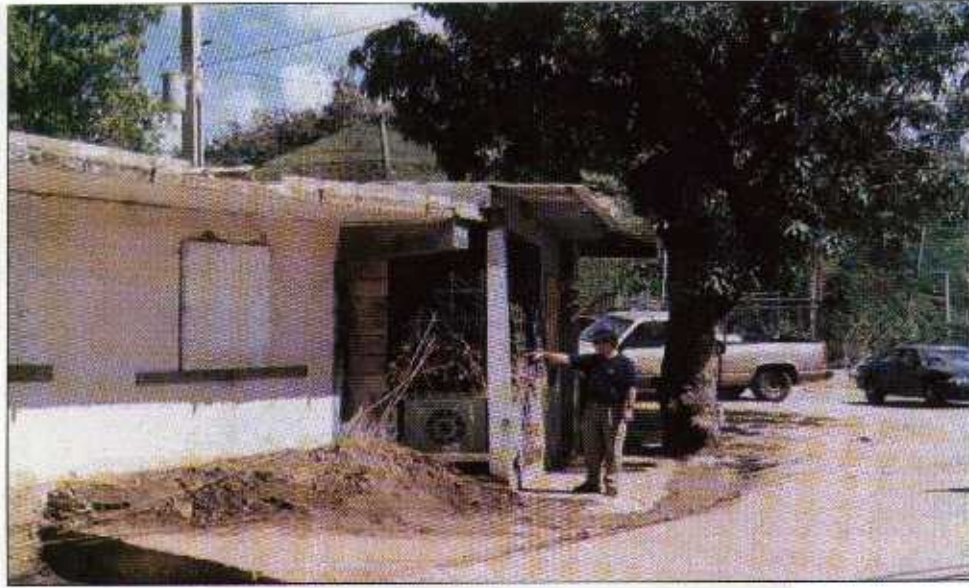
**FIGURE 3-5** Residential area on the opposite side of the river from the floodwall in Figure 3-4. The flooding in this area reached a depth of 5 feet.

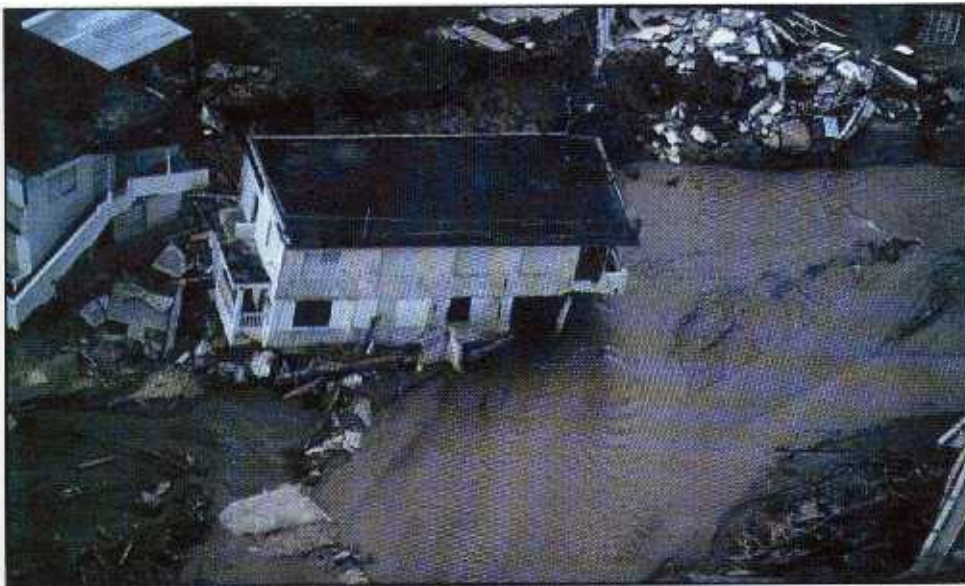
**FIGURE 3-6** Floodwaters eroded soil and undermined the foundation system of this building.

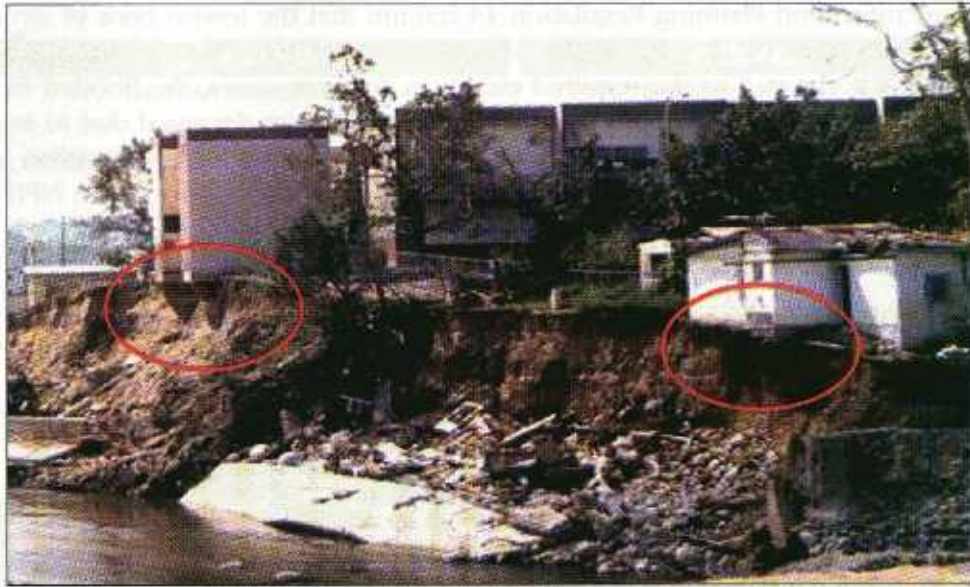
**FIGURE 3-7** Riverbank erosion resulted in the undermining of the building foundations of a school (pink building) and house (white building) in Jayuya.

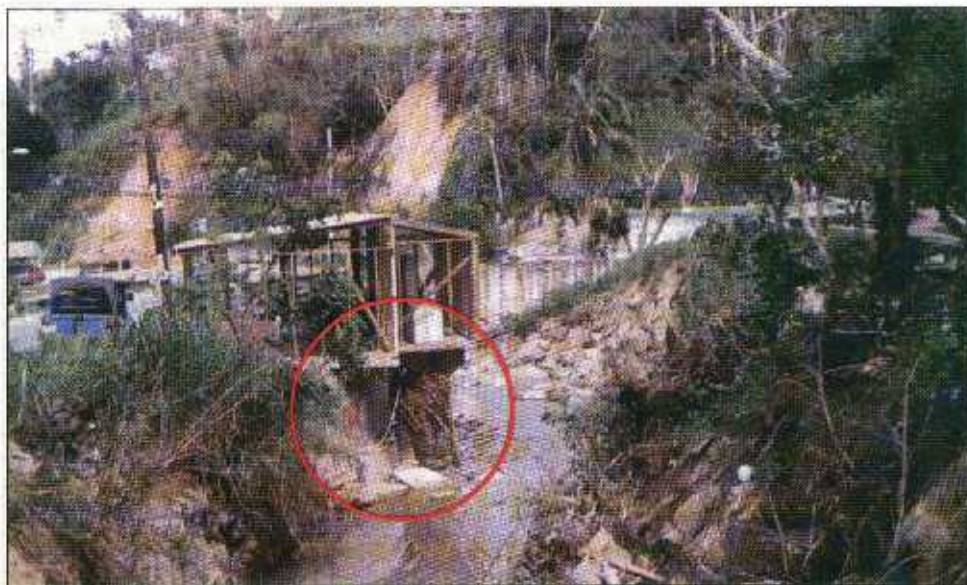
Siting of homes in floodprone areas, such as river and stream beds, was observed throughout Puerto Rico. Figure 3-8 illustrates a home constructed adjacent to and over an existing stream. Structures constructed in this manner are vulnerable to damage from floodwaters.

**FIGURE 3-8** Typical construction adjacent to and over the river. Note the debris trapped under the concrete foundation and between the framing.

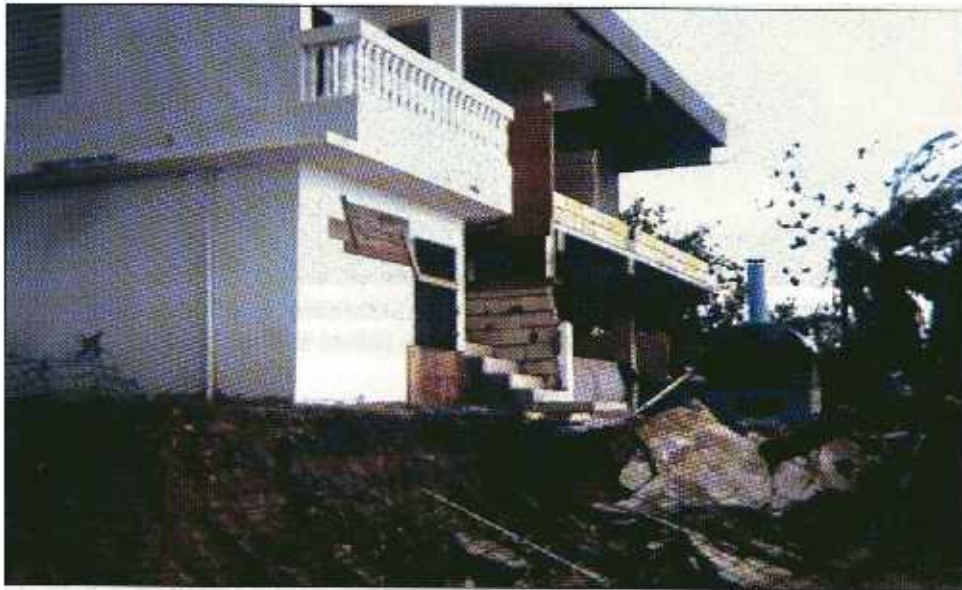
**FIGURE 3-9** Structure along the coast damaged by storm surge and wave action.

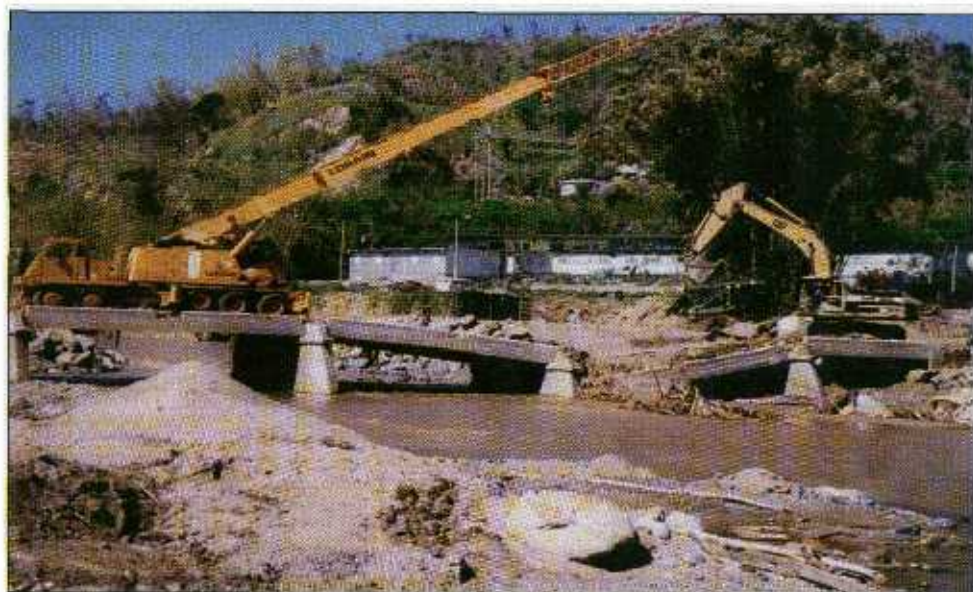
**FIGURE 3-12** This bridge outside Adjuntas collapsed due to insufficient design to resist the effects of floodwaters.

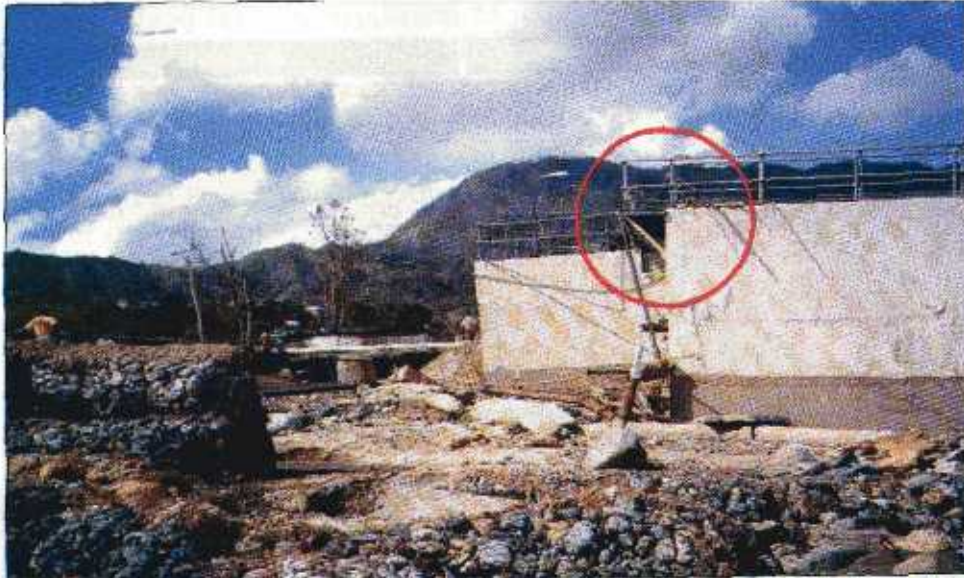
**FIGURE 3-13** Severely damaged water treatment facility located in the floodplain in Jayuya; floodwaters overtopped the concrete wall.

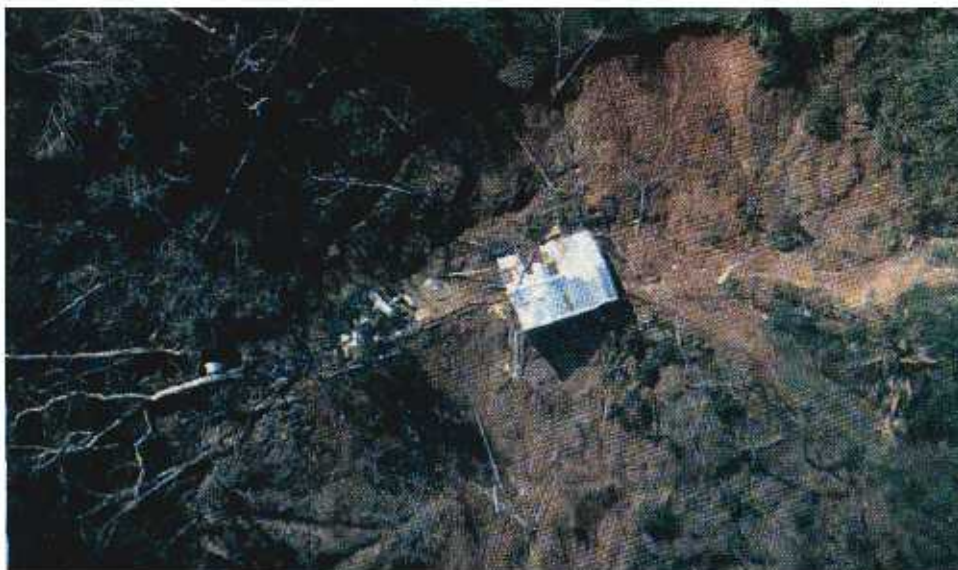
Puerto Rico's steep topography and shallow, sandy soils over bedrock make it susceptible to landslides. During Hurricane Georges, widespread rainfall in the more mountainous regions of the island resulted in numerous landslides that blocked and undermined roads, and even destroyed homes (Figures 3-14 and 3-15). This will become a greater problem in the future as more developments and houses are constructed in regions prone to such risks. A more detailed review and analysis of this problem needs to be undertaken. Figure 3-16 illustrates problems with unrestricted development. Many single-family homes are located beneath a cut that is void of vegetation, making the slope susceptible to landslides.

**FIGURE 3-14** Aerial view of a now uninhabitable house caught in a landslide.
