### 3.4 Overview of Buildings Evaluated

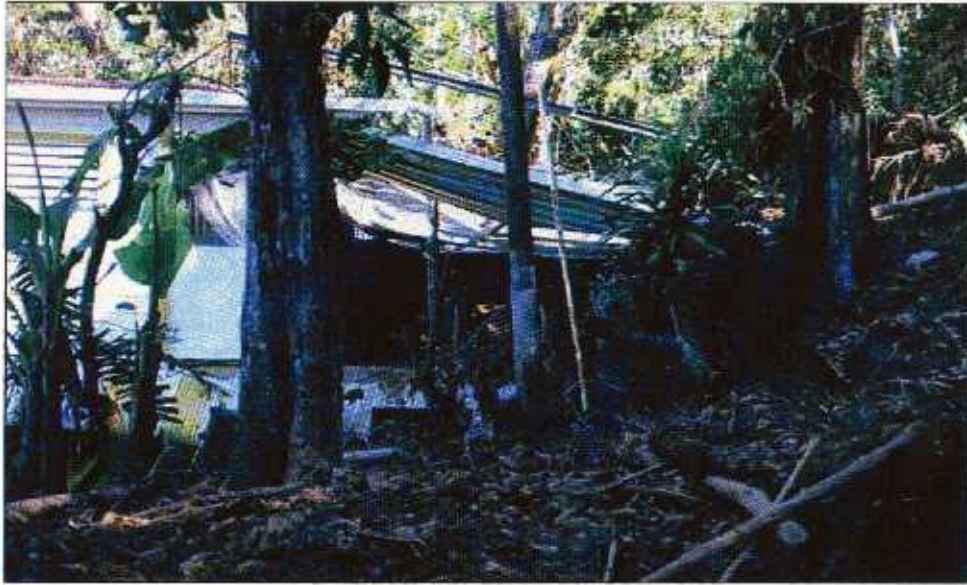
**FIGURE 3-15** A landslide inundated this house with up to 5 feet of soil.

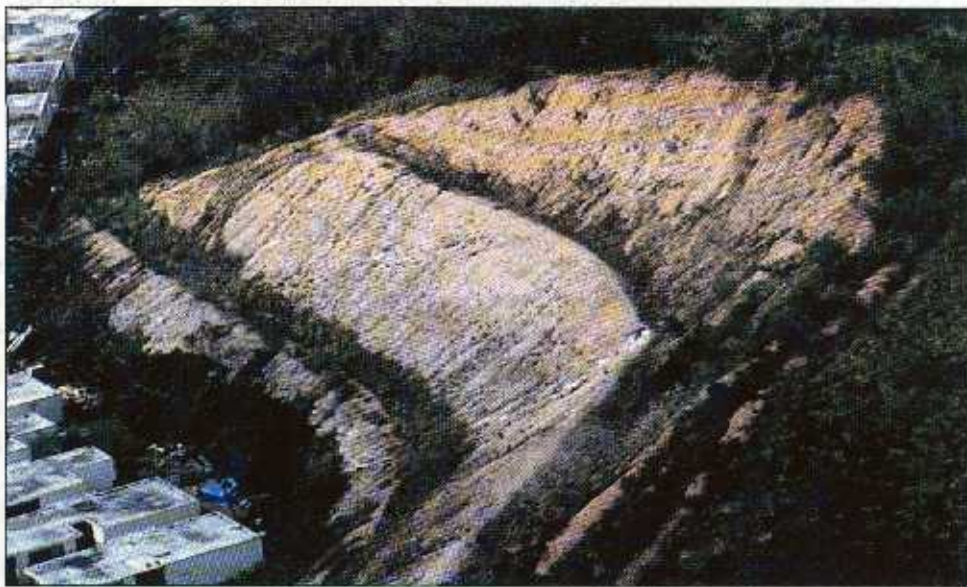
**FIGURE 3-16** Development adjacent to a representative unprotected cut; the potential for future landslide activity exists.

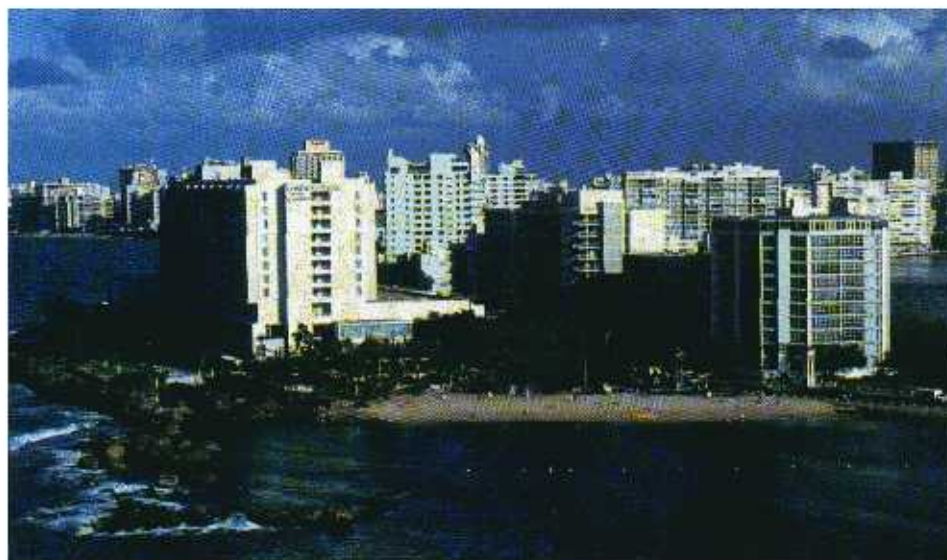
Both residential and commercial buildings constructed of concrete/masonry with concrete roof decks were investigated. Figure 3-17 shows commercial buildings of concrete construction with concrete roof structures. These large buildings performed well structurally during Hurricane Georges. Many, however, experienced significant interior damage and property loss due to breach of the building envelope. Loss of exterior windows due to wind and windborne debris was the primary damage observed (Figure 3-18).

**FIGURE 3-17** Commercial concrete structures with no structural damage. These structures are located to the east of Old San Juan.

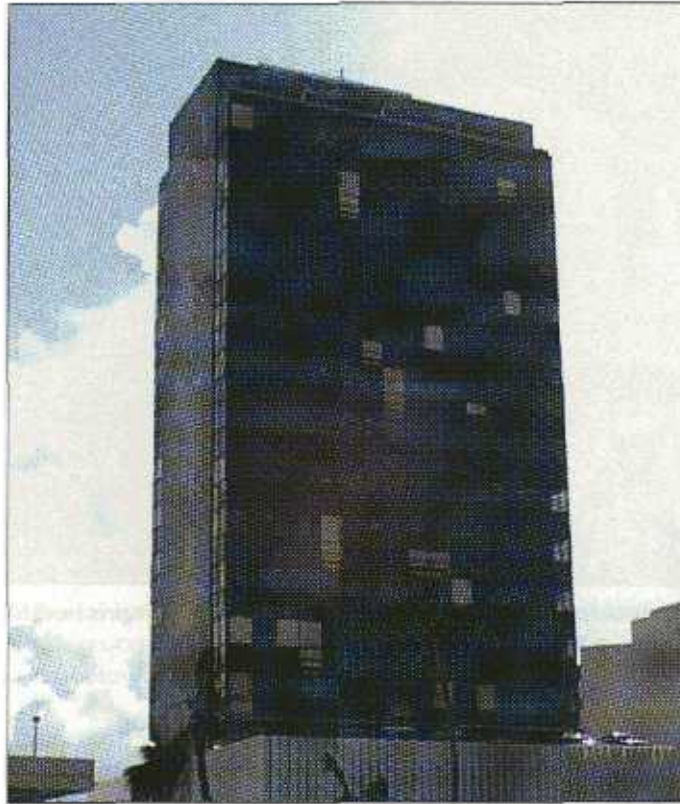
**FIGURE 3-18** Commercial concrete structure with interior damage due to breach of building envelope (failed windows). Note: Plywood sheets were installed after the storm to cover broken windows; they were not present prior to the storm.

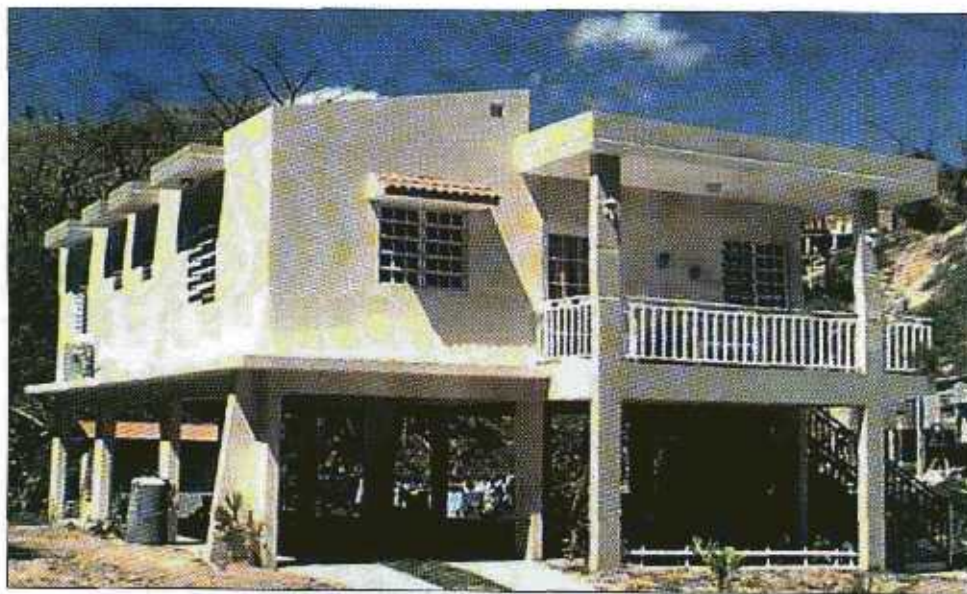
The BPAT observed that single-family homes constructed of concrete, masonry, (or a combination of both) and with concrete roofs performed well with no structural damage (Figure 3-19). These structures were primarily one- and two-story buildings with reinforced concrete columns/piers and both reinforced and un-reinforced concrete masonry units (CMU) block pier foundations supporting elevated concrete floor slabs.

**FIGURE 3-19 Residential concrete structure in the mountains north of Adjuntas with no structural damage following Hurricane Georges.**

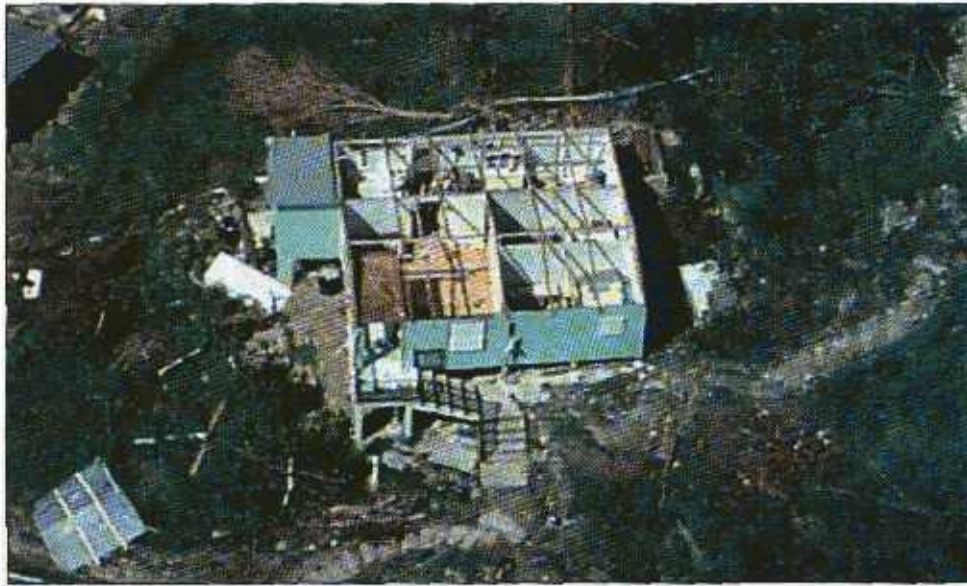
Most roofs inspected were gable roofs; the remainder were low-slope (flat roofs) and hipped roofs. Figure 3-20 represents a single-family home with a wood-frame gable roof structure that experienced a typical roof failure. Failure of roof structures at gable ends has been well documented following previous hurricanes, especially when insufficient attention has been paid to connection details at the masonry walls or to bracing the gable end wall. This was the case in Puerto Rico.

**FIGURE 3-20** Aerial view of a residential concrete/masonry structure with a wood-frame roof structure; only the roof rafters remain. The wood nailers and metal panels were blown off.

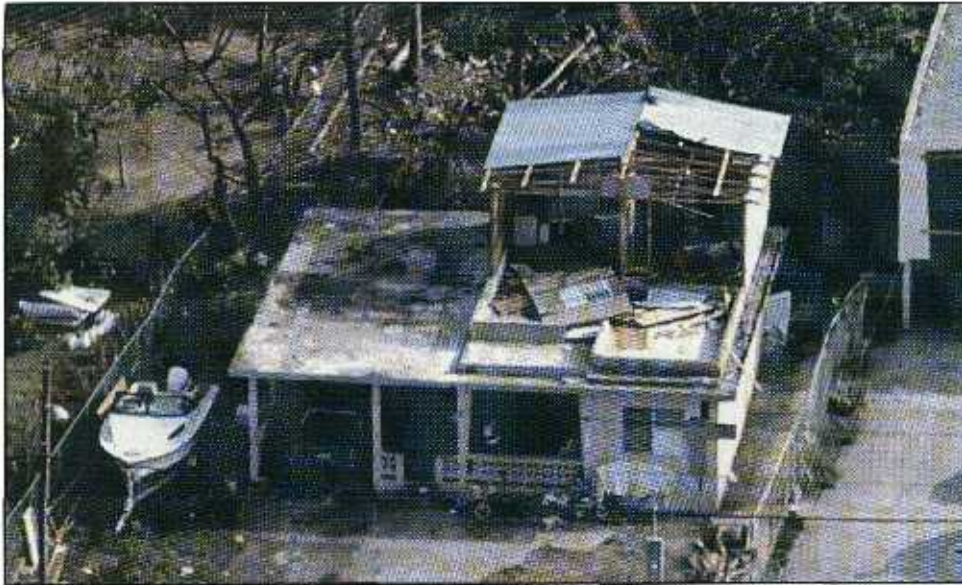
**FIGURE 3-21** A combination residential concrete/masonry structure with an elevated second-floor concrete slab and a wood-framed upper level. Note the lack of damage to the concrete/masonry section of the house and the damage to the wood-frame portion.

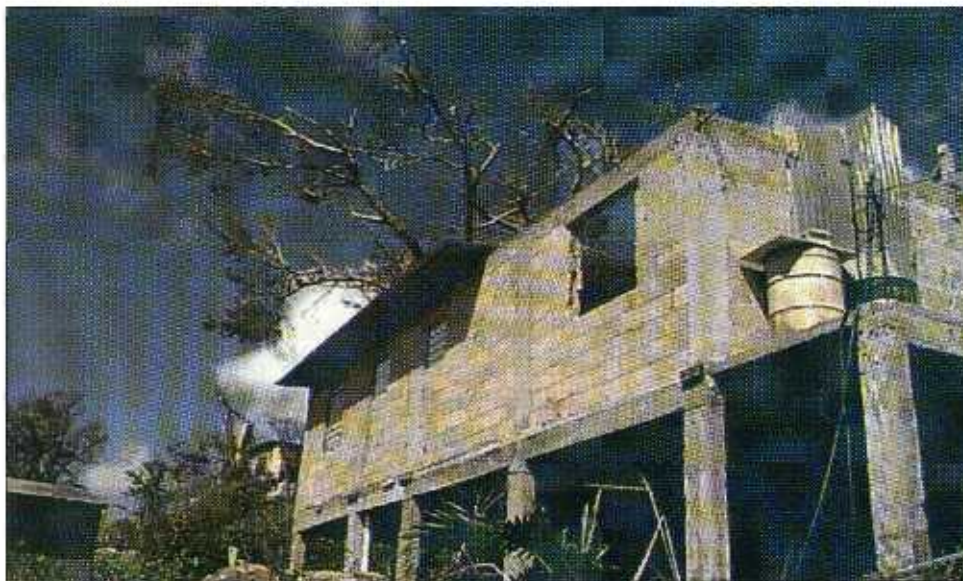
In Figure 3-22, the concrete/masonry building is under construction. Details regarding concrete columns, masonry block, and typical reinforcing steel were observed and noted.

**FIGURE 3-22** A residential concrete/masonry structure that is under construction. The photograph illustrates this common building practice: concrete columns with unreinforced masonry block infill walls. This is not seismic resistant construction.

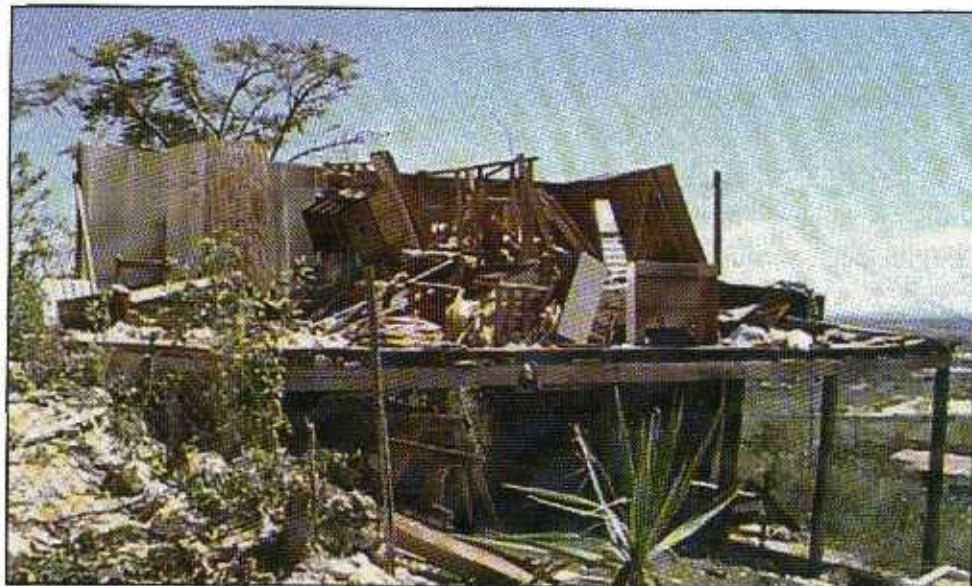
All wood-frame structures were almost exclusively limited to single-family homes. These structures were set atop concrete, masonry, or wood piers and foundations. The load path for wind- and seismic-induced loads from the foundations to the floor systems ranged from bolted steel band connectors to no connectors at all. The walls in these houses were constructed of nominal 2-in by 3-in or 2-in by 4-in lumber. Wall frames were weak with studs spaced up to 4-feet on-center. Sill and bottom wall plates were inadequately fastened to slabs or supporting floors. Stud wall construction contained little to no lateral bracing and only single member top plates. Roof support systems typically were nominal 2-in by 4-in members at 4-feet spacing with nominal 1-in by 3-in nailers supporting metal roof panels. Only a very small number of these structure types had a continuous load path from the roof system to the foundation. Figure 3-23 shows a typical wood-frame home that sustained significant damage during the hurricane.

**FIGURE 3-23** A residential wood structure located on the hilltops west of Ponce destroyed by wind. The roof system has been removed and the wall system partially collapsed.
