4 Structural Performance

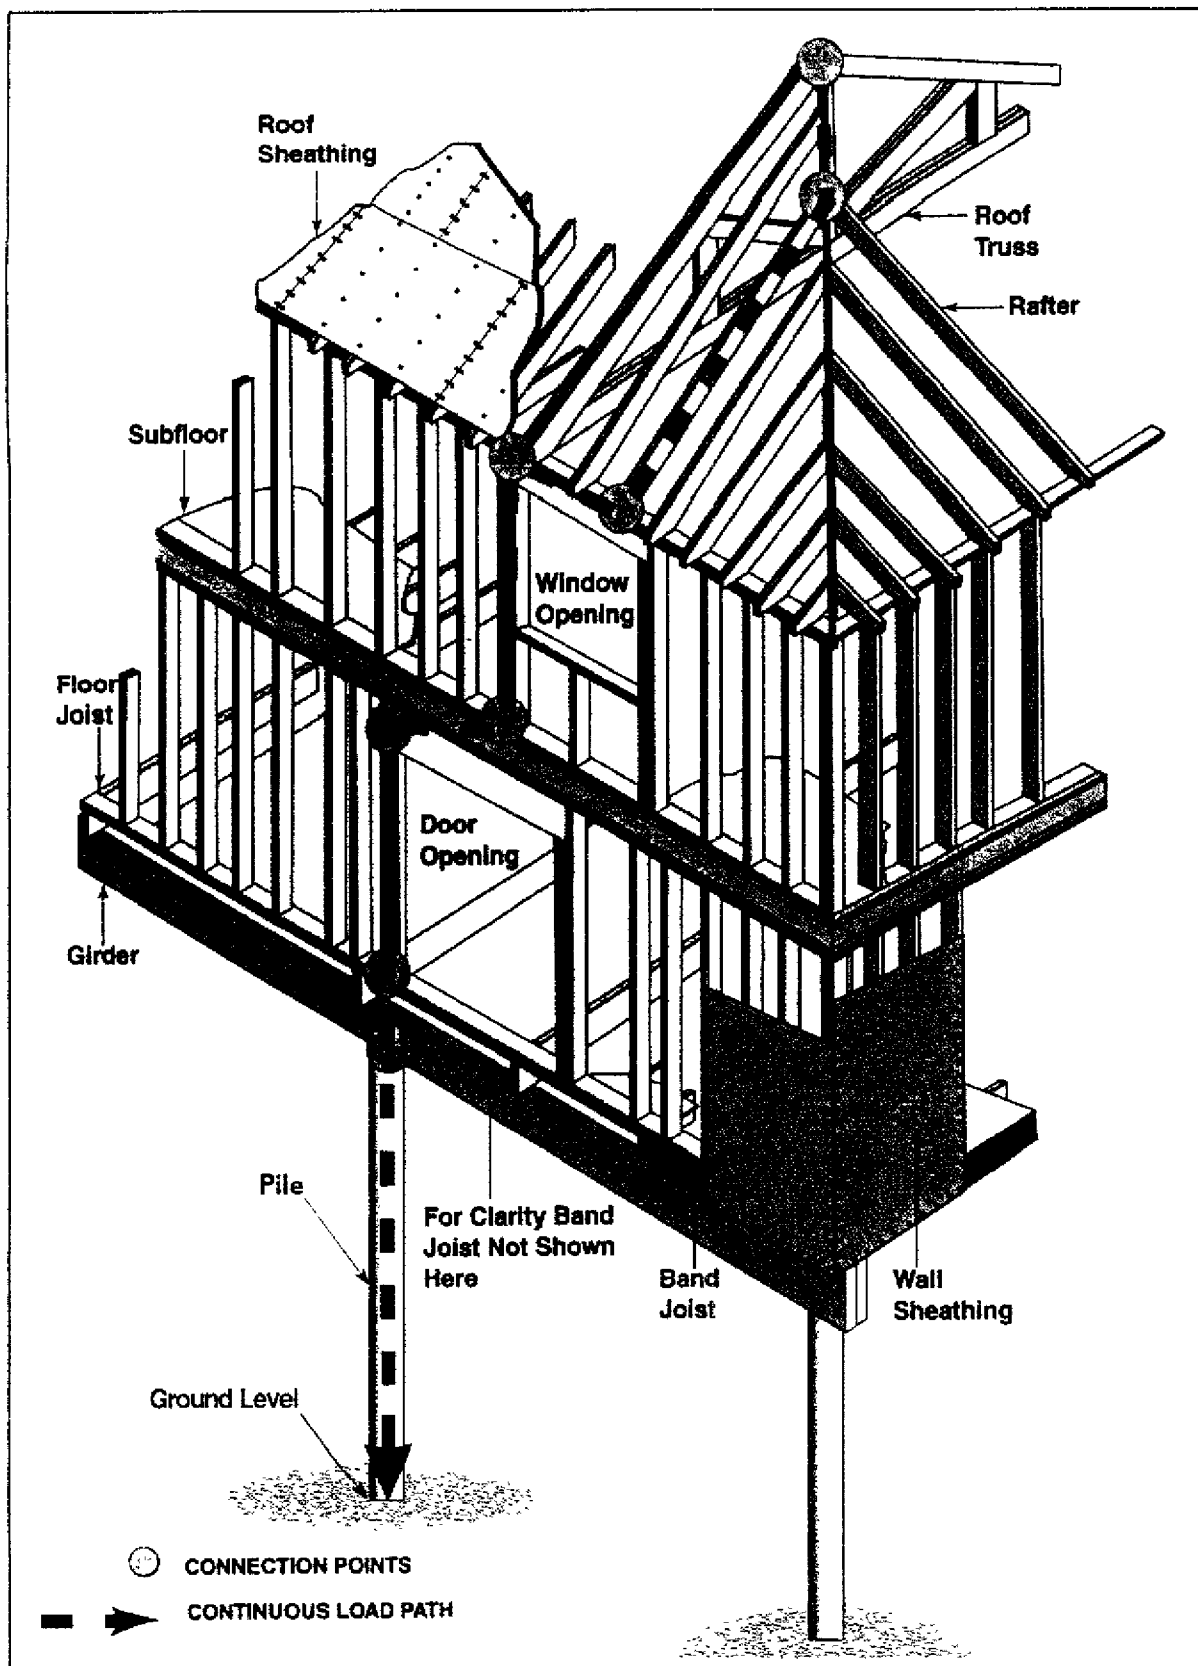
FIGURE 4-1 If a building has a continuous load path, forces and loads acting on any portion of the building will be transferred to the foundation of the building. This transfer occurs through building structural members (i.e., columns and beams) and the connections between these members. In this figure, the load path from the roof structure to the foundation is illustrated for an elevated, two-story wood-frame building.

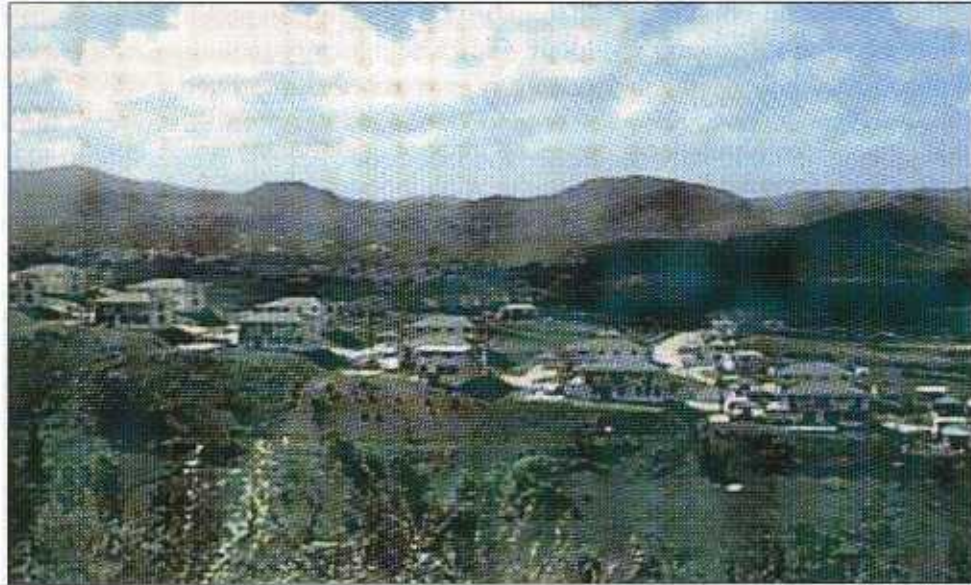
FIGURE 4-2 A residential community constructed of concrete and masonry buildings with concrete roof structures. This community, located to the west of Luquillo experienced no complete building failures. The eye of the hurricane passed to the south of this community, placing it in the strongest wind quadrant of the hurricane.

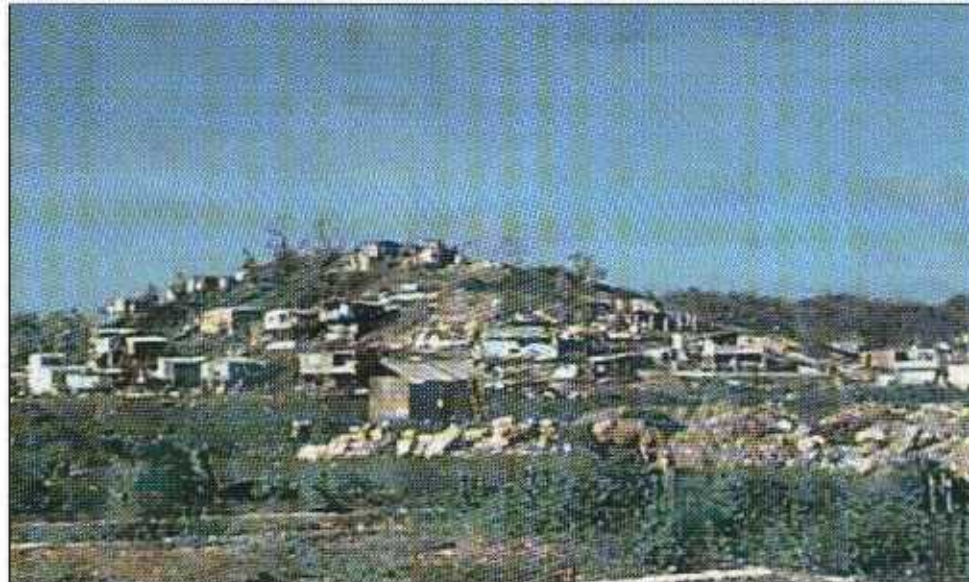
FIGURE 4-3 A residential community constructed of wood-frame structures only. This community located to the north of Canóvanas, experienced significant structural damage and failure to almost all of its buildings. The eye of the hurricane also passed to the south of this community, which is located approximately the same distance from the path of the hurricane as the community in Figure 4-2.

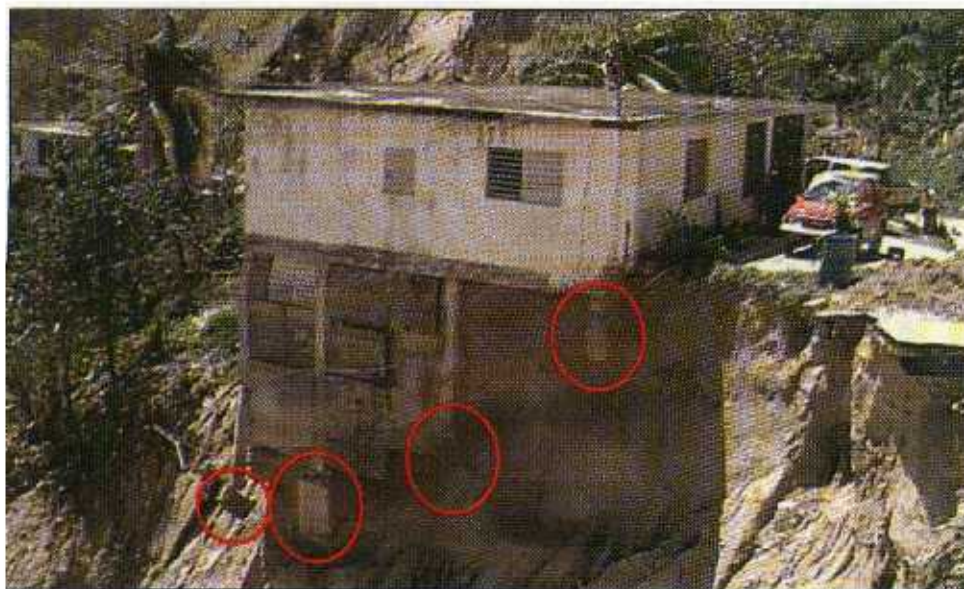
Residential reinforced concrete/masonry structures with concrete roof decks performed well regardless of wind direction or velocity. Concrete masonry structures with wood wall and roof framing generally performed poorly, regardless of siting. High velocity flood waters caused structural damage in SFHAs. Lower velocity floodwaters (also in SFHAs) inundated houses, causing considerable damage inside the buildings. Several concrete and masonry structures were left unstable from riverine and coastal erosion and mountain landslides (Figure 4-4).

FIGURE 4-4 Concrete residential structure with foundation damage caused by a landslide. Note unstable footings (circled).

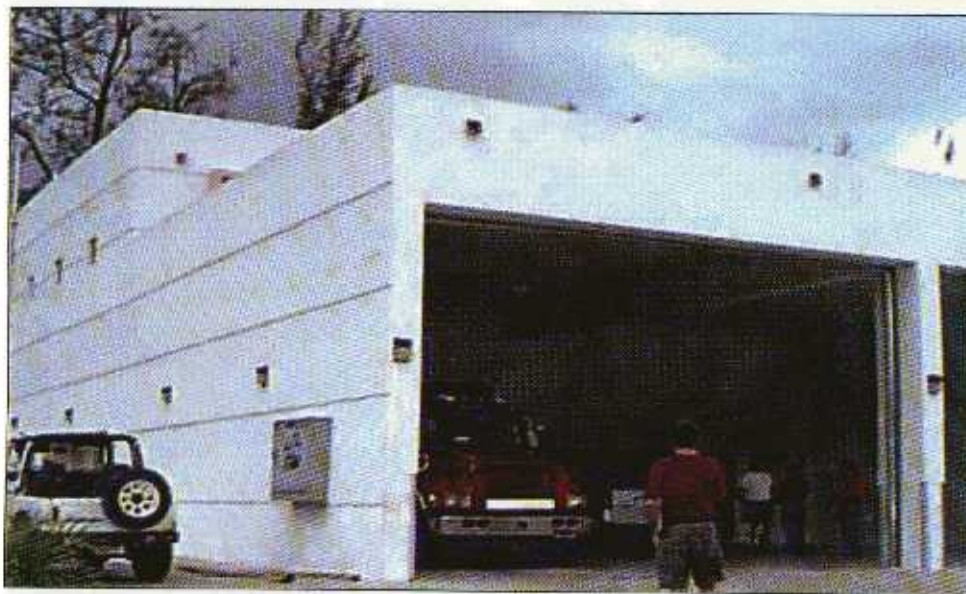
FIGURE 4-5 Fire station in Adjuntas.

The BPAT inspected two fire stations, one in Adjuntas and the other on the island of Culebra, located approximately 20 miles east of the main island. Both fire stations had concrete roof decks. The stucco finish on both buildings prevented a direct observation of the wall systems that reportedly consisted of concrete columns with CMU infill. These structures also had open security grilles in the truck bays rather than large rolling doors. Neither station sustained structural damage during the hurricane. The Adjuntas fire station, which completed construction in 1998, featured a small percentage of exterior windows and an emergency electrical generator that was protected and enclosed within the building envelope (Figure 4-5). The BPAT was unable to determine the seismic resistance of either fire station.

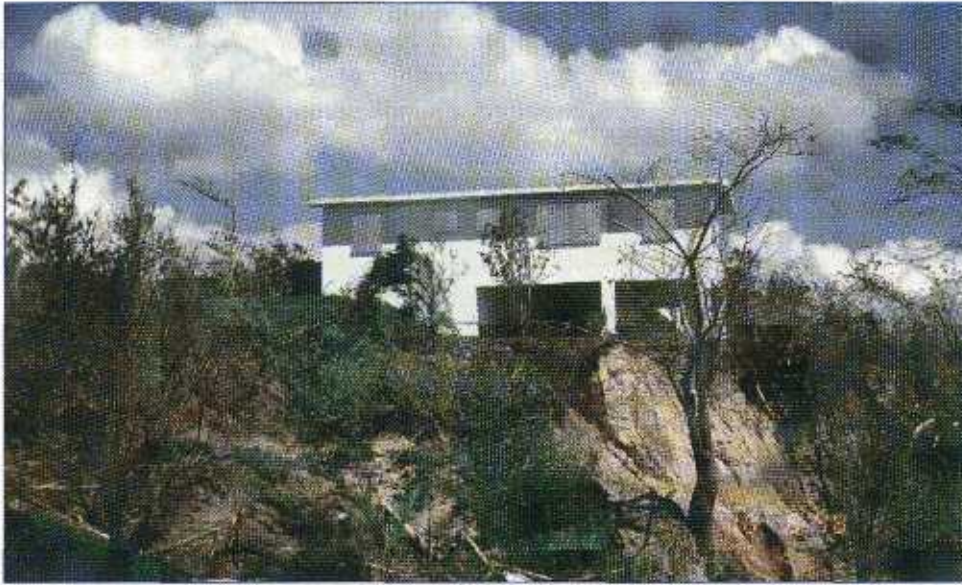
Reinforced concrete buildings (single-family homes) with reinforced concrete roof decks generally did not sustain structural damage (Figure 4-6). First floor walls in reinforced concrete residential buildings were usually 6-in to 8-in thick and constructed of reinforced concrete columns with masonry infill, or were solid concrete walls. CMU walls had varying amounts of reinforcement within the cells. Roof decks typically were flat and constructed of reinforced concrete. Many were exposed concrete with no roof covering. This structure type performed extremely well. Even buildings with unprotected wall openings did not experience structural damage.

FIGURE 4-6 Residential home constructed of reinforced concrete and masonry with a reinforced concrete roof deck in the mountains outside Adjuntas.

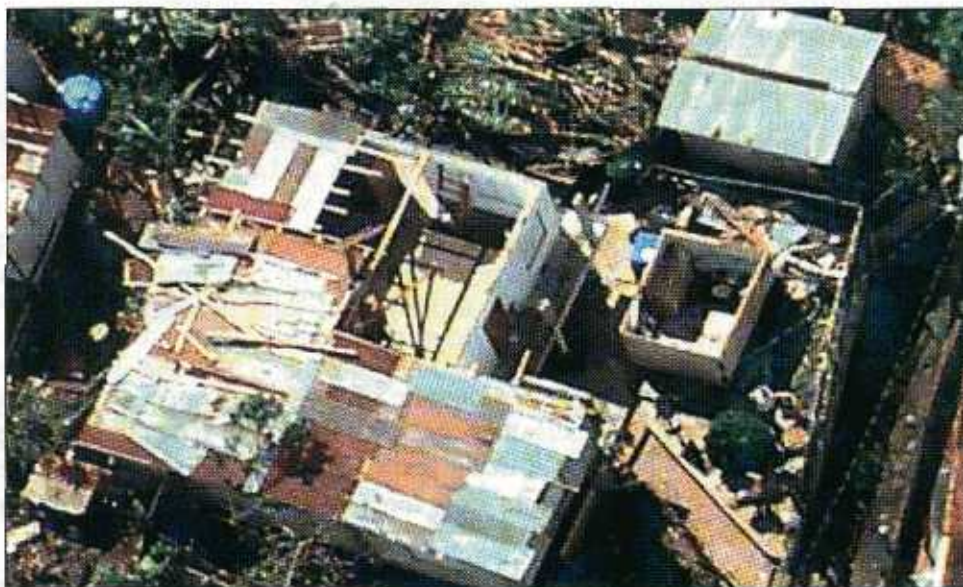
The BPAT investigated a limited number of residential and nonresidential masonry buildings. Most of the buildings observed had wood-frame roof structures that were damaged during the hurricane (Figure 4-7).

FIGURE 4-7 Typical roof system failure between wooden roof system and concrete or masonry wall system.

Rafters ranged from nominally sized lumber, 2-in by 4-in or 2-in by 6-in that spanned 10 feet to 16 feet, and were spaced from 2-feet to 4-feet on center. Rafters were typically toe-nailed to the sill plate and not connected with hurricane clips or straps. The ridge rafters bore on a ridge beam (although sometimes the ridge beam was omitted). No connection other than nailing was generally made at the ridge line. Self-built trusses were also used. Similar to rafters, these trusses were connected only by nails to the sill plate. These trusses were sometimes manufactured by nailing the truss members together by toe-nailing, or by use of nominal 1-in lumber, or plywood for gusset plates. These self-built trusses were inadequate for the wind loads. As a result, widespread wood-frame roof failures were observed (Figure 4-7).

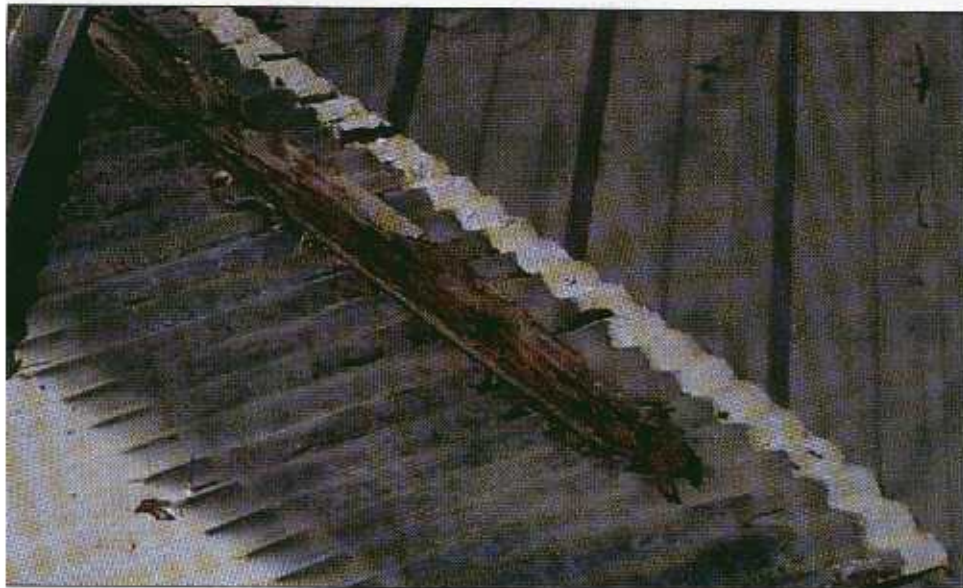
FIGURE 4-8 Termite-damaged wood purlin attached to metal roof panel. The entire roof system of this building failed and is shown in Figure 4-9.

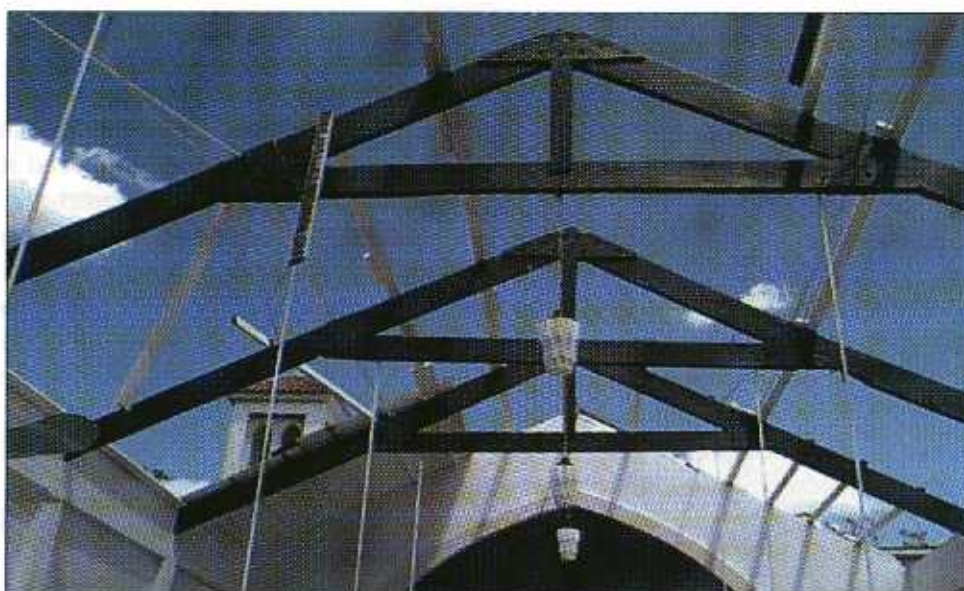
FIGURE 4-9 Masonry wall church that lost roof purlins and its corrugated metal roof. Nails were the only connections used to resist wind loads. The gable ends of this church were unsupported except for purlins resting in the masonry.

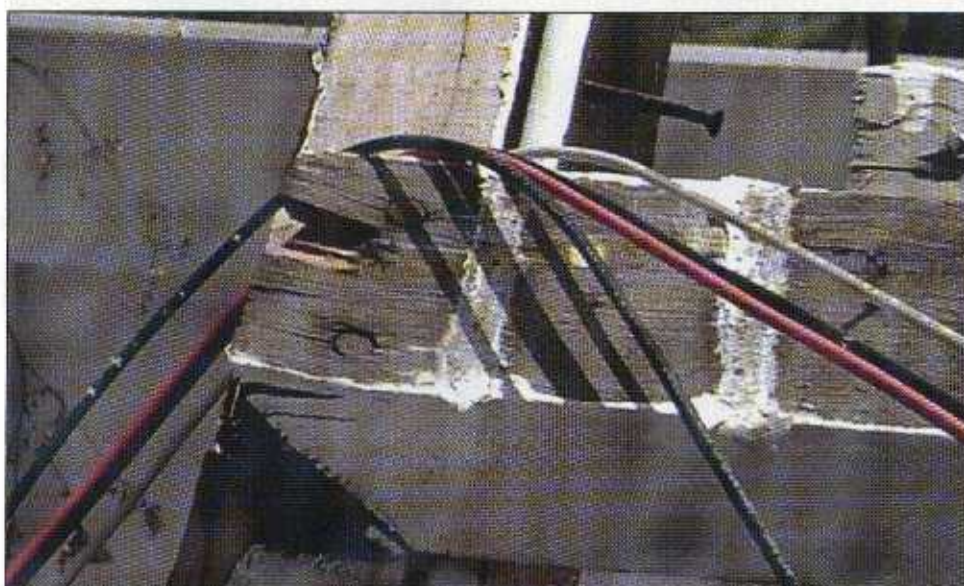
FIGURE 4-10 Nailed roof structure connection from church in Figure 4-9.

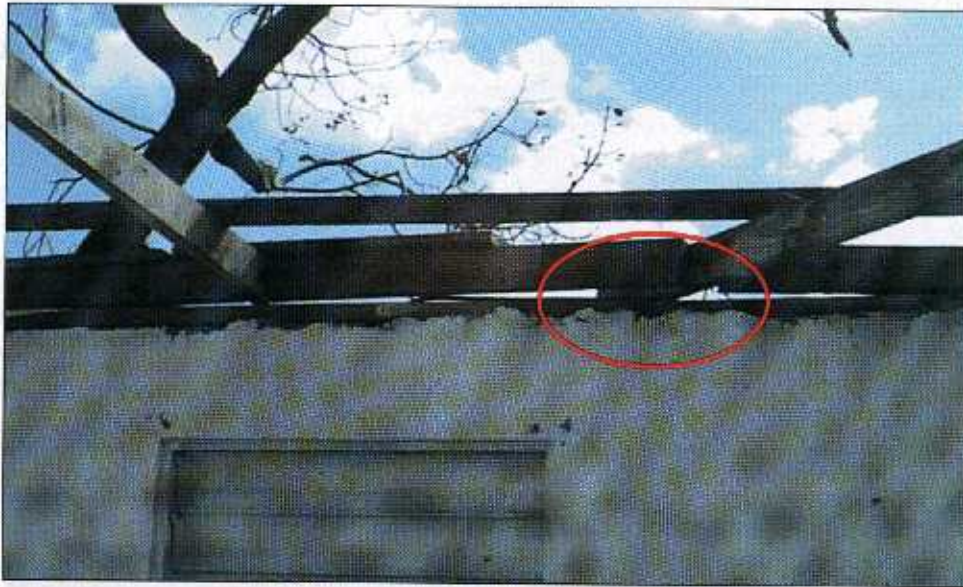
Successes and failures in masonry residential buildings were the same as those observed for concrete buildings. Success depended upon the existence of a continuous load path from the roof structure to the foundation for lateral and uplift loads. Conversely, wood-frame roof structures typically did not have a continuous load path to the foundation and widespread failure due to wind-induced uplift was observed. Figure 4-11 shows a typical nail withdrawal failure of a wood-frame roof/masonry wall connection.

FIGURE 4-11 Typical nail withdrawal failure in a wood-frame structure supported by a masonry wall with little uplift capacity at the connection.
