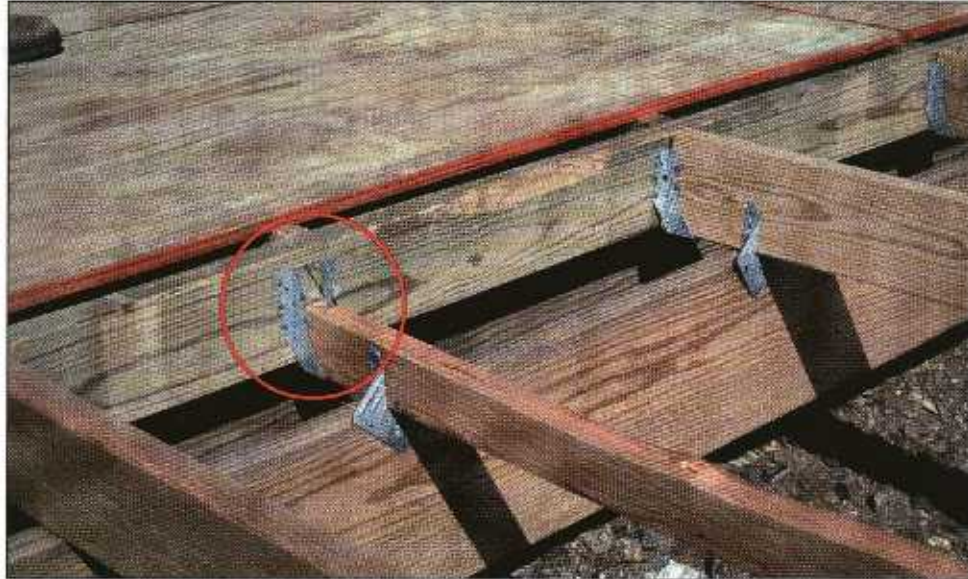
Traditional and inadequate nailing techniques were used on this structure while state-of-the-art clips, brackets, and fasteners were found lying beneath the building. Clips and hangers that were used did not employ the proper nails and failure resulted (Figure 4-13).

FIGURE 4-13 Example of the failure of wood member in the floor joist hanger due to the use of improper nails. The hurricane clip was used to secure the floor joist to the support beam. This house was located on the island of Culebra.

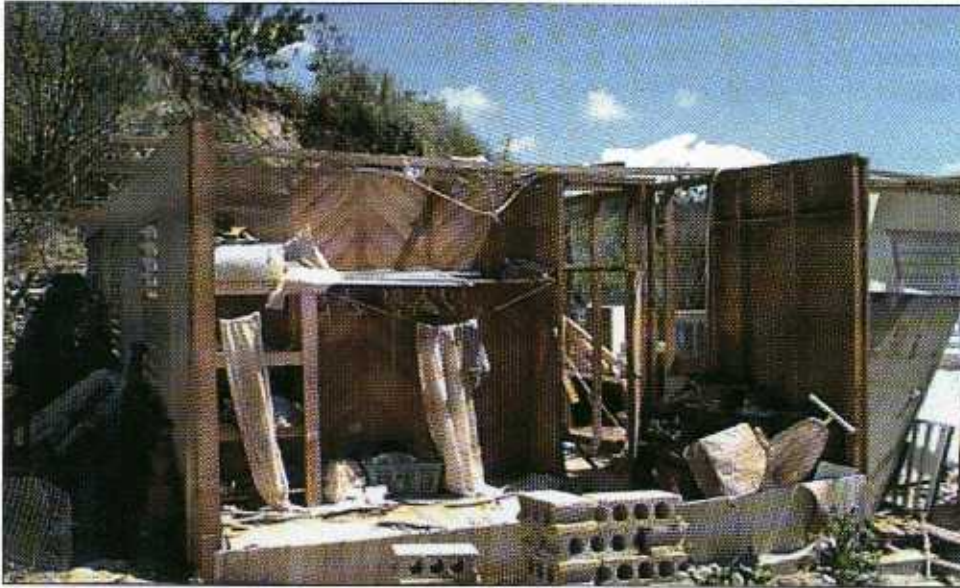
FIGURE 4-14 Example of wood-frame wall construction that failed during Hurricane Georges. This building was not constructed with any hurricane clips or straps.

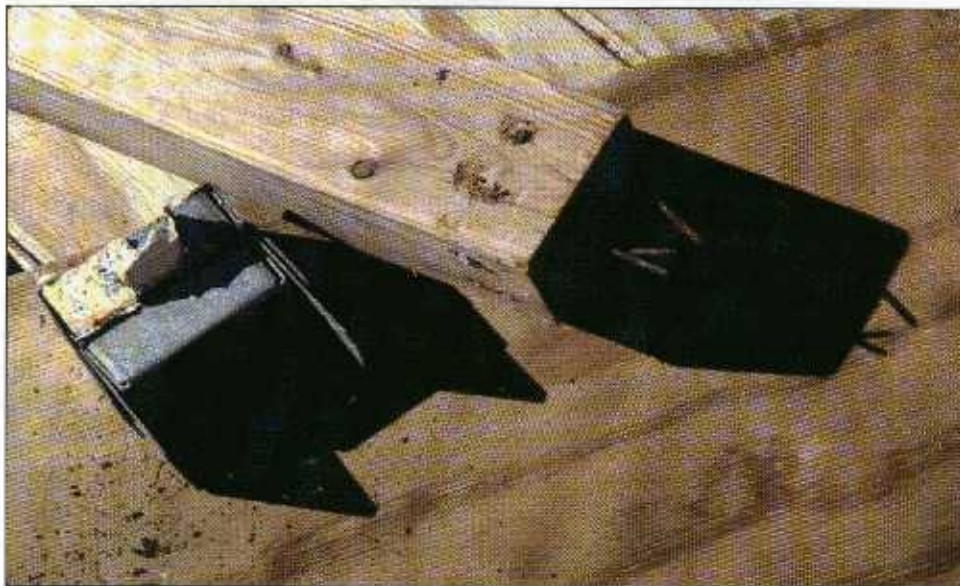
Framing layout and construction techniques used in almost all self-built wood-frame homes were not in compliance with Planning Regulation 7. Wall framing was constructed from nominal 2-in by 3-in and 2-in by 4-in studs. These studs were not properly supported laterally and not connected to the sill, bottom, or top plates with straps or connectors (Figure 4-14). The sill plate was inadequately (and often not) connected to the floor system with fasteners capable of resisting lateral and uplift forces. Top sill plates typically were single nominal 2-in by 4-in members that support the roof structure for gravity loading only. Nails appeared to be the primary connector used, with most connections being "toe-nailed." End column (nominal 4-in by 4-in) members were observed in the wall sections of some wood-frame houses (Figure 4-15).

FIGURE 4-15 Wood wall column that failed at connection to sill plate. This building was only two months old but was only partially constructed with clips, straps, and fasteners. The proper column fastener in the photograph was found unused beneath the house. This column was from the same house presented in Figure 3-13.

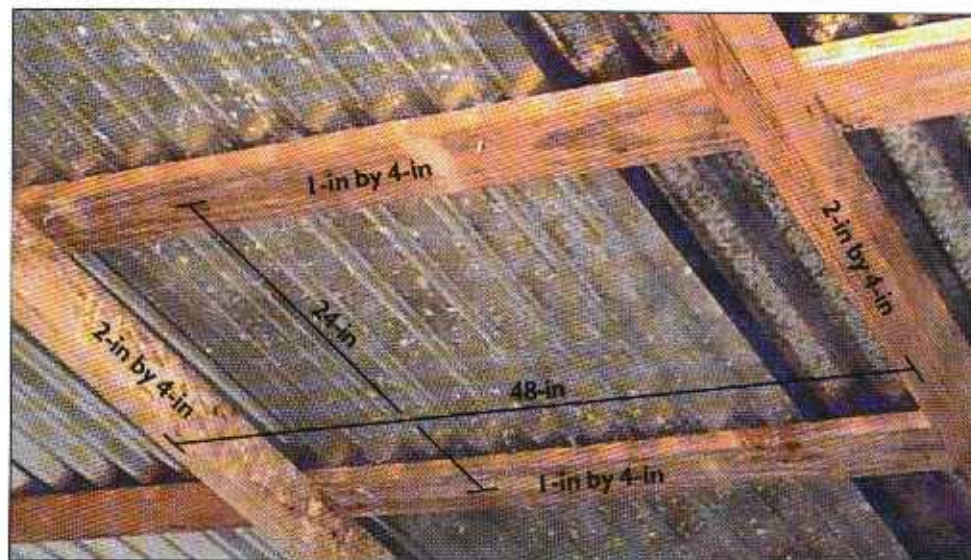
FIGURE 4-16 Typical wooden roof structure with metal roof panels above. Nails connected the metal panels to the nailers and the nailers were nailed to the joists.

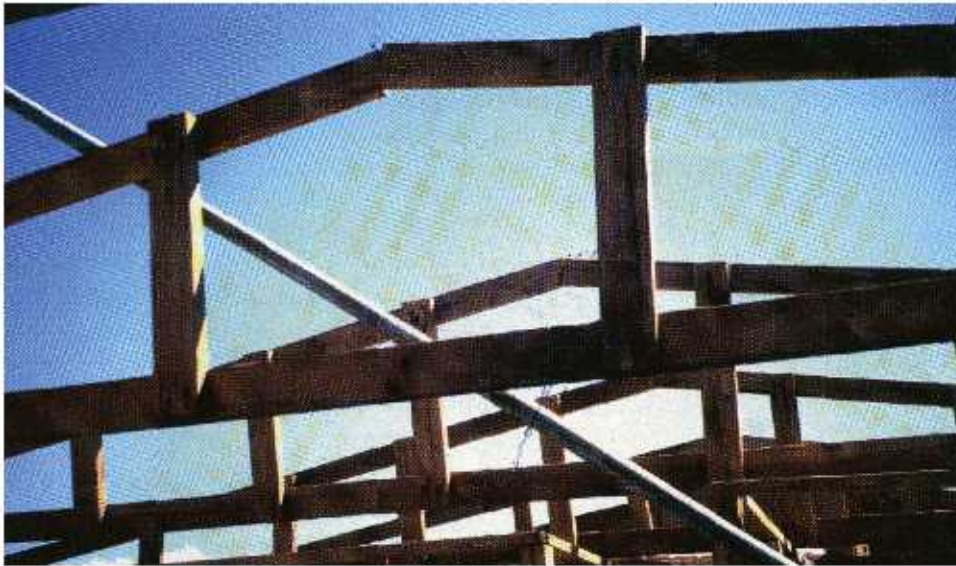
FIGURE 4-17 Example of a self-built, wooden roof truss.

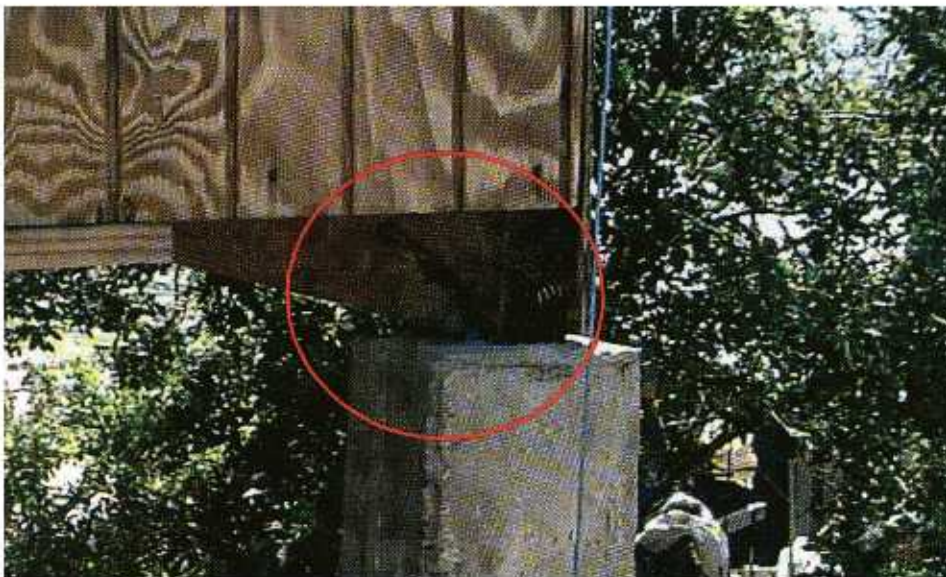
FIGURE 4-18 Example of a non-engineered connection between the building foundation (concrete column) and the floor system. The wooden floor beam is connected to foundation rebar with an improper nailed connection.

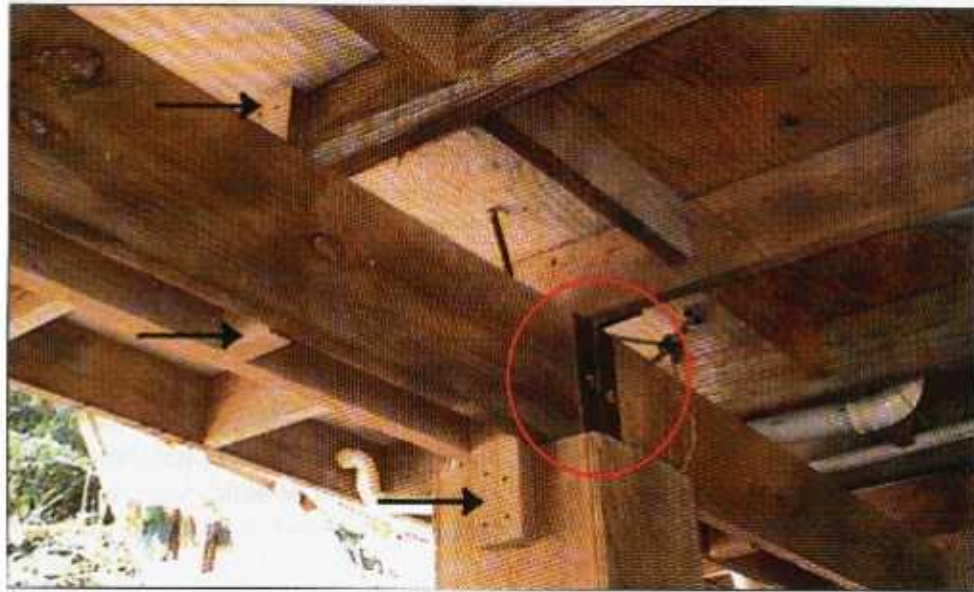
FIGURE 4-19 Example of an engineered connection between the floor beam and a concrete column (concrete column is enclosed in plywood). Vertical members (identified by arrows) provide continuous load path from floor joist to floor beams. Floor beams are connected to concrete columns with metal straps (circled). This house was located on the island of Culebra.

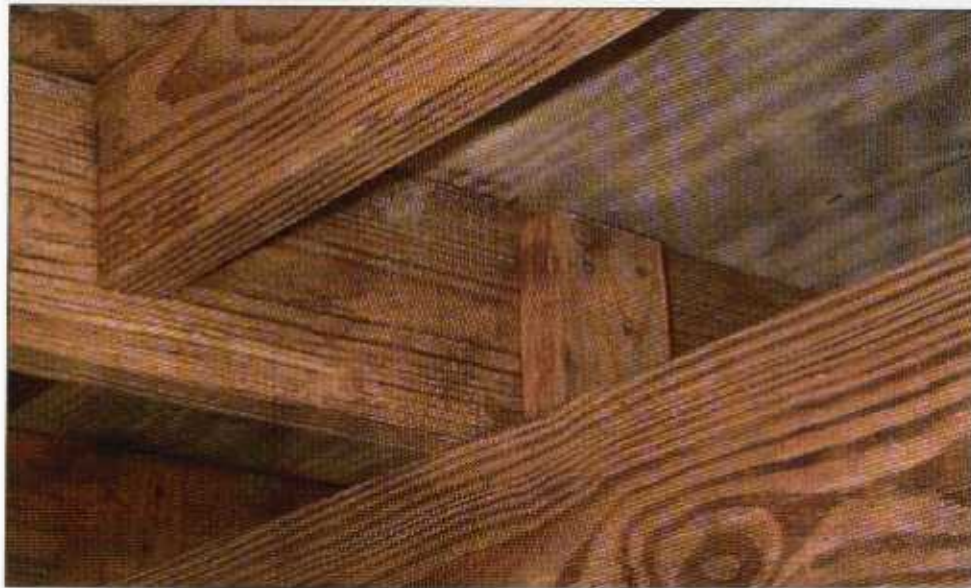
FIGURE 4-20 Example of a successful wood connection between support beam and floor joists. This is the same house shown above in Figure 4-19.

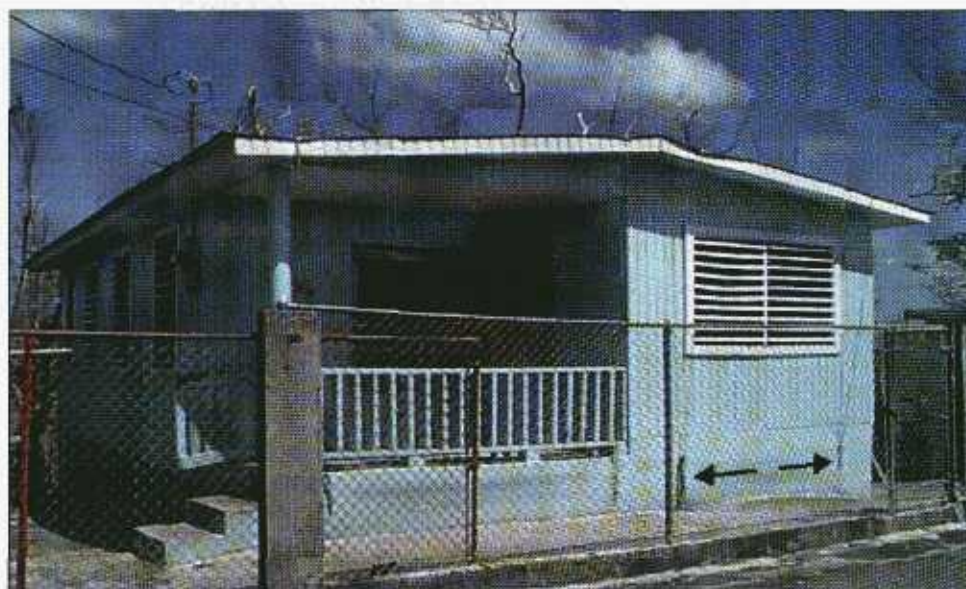
FIGURE 4-21 Wood-frame house with metal roof covering with hold-down cables that run parallel (see arrows) and perpendicular to the roof ridge line. This house was set atop a ridge that experienced significant winds. The lack of damage can be attributed to the extra care taken in fastening down the corrugated metal roofing. The strapping would not have prevented buckling of the roofing or uplift at the eave.

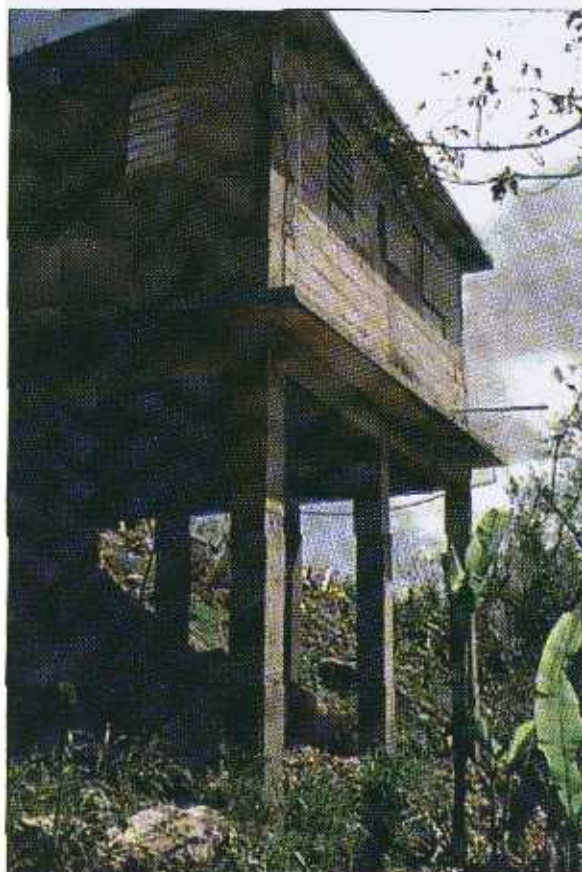
FIGURE 4-22 Residential building supported atop tall, unbraced concrete columns. This type of unbraced support column was common in many areas.

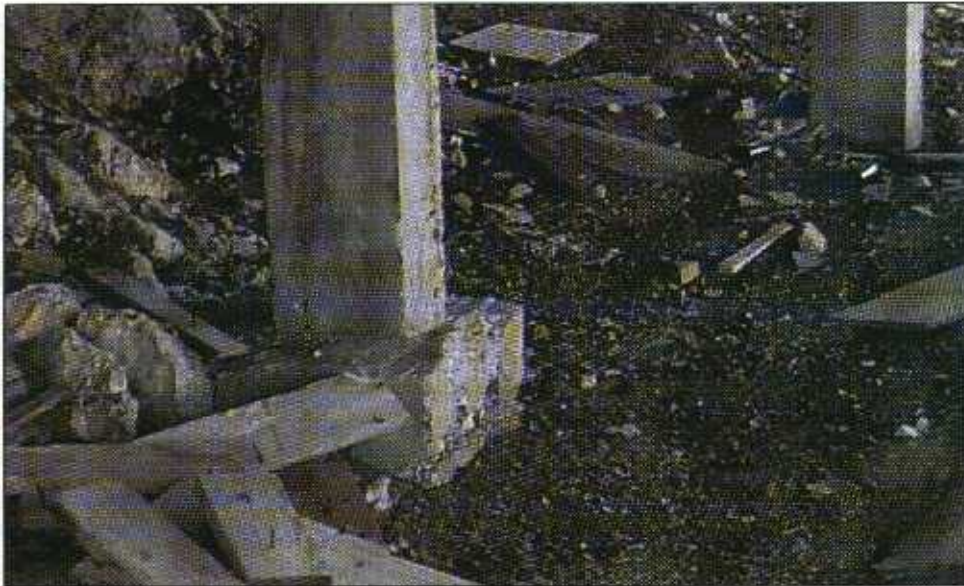
FIGURE 4-23 Footing for tall columns in Figure 4-22. This footing is not adequately anchored to the supporting rock to resist lateral forces that may be induced during a design seismic event.
