# 5 Building Envelope Performance

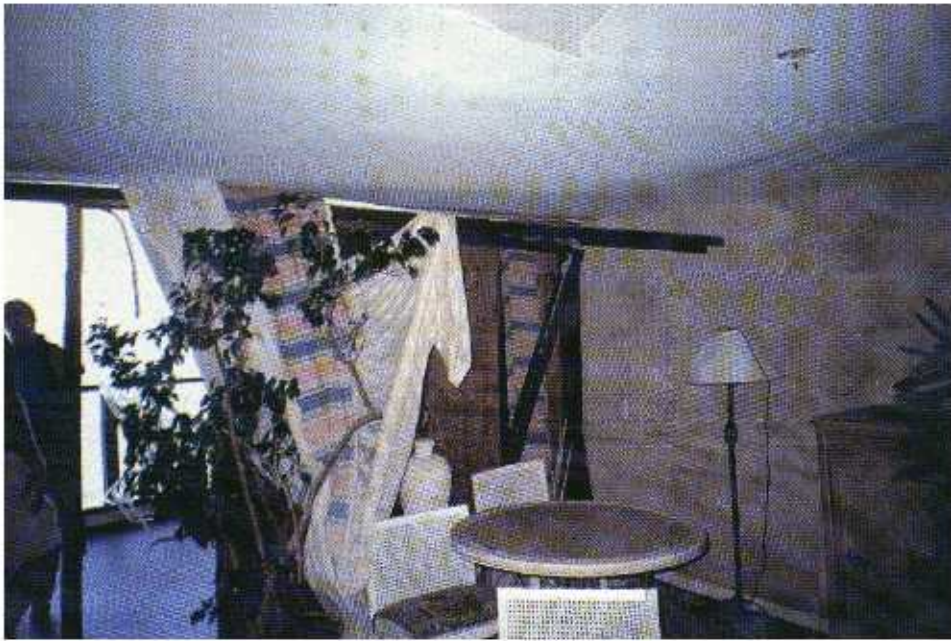
A variety of problems with glass doors were observed, including blow-out/blow-in of the door frame and glazing (Figure 5-1), door breakage and loss of glazing from its frame (Figure 5-2), and disengagement of sliding doors from their tracks. These problems were caused by over-pressurization or missile impact.

**FIGURE 5-1** This sliding glass door and window assembly in a hotel room was 7' 2" high and 14' long. The head of the frame was attached with four pairs of #12 or #14 screws in plastic sleeves. The sleeves pulled out and the entire length of the frame was pushed inward, resulting in substantial glass breakage. This building was located on Isla Verde in San Juan.

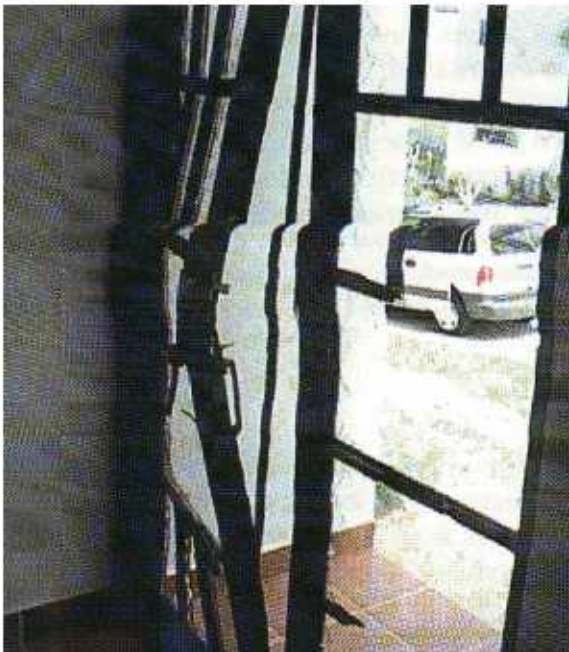
**FIGURE 5-2** Missiles broke this wood/glass door and several adjacent window panes.

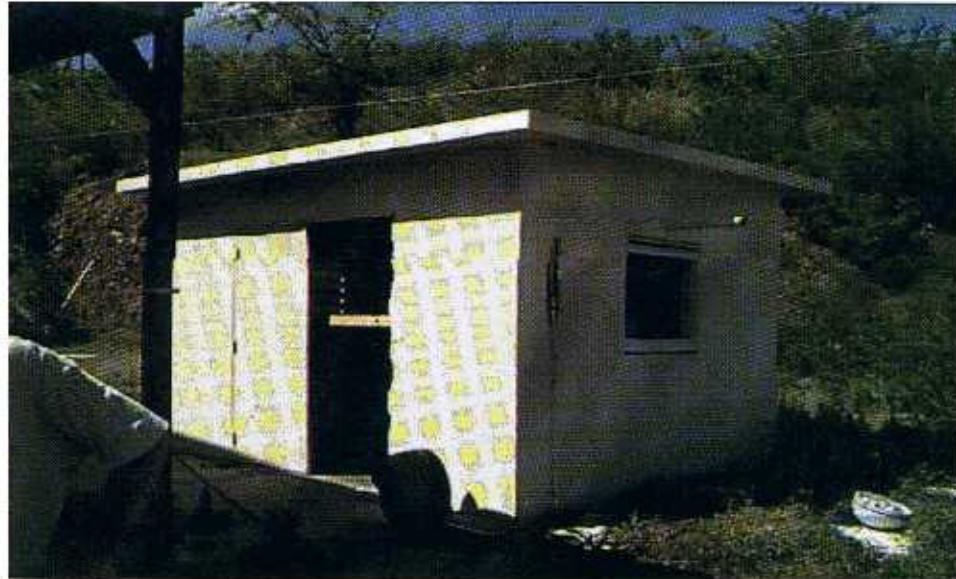
The BPAT observed few instances of door or door frame failure. However, Figure 5-3 illustrates a metal door that was blown out when the frame anchors pulled out. The door was blown out after the louvered window on the building failed, allowing an increase in internal air pressure.

**FIGURE 5-3** A missile traveling right to left struck the window louver. The door frame was attached by fasteners into wooden plugs that had been set into holes drilled into concrete. Once the louver failed, the door frame failed.

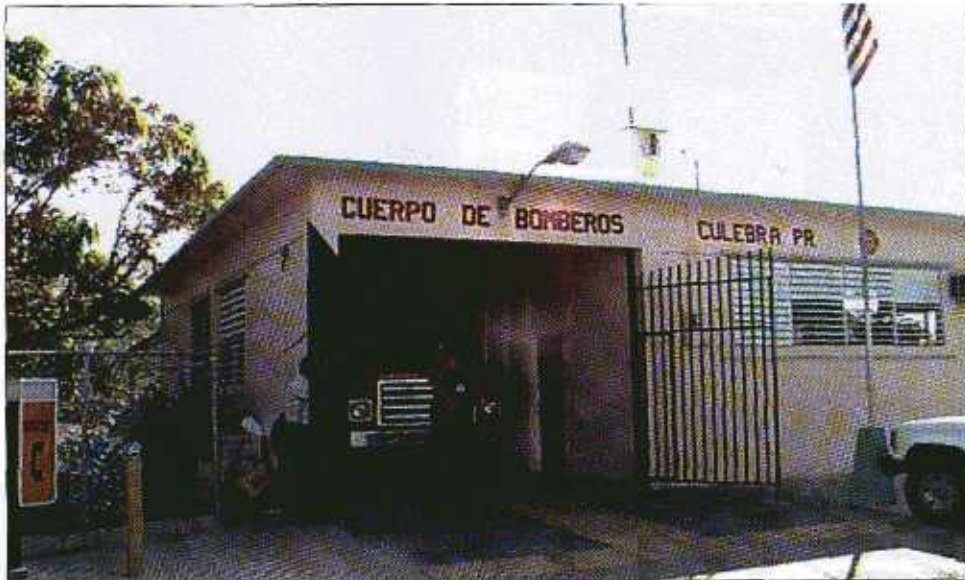
Rolling doors and garage doors frequently perform poorly during high winds. In several instances observed in Puerto Rico, large openings were protected with security grilles, rather than rolling or garage doors (Figure 5-4). Very little load is applied to security grilles during high winds because of the large amount of net free open area. As a result, security grilles performed very well. Depending on the grilles, security grilles may stop large airborne missiles. It is important to note that areas with security grilles must be designed as open structures (without a building envelope). This will normally increase wind pressures acting on the structural frame of the building, as well as components and cladding.

**FIGURE 5-4** The security grille on this fire station offers greater wind performance reliability than a solid door because very little air pressure is applied to it during high winds. This fire station is located on the island of Culebra.

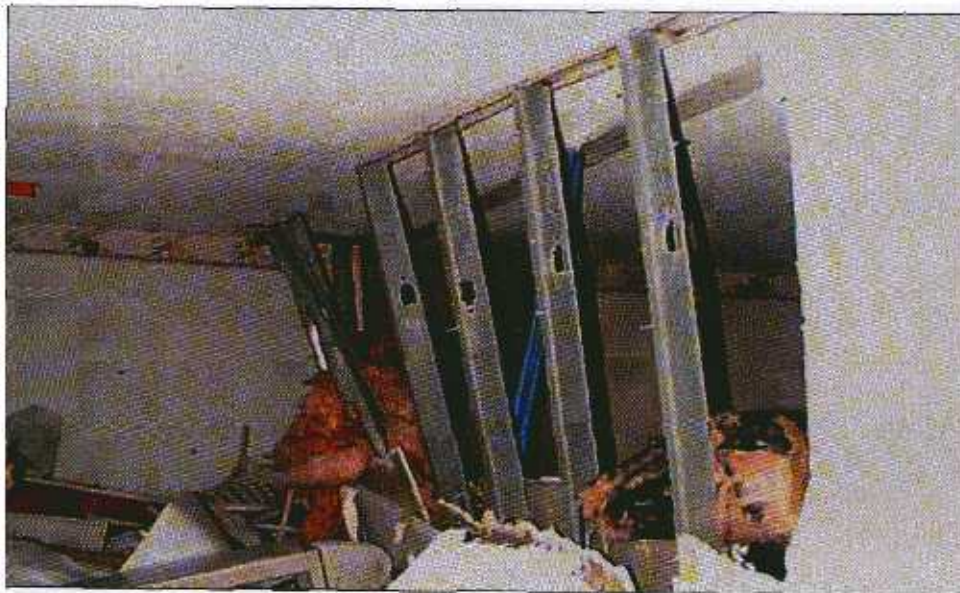
Non-load bearing walls (or door or window assemblies) that fail can cause extensive interior damage because of the development of high internal air pressure and/or wind-driven water infiltration. Figure 5-5 shows the damage that occurred when a portion of the exterior envelope failed. Composite wall panels and their connections, exterior insulation finish system (EIFS), and other types of exterior wall coverings should be tested to ensure the components have suitable strength.

**FIGURE 5-5** The gypsum wallboard was blown off this interior partition after the exterior non-load bearing wall was blown away, allowing an uncontrolled, rapid increase in internal air pressure.

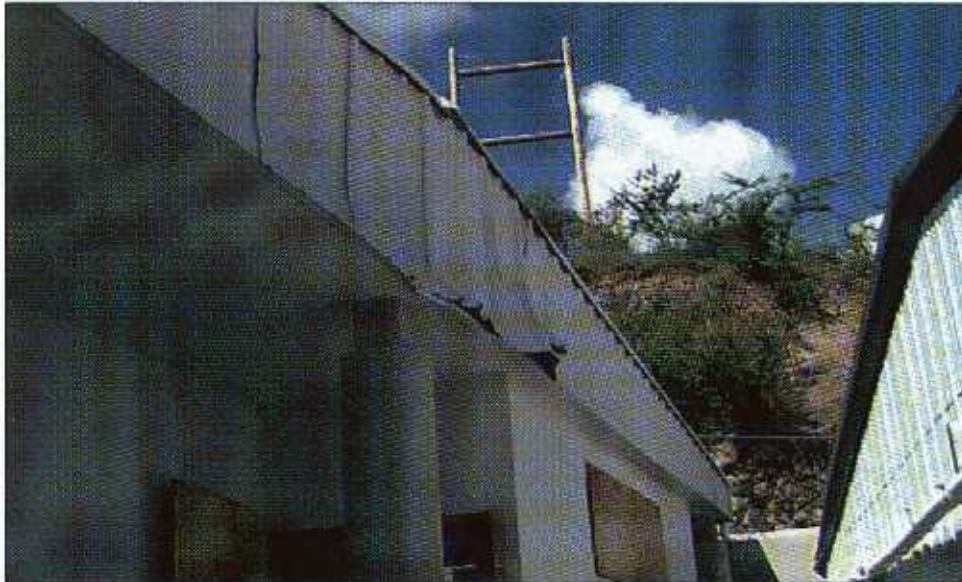
Metal panels over light-gauge steel framing were the most common non-load bearing walls observed. The BPAT noted the loss of metal panels due to an insufficient number of panel fasteners. In one instance, metal panels at the gable end of a building were damaged when a rooftop water tank blew off and struck the side of the building (Figure 5-6).

**FIGURE 5-6** Rain entered this hospital on Culebra after a water tank struck the metal wall panels.

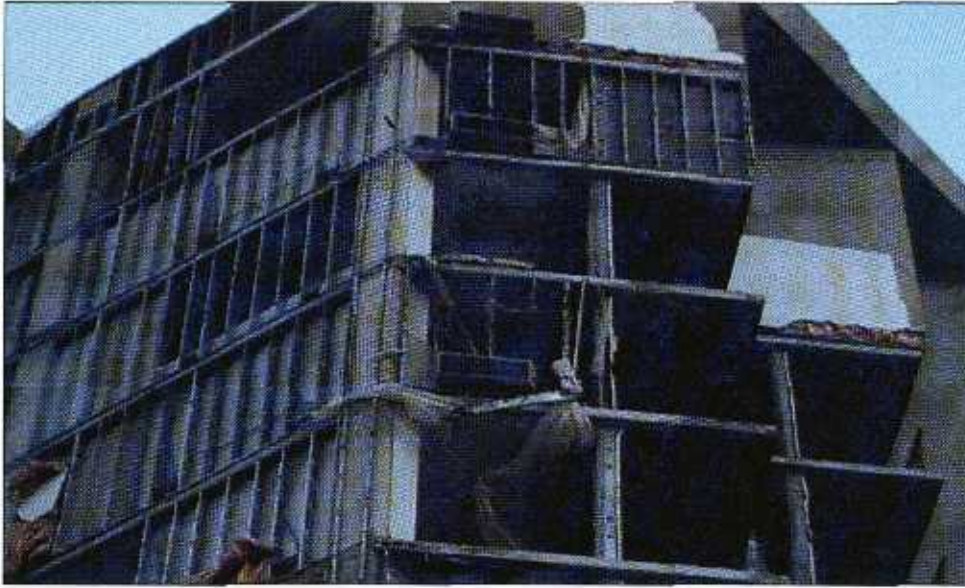
A problem with EIFS at an ocean front high-rise was also observed. It appeared that the exterior wall stud tracks were insufficiently attached (Figure 5-7). Failure of the wall system resulted in substantial interior damage.

**FIGURE 5-7** This EIFS wall system was composed of synthetic stucco over 1-in thick expanded polystyrene insulation (EPS) over a layer of exterior gypsum board over 6-in deep steel studs, with a layer of gypsum board on the interior side of the studs. Fiberglass batt insulation was installed within the stud cavity. There were several different planes of failure. Insufficiently attached stud tracks appeared to have been the initial failure point. This building was located on Isla Verde.

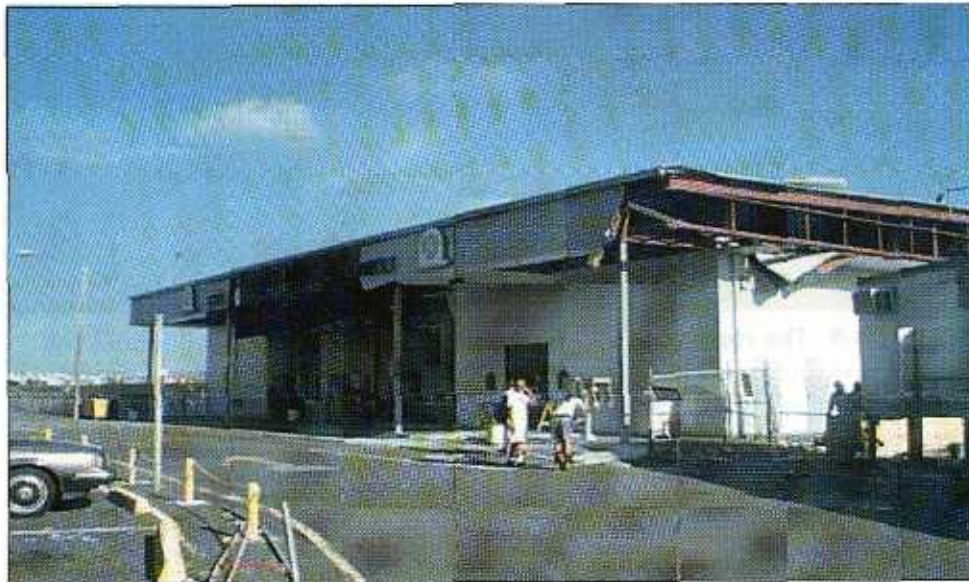
The BPAT observed two buildings with composite wall panels composed of thin metal sheets bonded to a cardboard honeycomb core. The panels were attached with screws from the metal framing into the interior metal skin. On one building, the panels were also used as the soffit. In both buildings, the panels blew off because of insufficient strength of the connections between the composite panels and the structural frame of the building (Figure 5-8).

**FIGURE 5-8** Several composite panels blew off from the fascia and soffit of this building at the airport on Isla Grande. Although several screws were installed, the metal into which they were driven was too thin to develop sufficient blow-off resistance to withstand the wind loads.

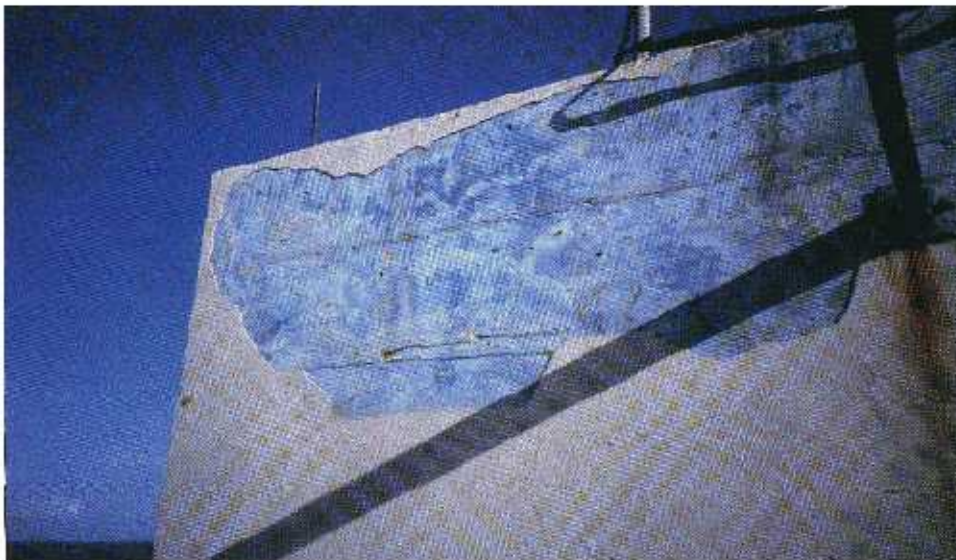
The loss of stucco applied over cast-in-place concrete was the most common problem observed with wall coverings (Figure 5-9). Rather than cast concrete with a relatively flat and smooth surface, traditional practice in Puerto Rico has been to cast the concrete rough, as shown in Figure 5-10, and apply a stucco finish.

**FIGURE 5-9** The stucco was blown off the corner area of this wall, where the suction pressures were high. Note the rough texture of the concrete.
