5.3 Roof Coverings

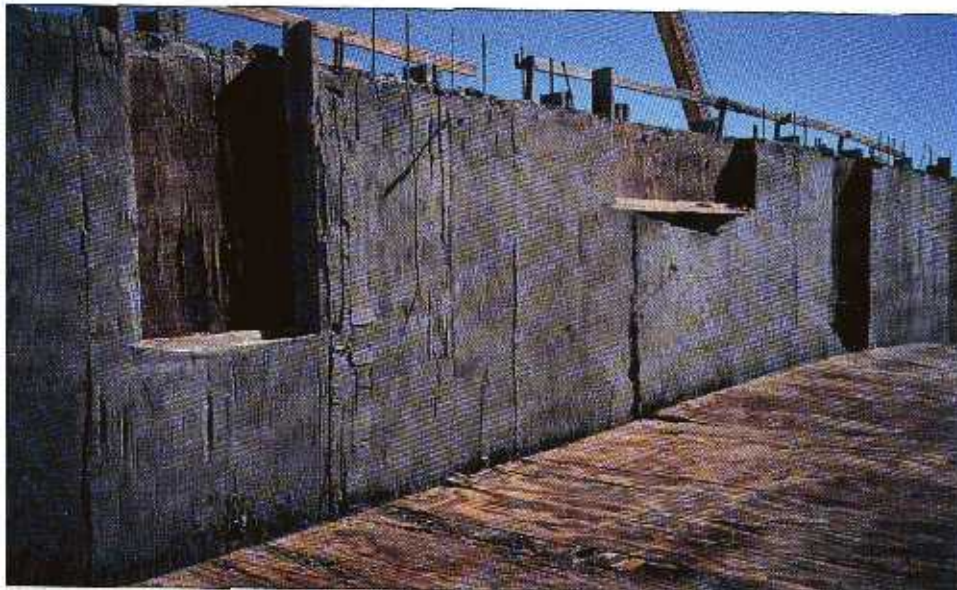
FIGURE 5-10 This house is under construction. The surface of the concrete is very rough because the plywood form (which is lying down on the ground) was used repeatedly. The rough texture will be compensated for with a stucco surfacing.

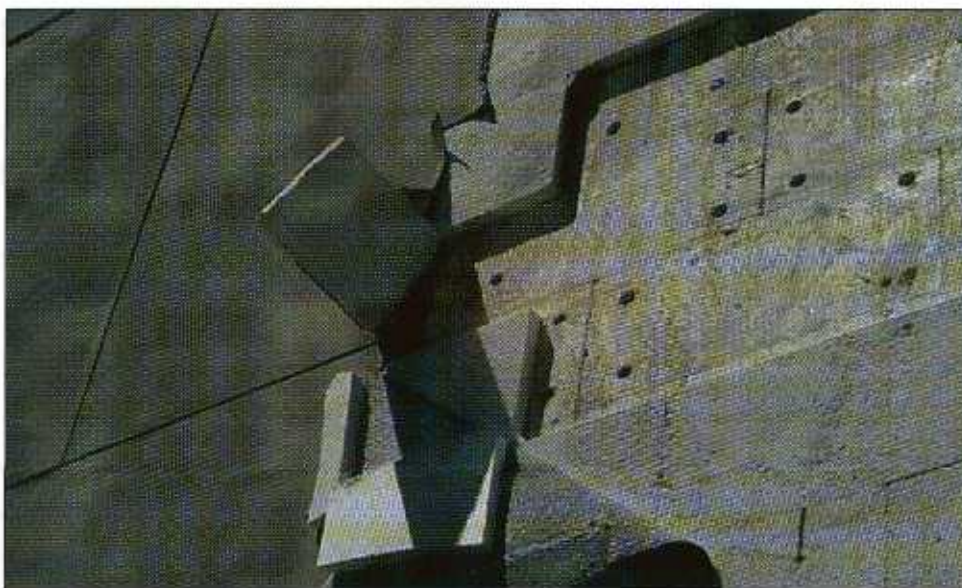
The BPAT observed an EIFS covering consisting of synthetic stucco applied over two layers of EPS over concrete. There was a superficial bond between the two EPS layers (Figure 5-11). Ceramic tiles were blown off of concrete spandrel panels on a high-rise building (Figure 5-12) and wind scour caused some exterior paint finish damage (Figure 5-13).

FIGURE 5-11 At this EIFS covering, the synthetic stucco appeared to be well-adhered to the outer EPS layer, but there appeared to be minimal bonding between the two EPS layers. In at least the lower portion of the wall, the first layer was attached with mechanical fasteners deeply recessed into the foam. The delamination occurred near the corner of the building, where the suction pressures were high.

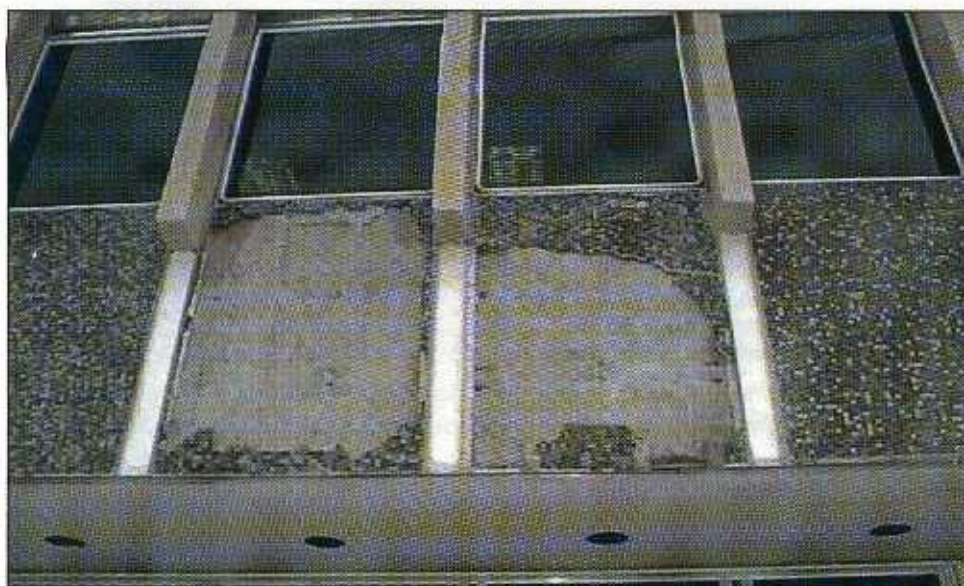
FIGURE 5-12 A mortar skim coat was applied over the concrete, and the ceramic tiles were set in to the mortar. The primary failure plane was between the mortar and concrete.

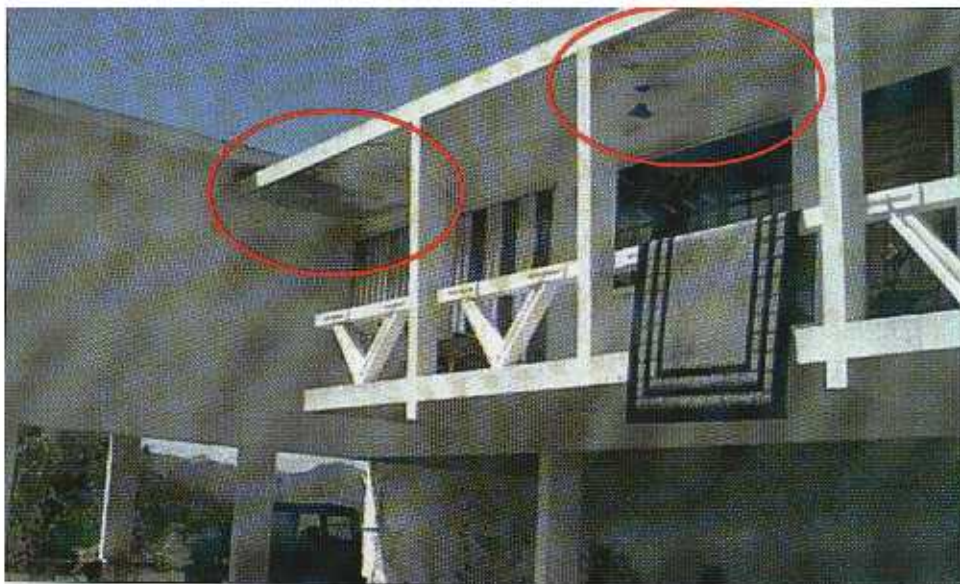
FIGURE 5-13 This house was located on a mountain top that experienced very high wind conditions. The paint scoured off at some of the soffit areas and along the recessed wall.

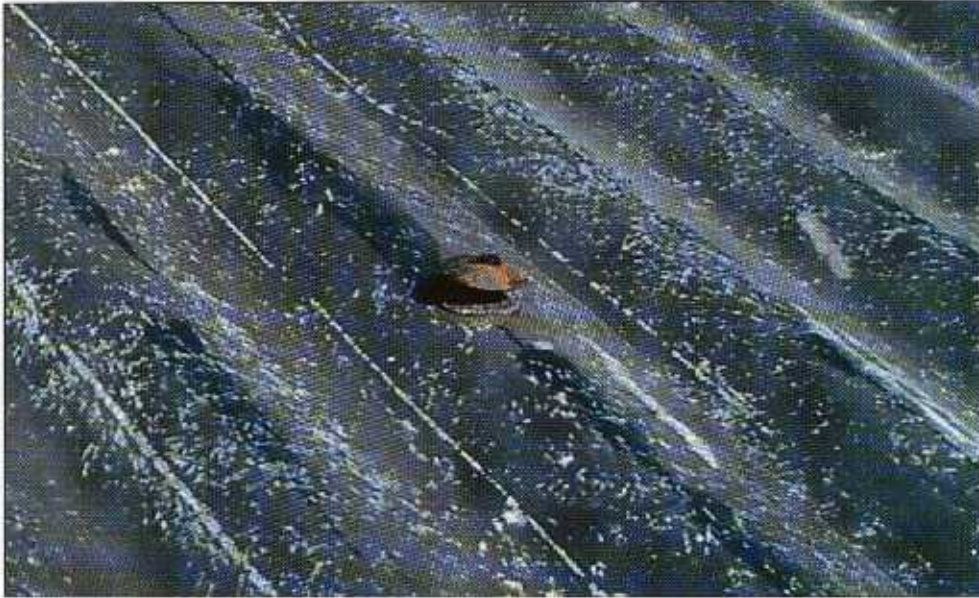
The BPAT observed a variety of architectural and structural metal panels. Corrugated galvanized steel with exposed fasteners was the most common type found on residences. These panels generally were fastened with smooth- or screw-shank nails (Figure 5-14). With few exceptions, the spacing of fasteners along side laps, eaves, hips, and ridges was insufficient (Figure 5-15).

FIGURE 5-14 The nail attaching this corrugated metal panel partially backed-out. Screws are much more resistant to back-out. Nail back-out is a problem with metal panel systems because of the large number of load cycles and large amount of deformation the panels can experience during a hurricane. Elsewhere on this roof, some of the panels were blown off.

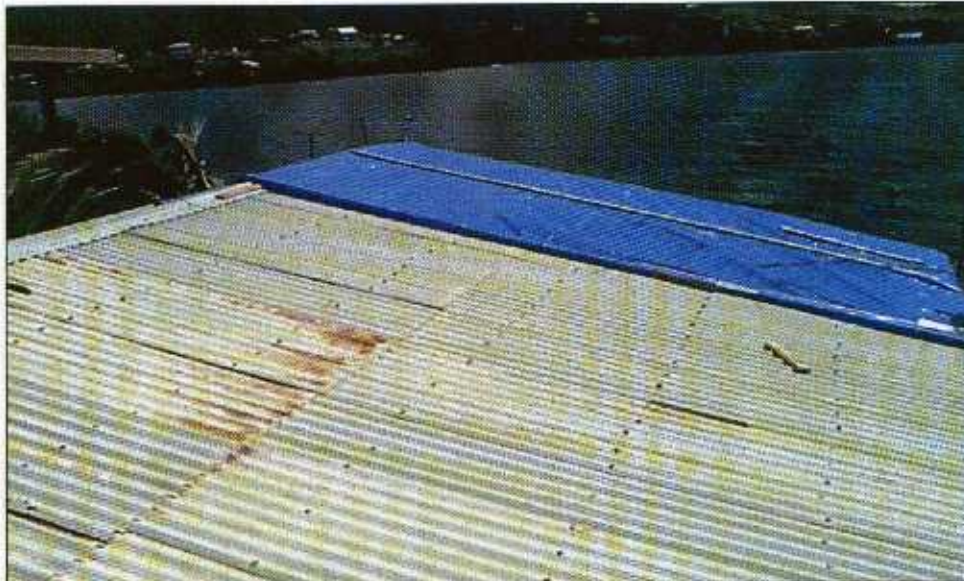
FIGURE 5-15 Only a single row of fasteners were installed along the eave and along each side of the ridge. The side laps are insufficiently attached and are lifting in a few areas. The end lap is too far away from the first row of fasteners—another nailer should have been installed. Clips between the joists and wall were retrofitted prior to the hurricane; however, enhanced attachment of the metal roofing was not performed as part of that work. As a result, several of the metal panels were blown off.

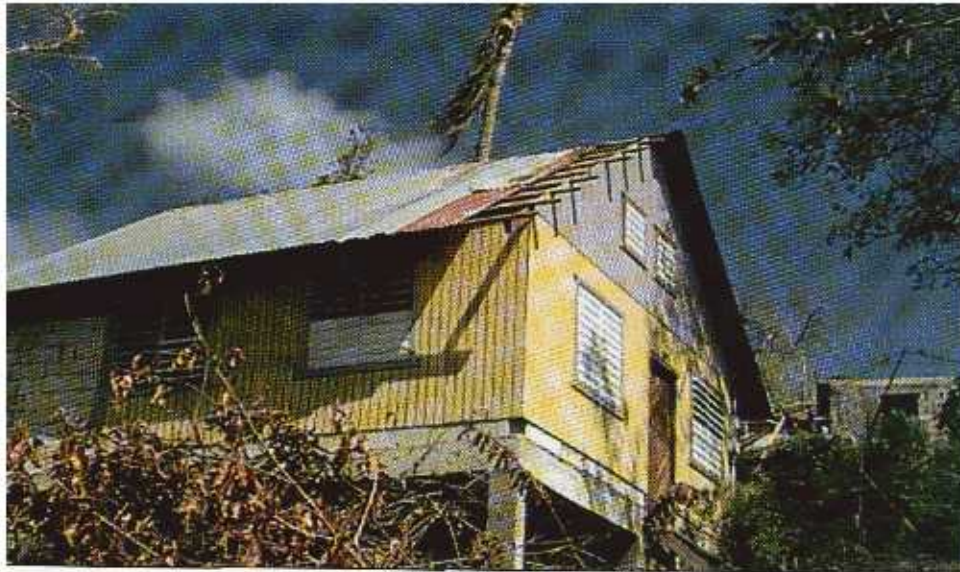
In some instances, a framing member was not provided along rake overhangs. Instead, the nailers were simply cantilevered and the metal panels were just attached at each nailer (Figure 5-16). With a continuous rake framing member, as shown in Figure 5-17, the metal panels can be attached with closely-spaced fasteners. Panel fasteners should be closely spaced along the rake because of the extremely high uplift forces that occur in this area during a hurricane.

FIGURE 5-16 The metal panels along this rake were insufficiently fastened. A framing member was not run up the rake.

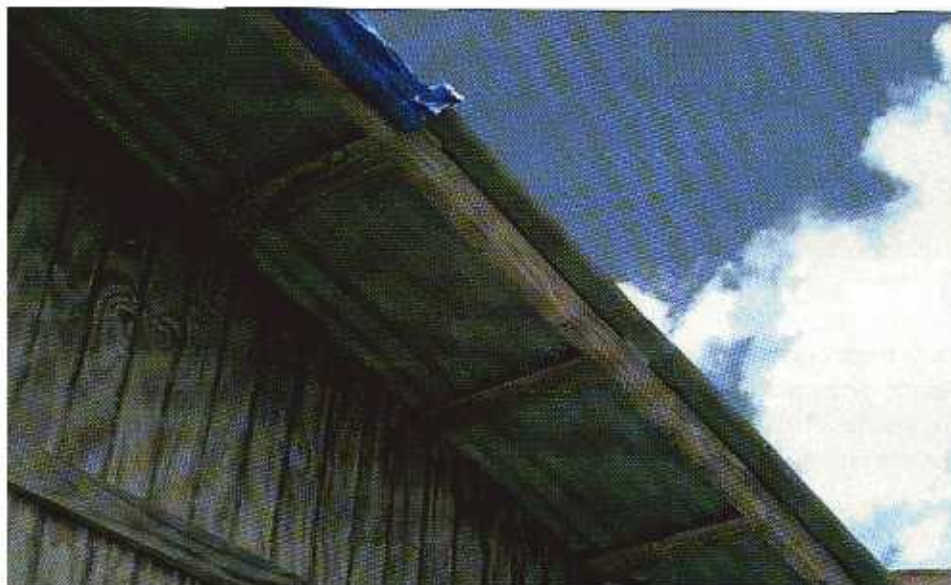
FIGURE 5-17 At this house, a framing member was run up the rake, which allowed the metal panels to be fastened between the nailers (purlins). However, the rake member must have sufficient strength to resist design uplift loads, which does not appear to be the case with this member. Rather than installing a metal edge flashing, these metal panels simply were cantilevered beyond the rake framing, providing a loose edge that is susceptible to lifting and peeling during high winds. Other deficiencies that are noted in this photograph include incorrect nailing of roof material to rake member and inadequately sized and spaced nailers.

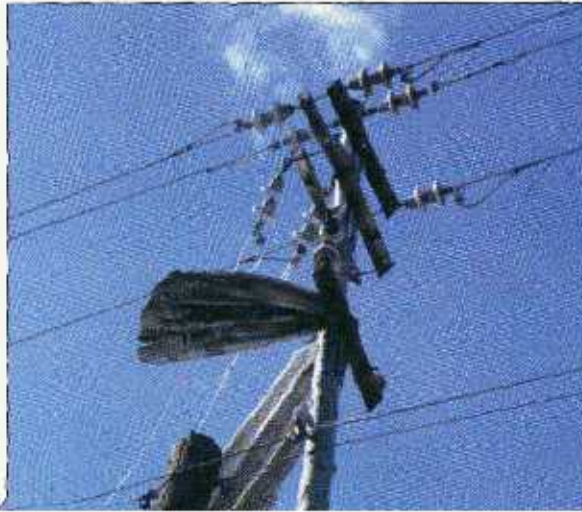
In addition to the interior water damage that occurs upon blow-off of metal roof panels, the panels themselves can become high-energy missiles that can damage buildings and other property (Figure 5-18). Metal panels contributed significantly to the amount of debris from Hurricane Georges.

FIGURE 5-18 Corrugated metal panel wrapped around a power pole.

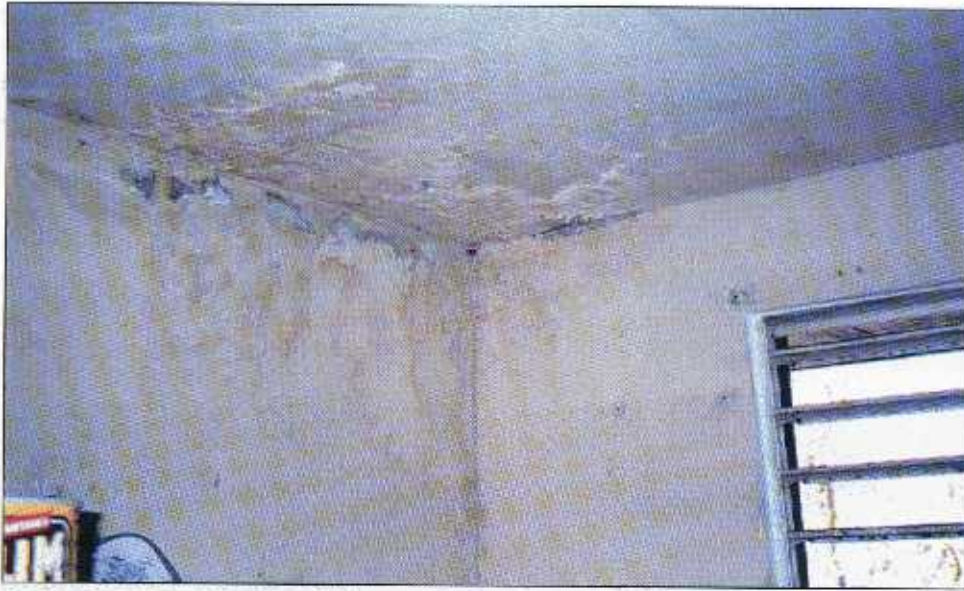
The BPAT observed several cast-in-place concrete roofs with no roof covering. While these roofs provided excellent wind performance, some leaked during the hurricane due to the heavy rains that accompanied the storm (Figure 5-19). Roofs with liquid-applied membranes over the concrete provided excellent performance.

FIGURE 5-19 This concrete roof deck did not have a roof covering. During the hurricane, water entered the house through the deck. The concrete deck and CMU walls were skimmed with a skim coat of plaster. This house has Miami windows.

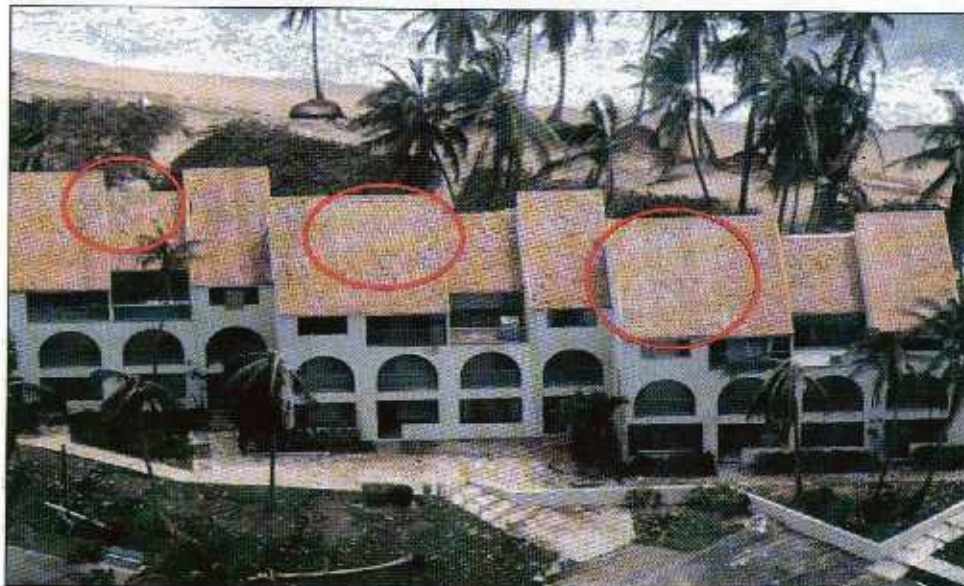
While the BPAT observed clay and concrete tile roofs, they make up only a small percentage of steep-slope roofs in Puerto Rico. The BPAT observed many damaged tile roof coverings (Figure 5-20). In some cases, uplift pressure initiated failure while in others it was caused by missile impact.

FIGURE 5-20 These tiles were heavily damaged, although the wind speed at this location was not very high. As can be seen in the foreground, the roof covering generated a substantial number of missiles. Because of the relatively low wind speed, the tile debris did not travel very far.

Concrete and clay tile roof coverings were vulnerable to missiles. Even when their attachment was well designed and tiles were properly installed, their brittle nature made them especially susceptible to relatively low-energy missiles. Debris from a single damaged tile can impact other roof tiles and lead to a progressive cascading failure. In addition to the roof damage, many high-energy missiles can become airborne.

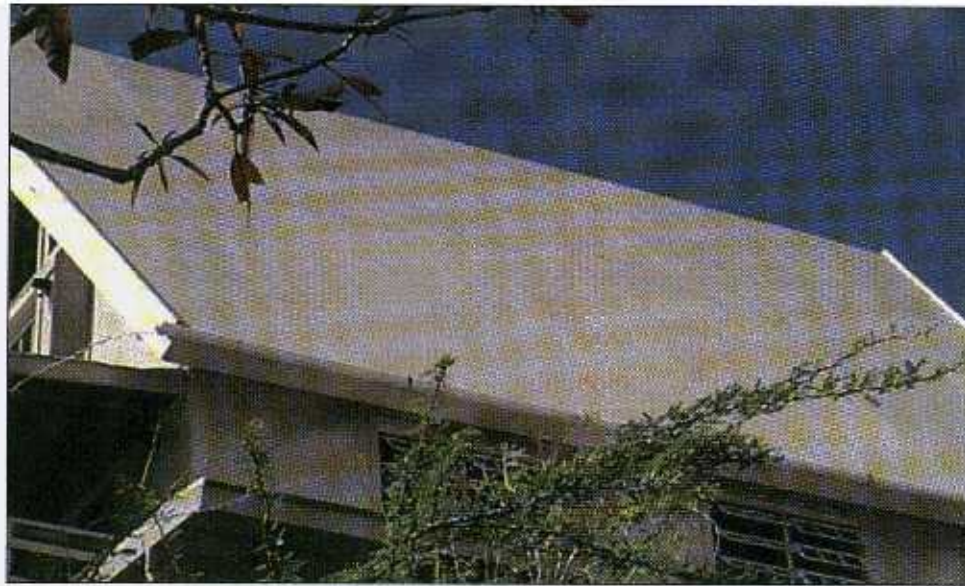
The BPAT observed only a few liquid-applied membranes over plywood. As long as the roof structure did not fail they provided excellent wind performance (Figure 5-21).

FIGURE 5-21 This house had a liquid-applied membrane over plywood roof sheathing. This type of roof system typically offered excellent wind performance provided the plywood does not lift. This house was located on the island of Culebra.
