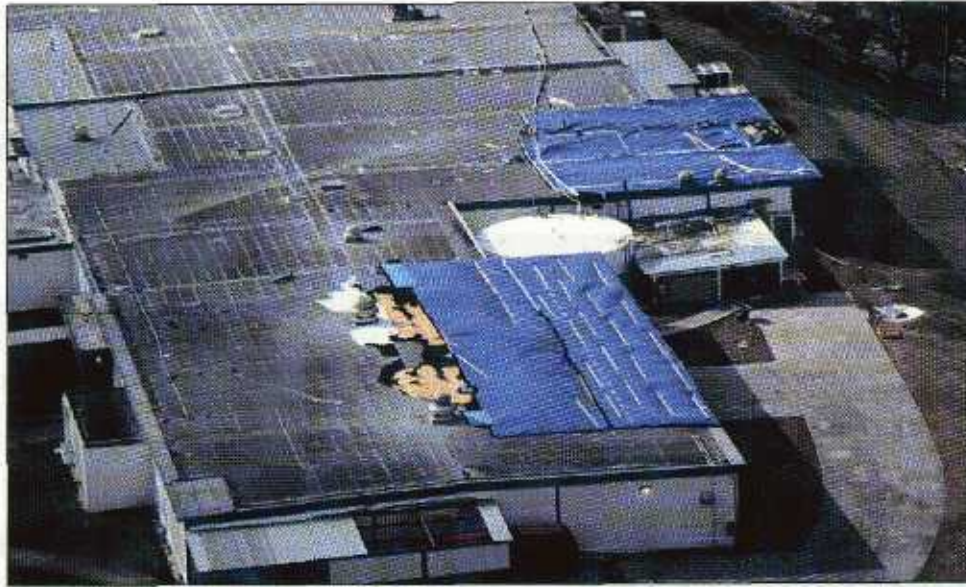
FIGURE 5-22 This built-up membrane had a mineral surface cap sheet. Because of the roof covering damage, this manufacturing facility on the island of Culebra was shut down for approximately two weeks after the hurricane. This building also experienced roof damage during Hurricane Hugo in 1989.

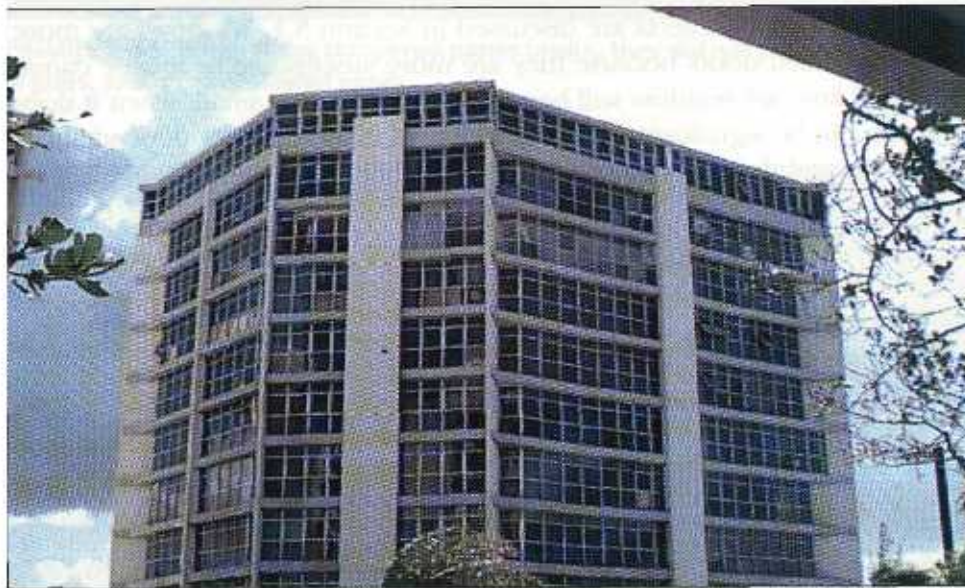
FIGURE 5-23 The windows in this building were broken by aggregate from the built-up roof of a nearby building (Figures 5-24 and 5-25).

The building in Figure 5-23 had approximately 100 windows broken by aggregate that blew off of a built-up membrane roof across the street. Some panes were tempered glass (Figure 5-24) and others were annealed (Figure 5-25).

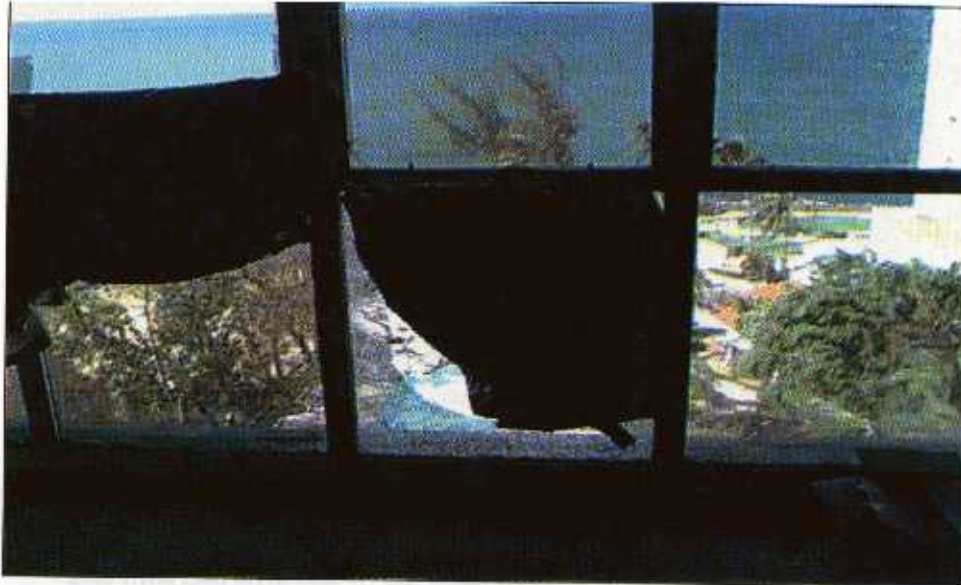
Windows can be protected from missile damage by special glazing or exterior shutters. Previous research and testing has shown that if special glazing is used, laminated rather than tempered glass should be specified. Although laminated glass is more easily broken than tempered glass, there is a greater probability that broken laminated glass will stay in the frame (provided the frame detailing is suitable); tempered glass will shatter and fall out of the frame as illustrated by Figures 5-24 and 5-32.

FIGURE 5-24 When these tempered panes broke, they did not produce shards of glass, as did the annealed panes.

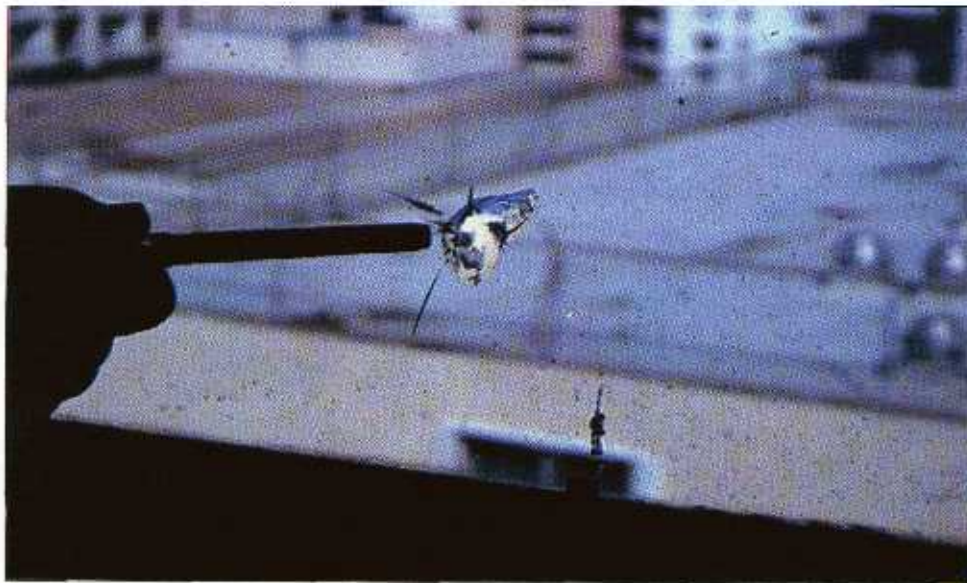
FIGURE 5-25 Although some annealed panes broke into shards, others just broke at the impact point.

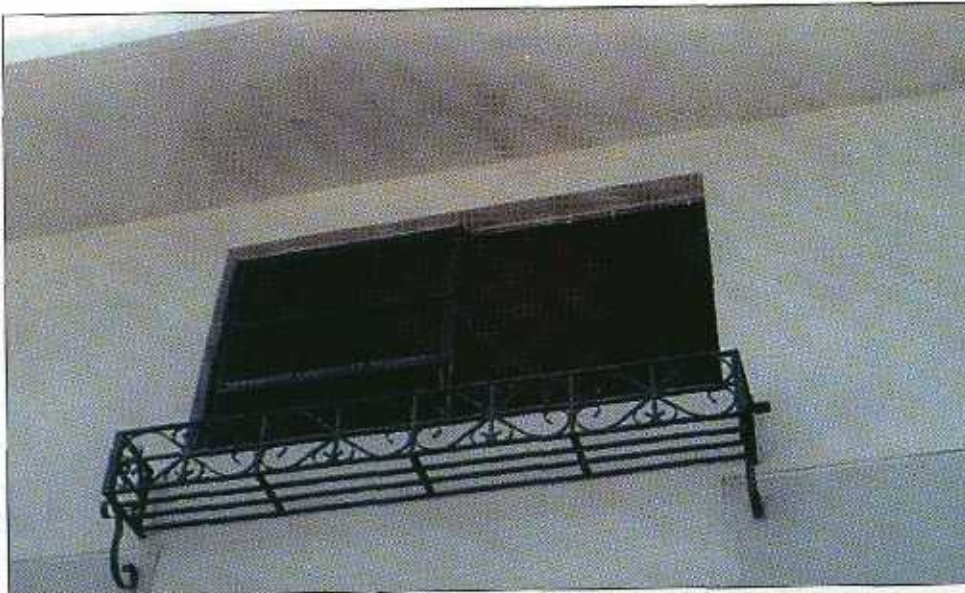
The window frame in Figure 5-26 was blown out by over-pressurization of the building interior when the building envelope was breached elsewhere in the building. Missiles broke the glass shown in Figures 5-27 and 5-28. The three buildings in these photos are all located near one another.

FIGURE 5-26 Half of the window frame blew out. It was attached with two screws in plastic sleeves at the head, three screws at the jamb, and two screws at the sill.

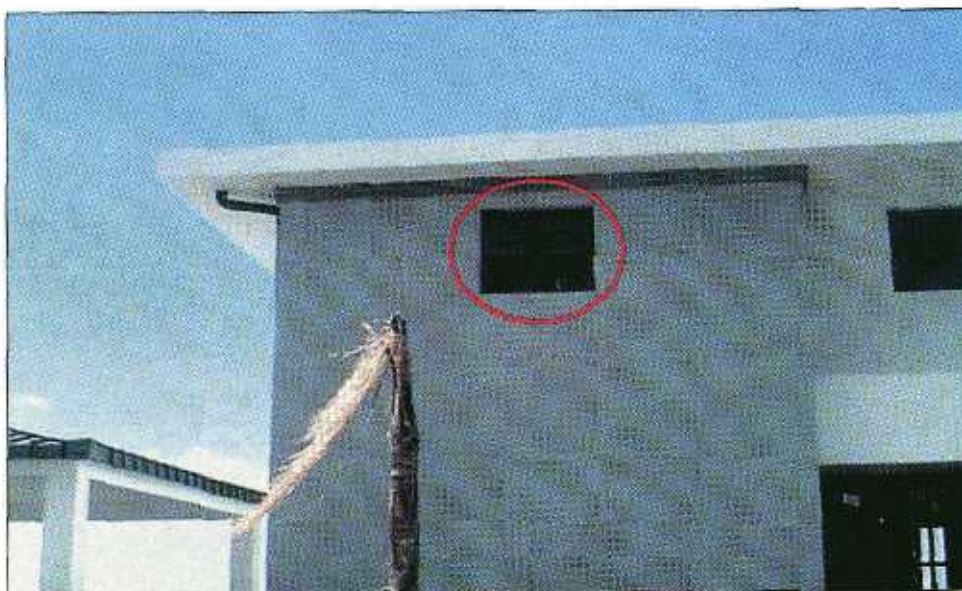
FIGURE 5-27 One pane in this window was broken by a missile, perhaps from the palm in the foreground.

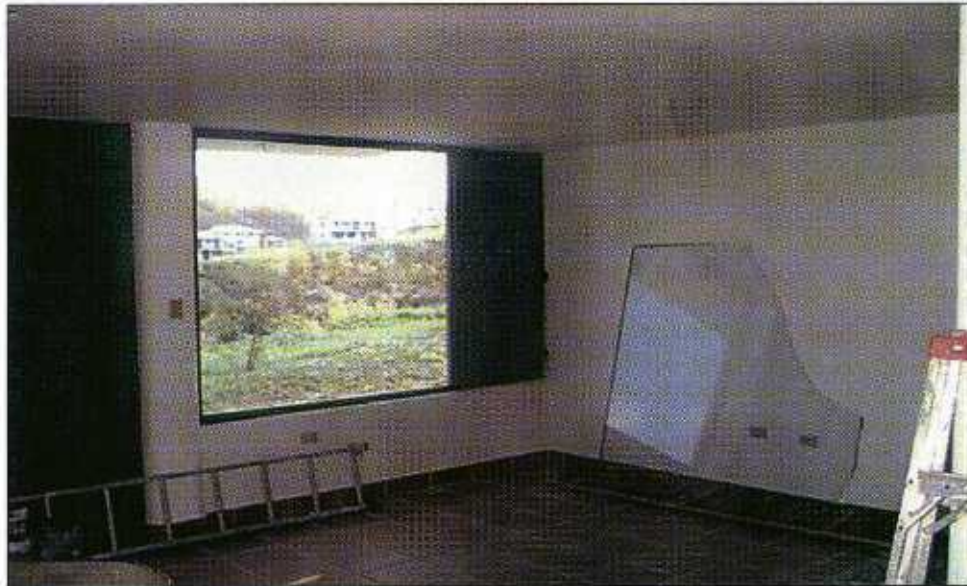
FIGURE 5-28 This large window, which was removed and leaned against the wall after the storm, was broken by a missile, most likely a tree limb.

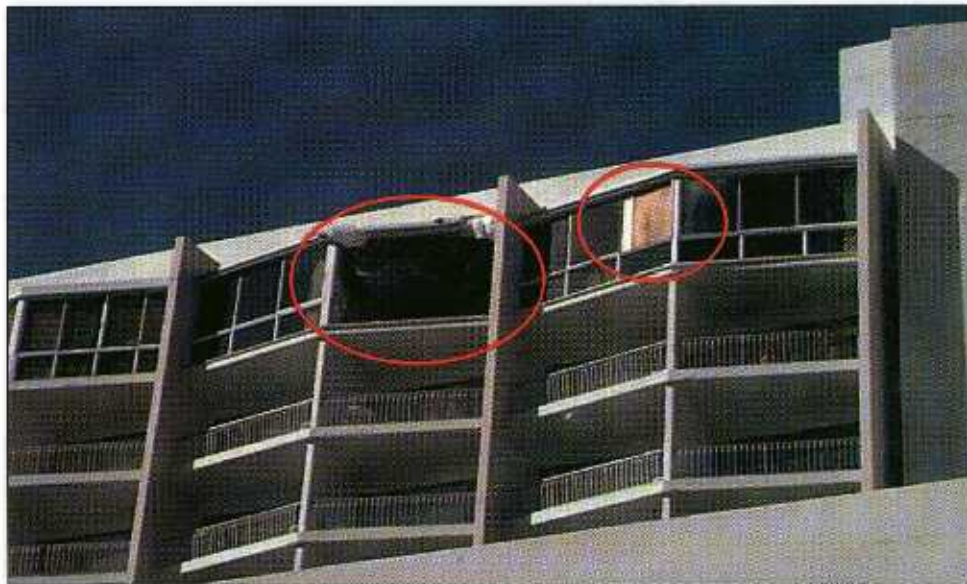
In Figure 5-29, some window frames in this mid-rise building were blown out while in other cases, just the glass was blown out. This appeared to be caused by negative pressure (suction).

FIGURE 5-29 The glass and frames were blown out at the center room on the top floor. At the room to the right, one of the glass panes was blown out.

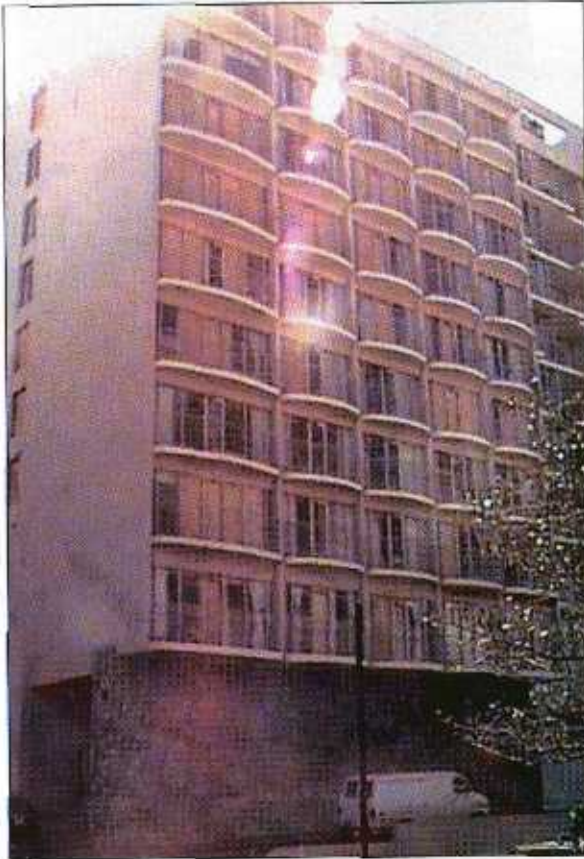
The building in Figures 5-30 and 5-31 experienced substantial damage to windows and sliding glass doors. Missiles caused at least part of this damage. The window in Figure 5-32 broke, but since the glass was laminated it did not fragment into separate pieces.

FIGURE 5-30 Several window and glass door openings broke during the hurricane. They were subsequently covered with plywood (Figure 5-31).

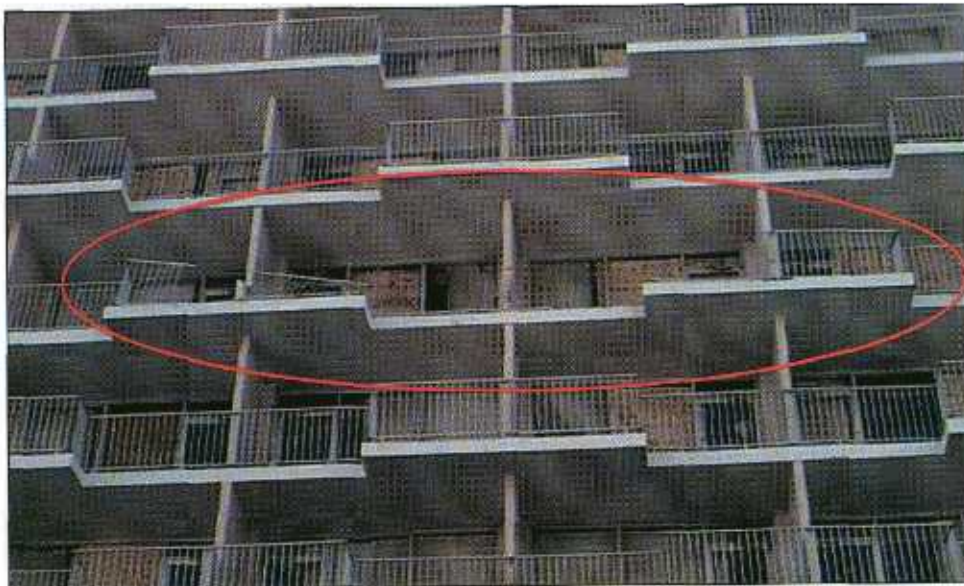
FIGURE 5-31 High-energy missiles from a nearby building damaged several railings of this building.

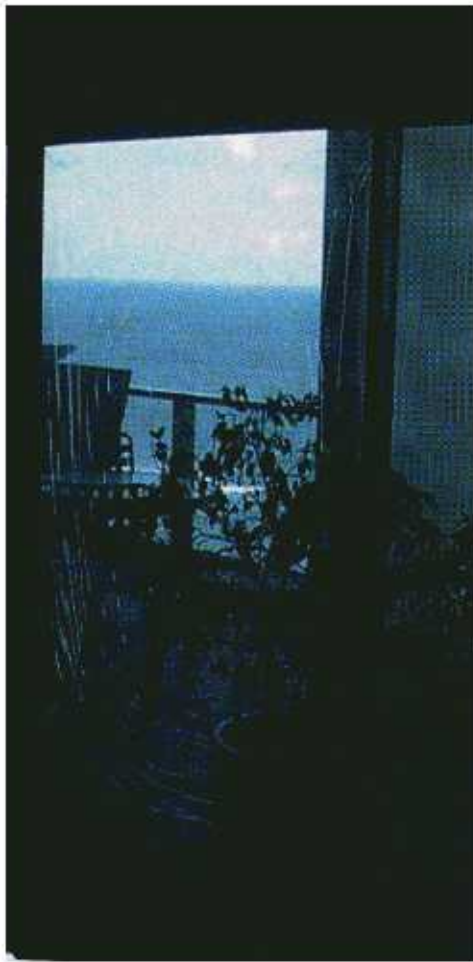
FIGURE 5-32 The broken light in the center is laminated. A sliding glass door located to the left had tempered glass, which was blown out of the frame.

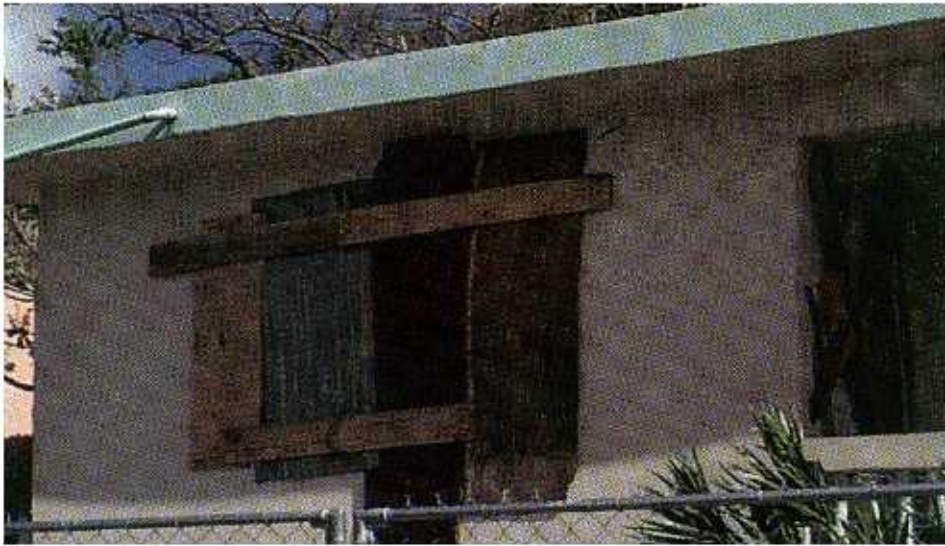
FIGURE 5-33 A combination of boards and metal panel was used to construct this shutter. Unless shutters are well attached, they can blow off during high winds and become missiles themselves.

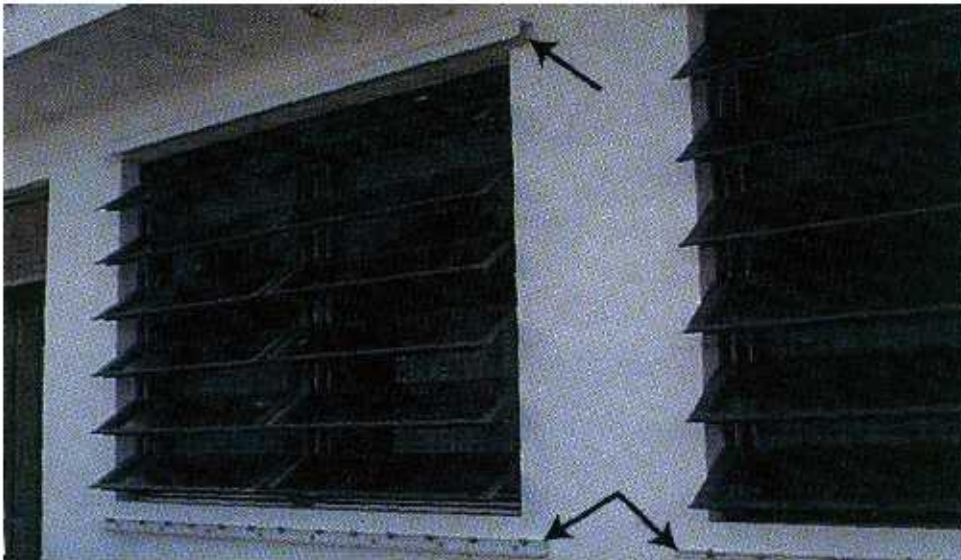
FIGURE 5-34 These windows were equipped with permanent head and sill shutter tracks, which were attached to the wall with closely-spaced fasteners (Figure 5-35).

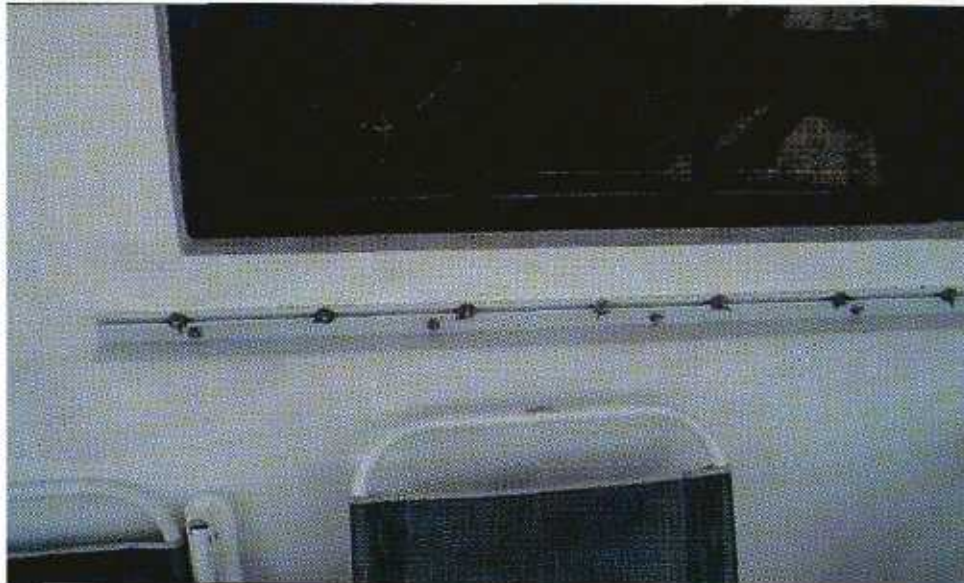
FIGURE 5-35 Close-up of Figure 5-34. The steel shutter panels were designed to be locked into the track with wing nuts spaced 6-in on center, a more reliable attachment than that shown in Figure 5-36.

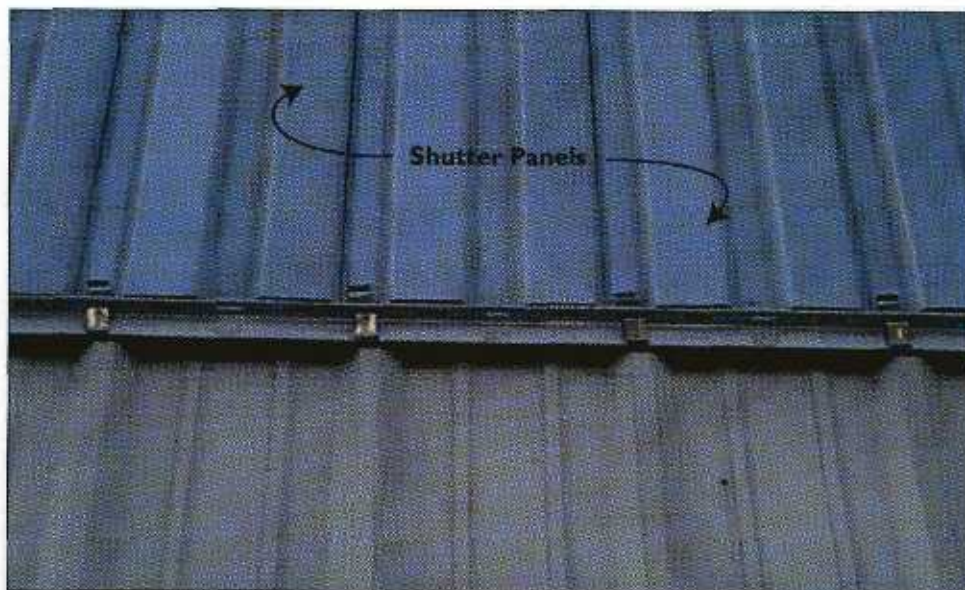
FIGURE 5-36 Looking up at a shutter panel held in place by clips (a metal wall panel occurs below the shutter track). These clips were spaced 12-in on center. Clips are not as reliable as the bolted attachment shown in Figure 5-35.

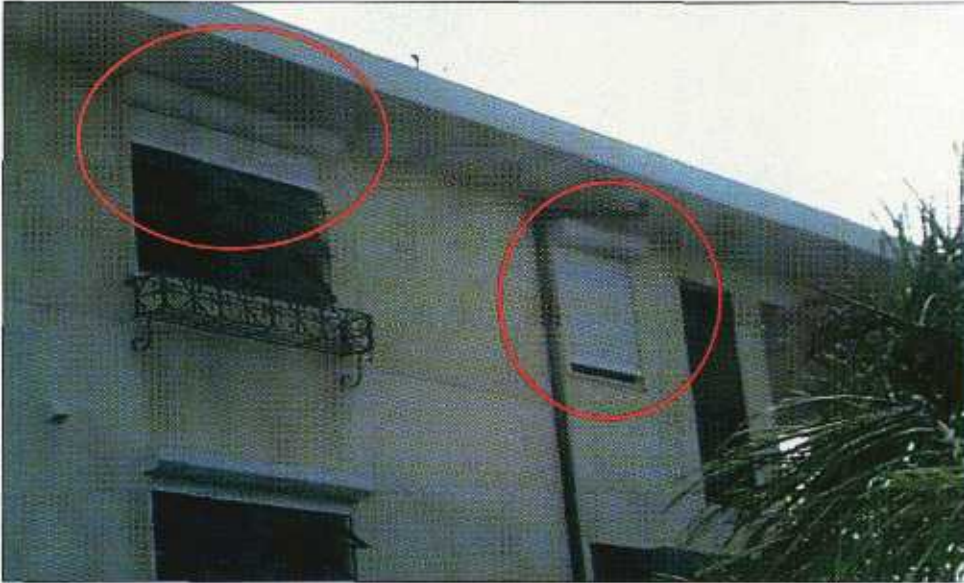
FIGURE 5-37 These windows were equipped with roll-up shutters.

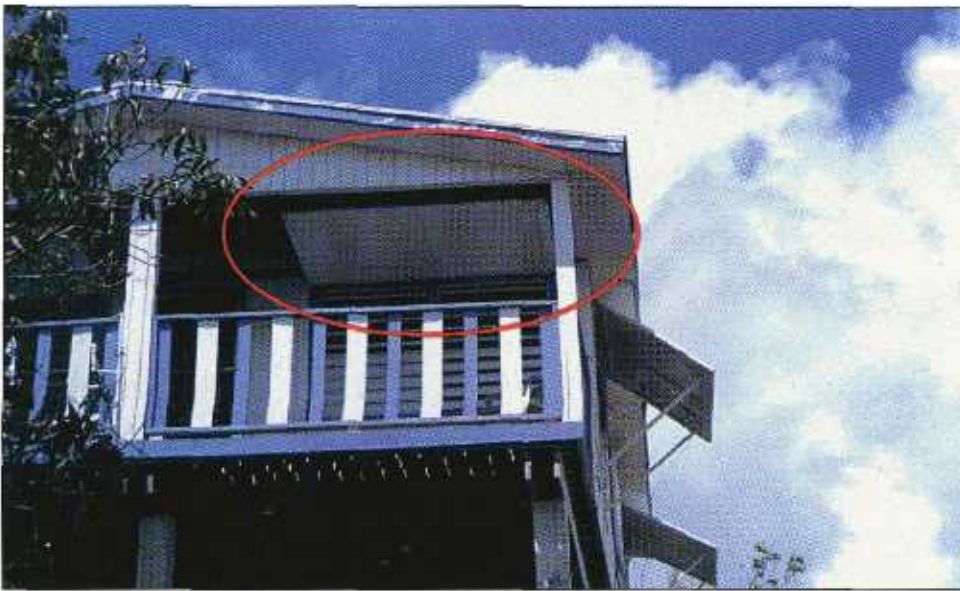
FIGURE 5-38 This house had hinged plywood shutters. The front shutter protects a Miami window.

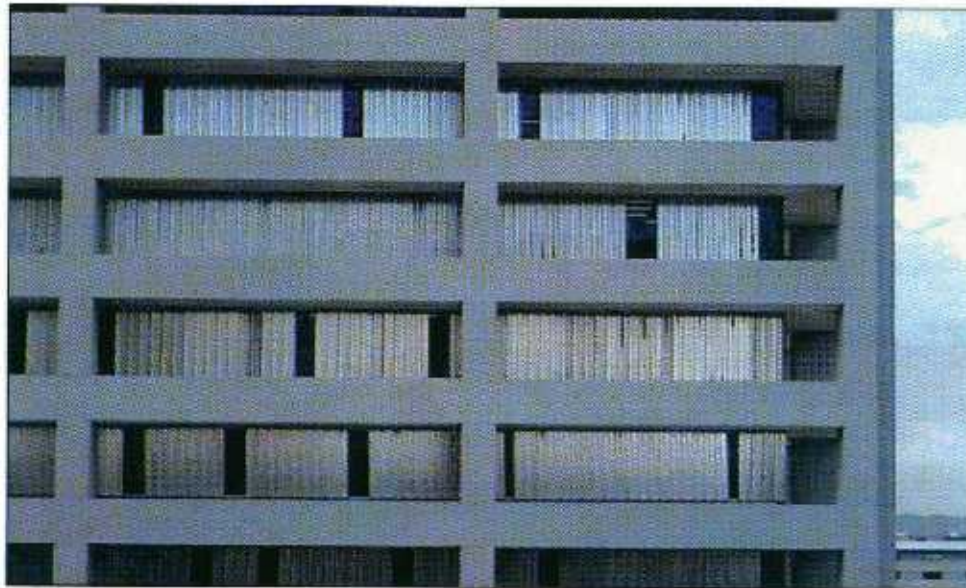
FIGURE 5-39 Steel shutters were used on this mid-rise building, which had a narrow balcony in front of the windows. Since wind speed increases with building height, the shutters on the upper floors can receive very high wind loads. The length of the shutters on this building requires the shutter panels and their connection to the tracks to be strong enough to resist being blown out of the track. The shutter panels also must be stiff enough to prevent deformation against the glass, or they must be set far enough away from the glass so they do not press against it.

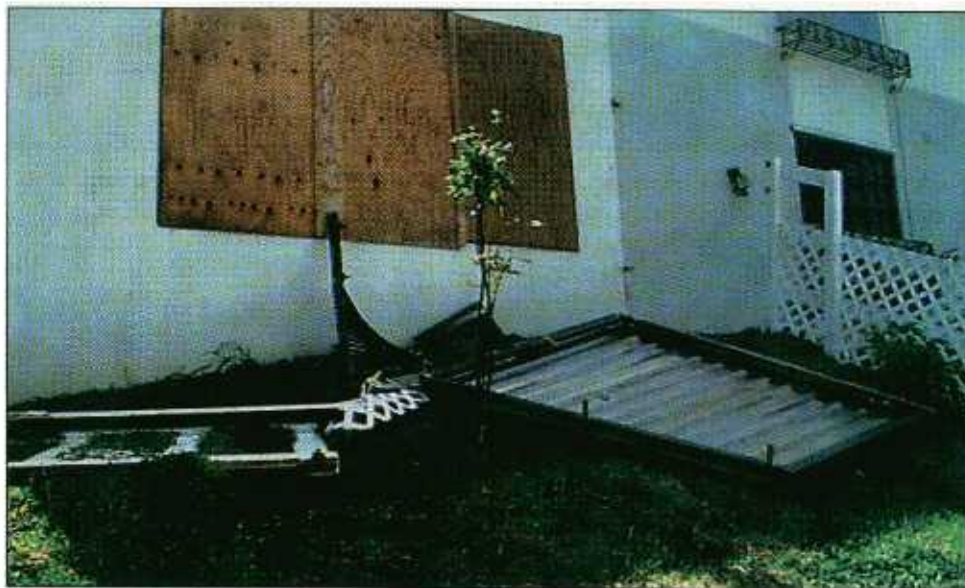
FIGURE 5-40 The window lying on the ground was protected by a shutter. However, the shutter was attached to the window frame. The window frame fasteners were over-stressed and the entire assembly failed. Attachment of the shutter directly to the wall framing is a more reliable method of attachment.

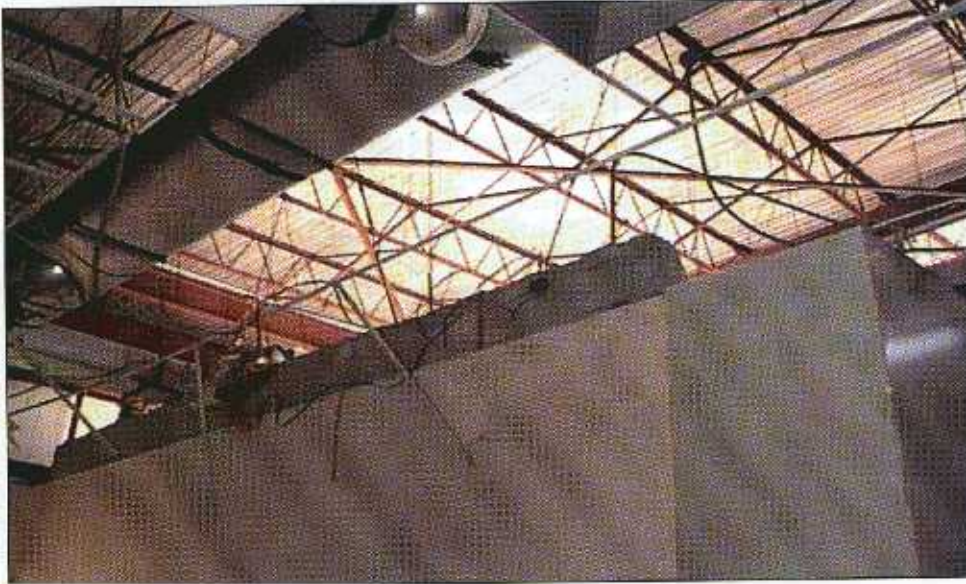
The BPAT noted the lack of compression struts, diagonal ties, and perimeter suspension wires in several buildings with acoustical ceilings (Figure 5-41). A lack of bracing was observed on some interior gypsum board/stud partitions as well as inadequate reinforcement and bracing of interior non-load bearing CMU walls (Figure 5-42).

FIGURE 5-41 Part of the exterior envelope of this building blew away, resulting in damage to the acoustical ceiling. This revealed a lack of seismic resistance of the ceiling system, light fixtures, and ductwork.

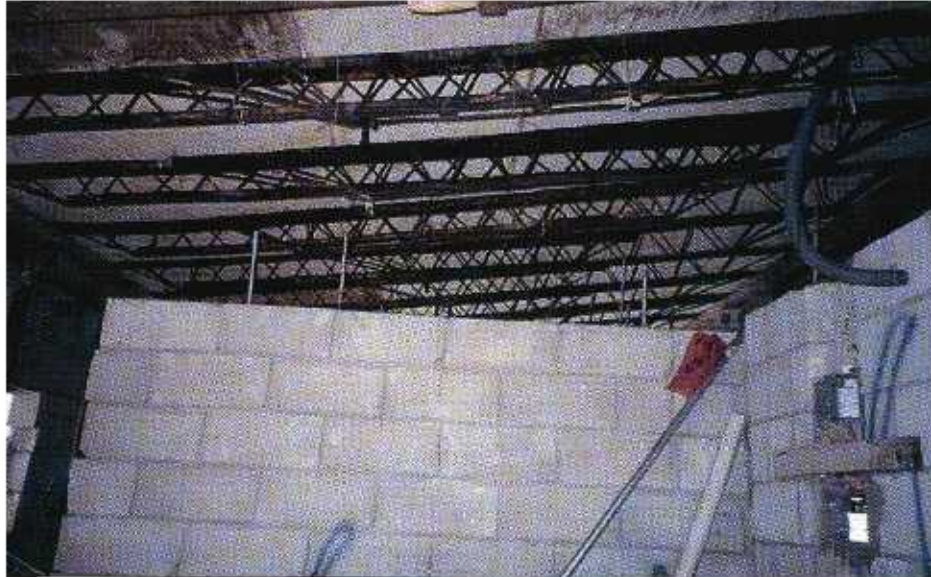
FIGURE 5-42 An interior view of a house under construction (the steel joists are supporting formwork for the concrete slab). The CMU partition is inadequately reinforced and is not supported or laterally braced at the top of the wall.
