6 Exterior Mechanical and Electrical Equipment

7 Electrical Distribution System

8 Conclusions

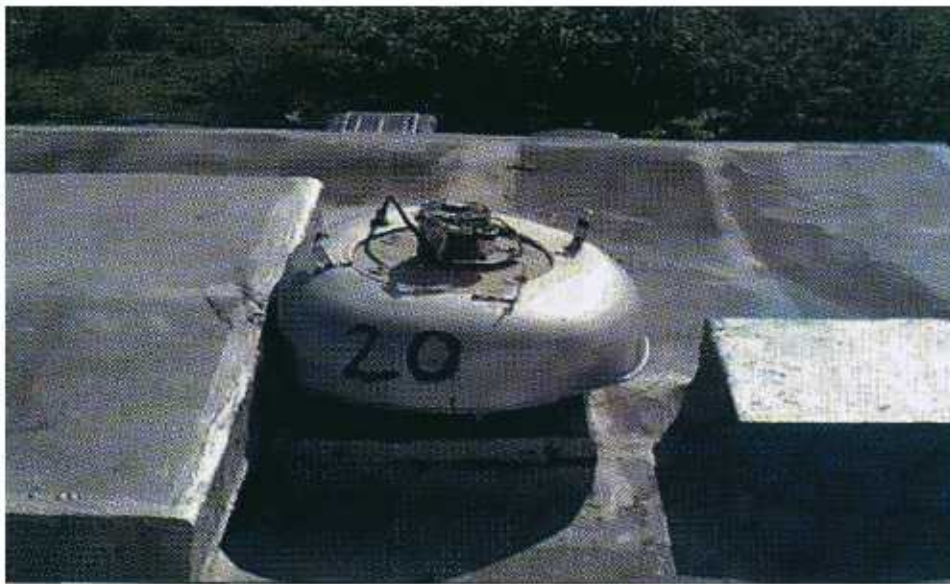
Hurricane Georges caused few problems to Puerto Rico's exterior-mounted mechanical and electrical equipment. The most commonly observed problem was blow-off of exhaust fan cowlings, as shown in Figure 6-1. Many residences and other buildings have water storage tanks on their roofs and most appeared to have performed well. However, as documented in Section 5.2.1, one tank blew off and damaged a hospital. Solar hot water heaters are located on many buildings and they also performed well. One solar heater that did not is shown in Figure 6-2.

FIGURE 6-1 This exhaust fan lost its cowl.

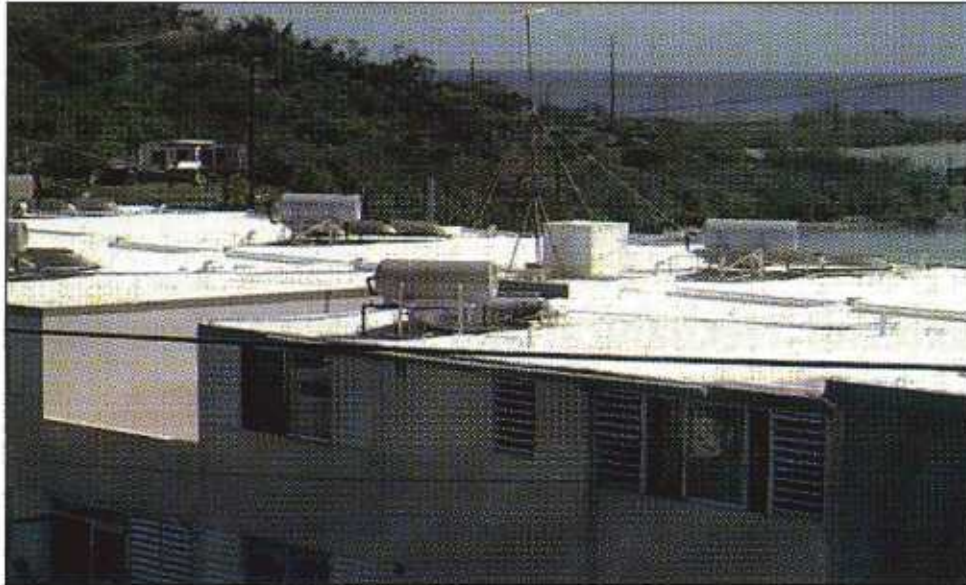
FIGURE 6-2 This roof had several solar hot water heaters that successfully weathered Hurricane Georges. However, the unit in the foreground was damaged.

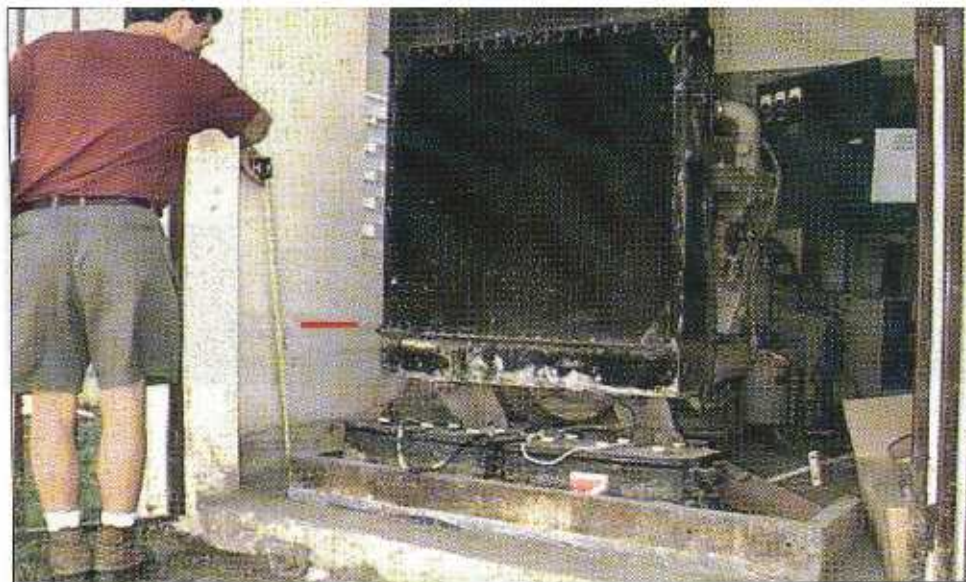
During Hurricane Georges, an emergency generator at a water treatment plant was flooded by a nearby river, rendering the generator unusable. As shown in Figure 6-3, the water rose approximately 2 feet above the generator room floor

FIGURE 6-3 Flood water entered this generator room and reached a height of about 2 feet, as indicated by the red line. This facility is located in Jayuya.

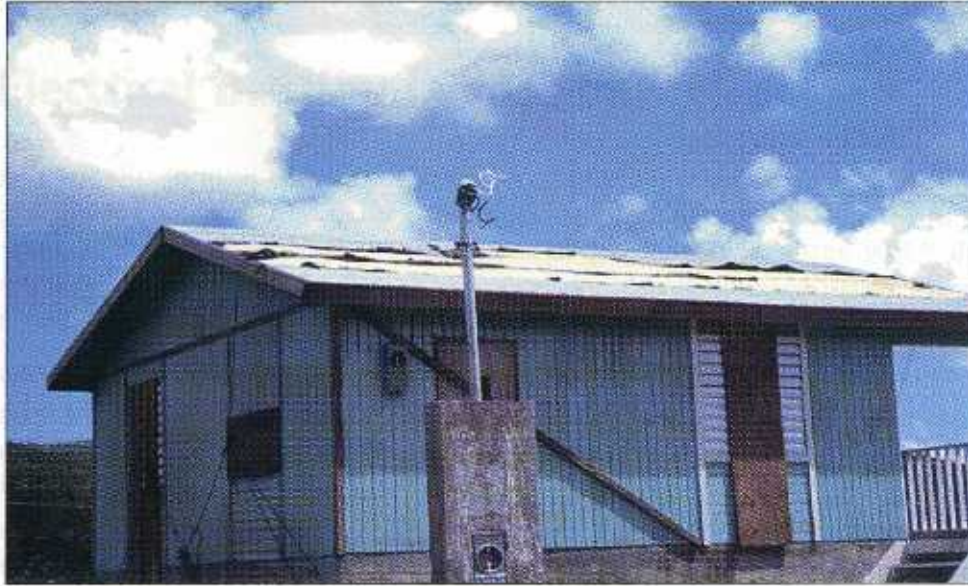
Several residences in Puerto Rico have overhead electrical service to a service mast mounted on a free-standing concrete pylon. From the service mast to the building, the service was underground, as shown in Figure 6-4. The advantage of this type of service mast versus one mounted through the roof is that if the mast deflects or is torn away, the roof is not damaged.

FIGURE 6-4 This service mast is mounted on a concrete pylon. This form of service connection was successful in eliminating roof damage when the overhead service blew down.

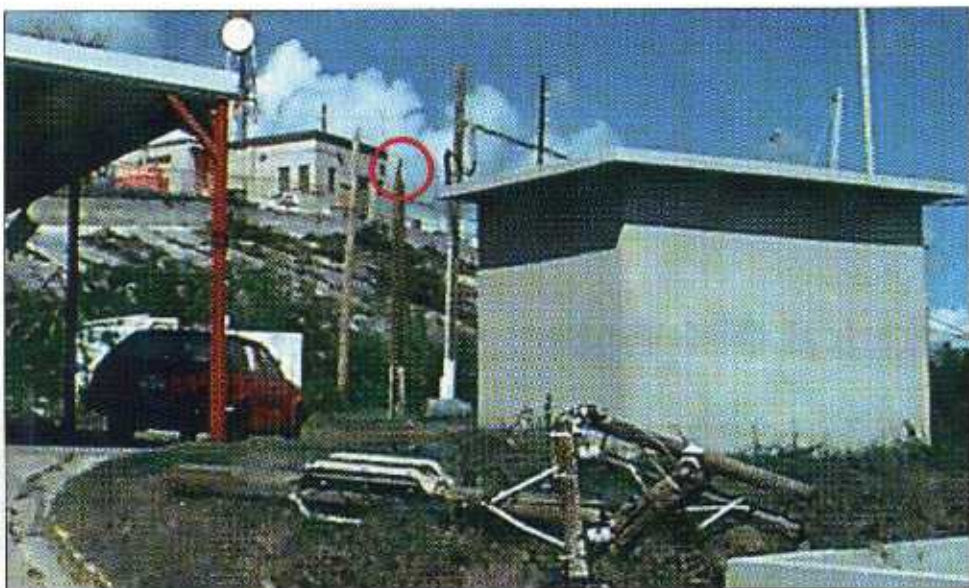
- Broken wood poles: This was caused by too great a load on the pole, including too large a span or various heavy communication lines on the poles (Figures 7-1 and 7-4).
- Leaning poles (wooden and concrete): This was considered minor damage and was easily corrected by straightening and properly embedding the poles in the ground (Figure 7-2).
- Broken concrete poles: Round spun concrete poles generally perform better than the reinforced concrete poles that are widely used in Puerto Rico. There was evidence of spalling and cracking of reinforced concrete poles indicating a probable quality control problem (Figure 7-3).
- Fallen poles: This was a result of improper embedment. Additional damage occurred to the conductors, causing progressive failure to other poles.

FIGURE 7-1 Damaged wood pole. The portion of the wood pole in the foreground broke from the pole (circled) in the back of the picture.

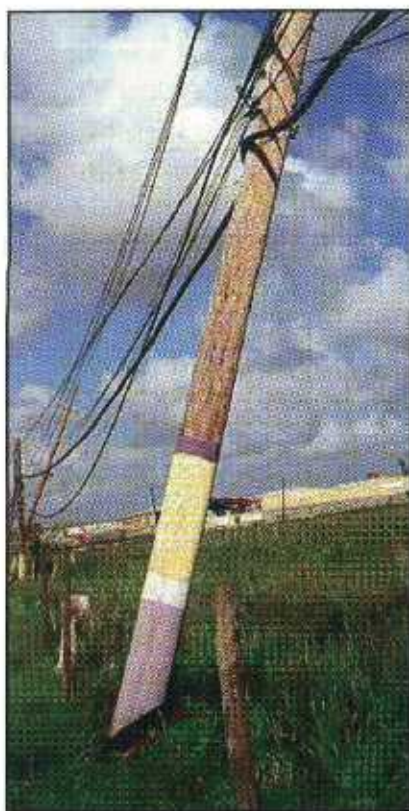
FIGURE 7-2 Leaning wood pole due to inadequate embedment.

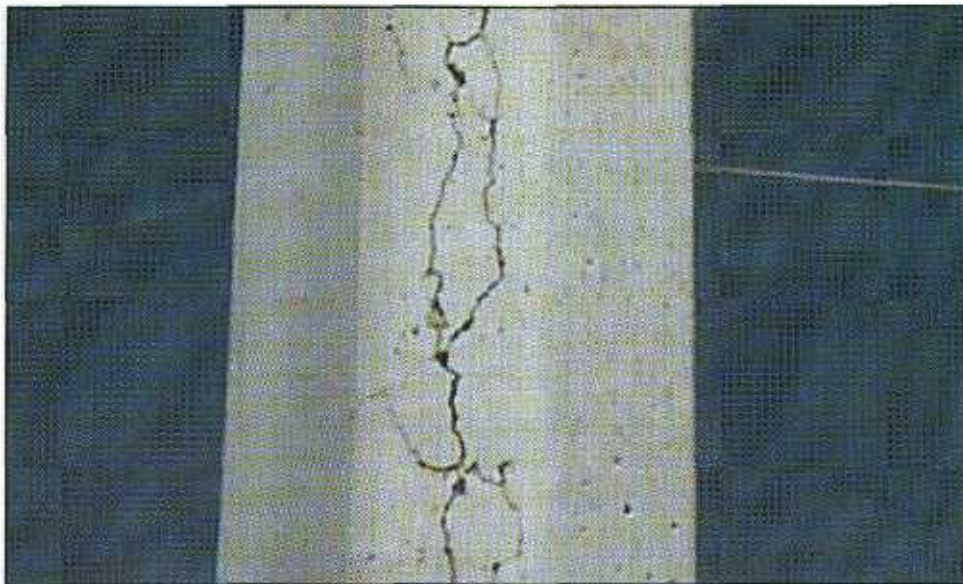
FIGURE 7-3 Observed crack in concrete pole that appears to be a quality control problem.

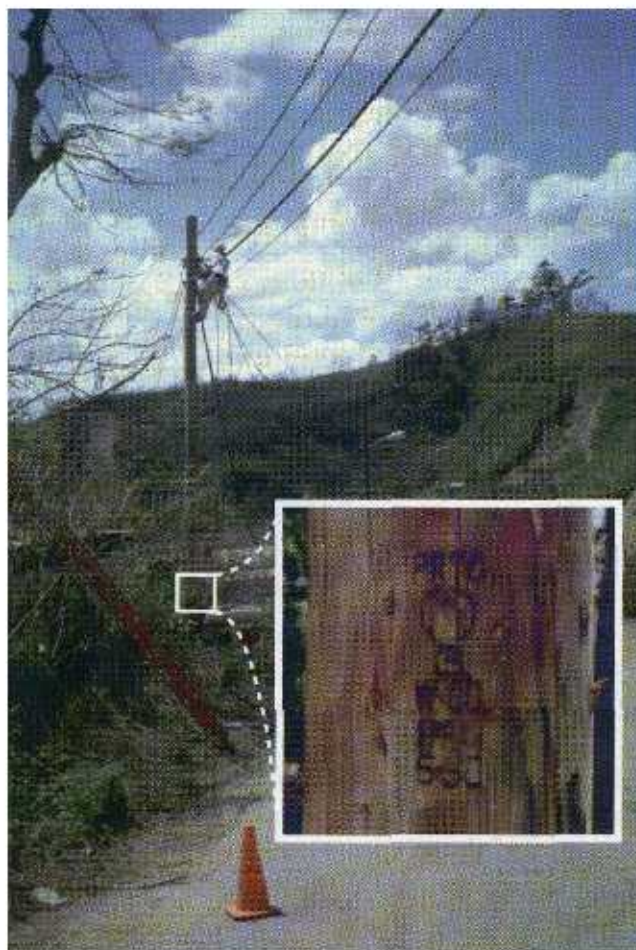
FIGURE 7-4 New wood pole replaced after the hurricane; utility lines are still being attached to the pole. Inset shows wood pole grade marking. This #3 pole was typical of those used throughout the island.

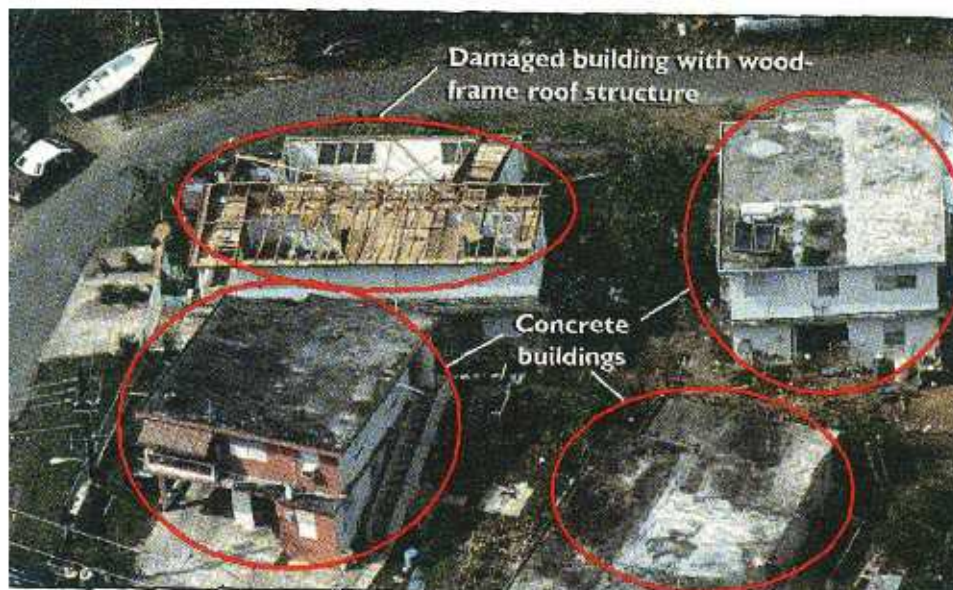
The most prevalent and successful mitigation measure the BPAT observed was the use of concrete and masonry for the construction of the exterior walls and roof. Reinforced concrete and masonry envelopes almost without exception provided excellent resistance to wind forces and windblown debris. They were also extremely reliable and durable, as illustrated in Figure 8-1.

FIGURE 8-1 The three concrete/masonry buildings in this photo appeared to be undamaged. However, the building with the wood-frame roof structure experienced significant damage.

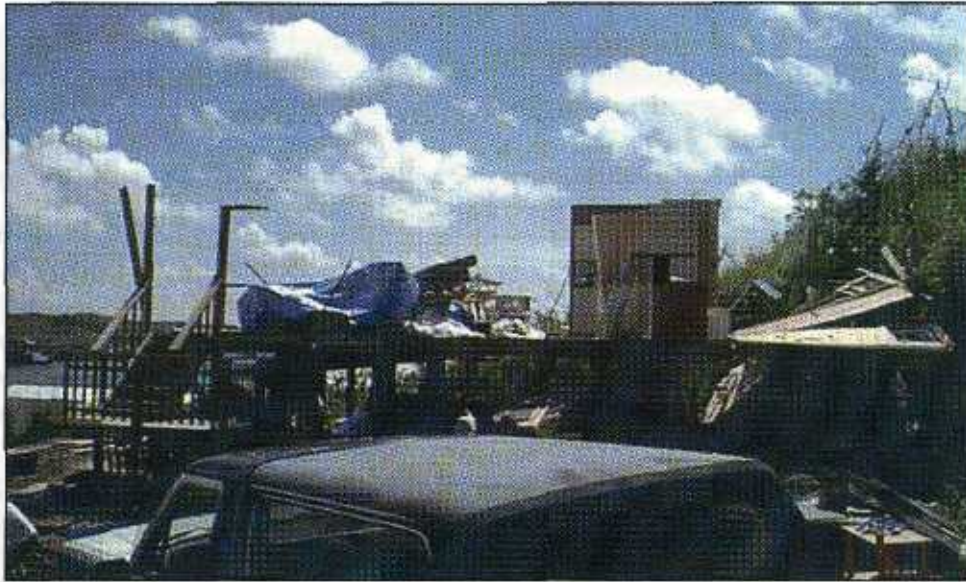
Although the BPAT observed many wood-frame building failures, as illustrated in Figure 8-2, wood-frame buildings perform well in high winds if effective mitigation measures are taken during design and construction. This is illustrated in Figure 8-3.

FIGURE 8-2 This wood-framed house was nearly totally destroyed. This is in remarkable contrast to the nearby building shown in Figure 8-3.

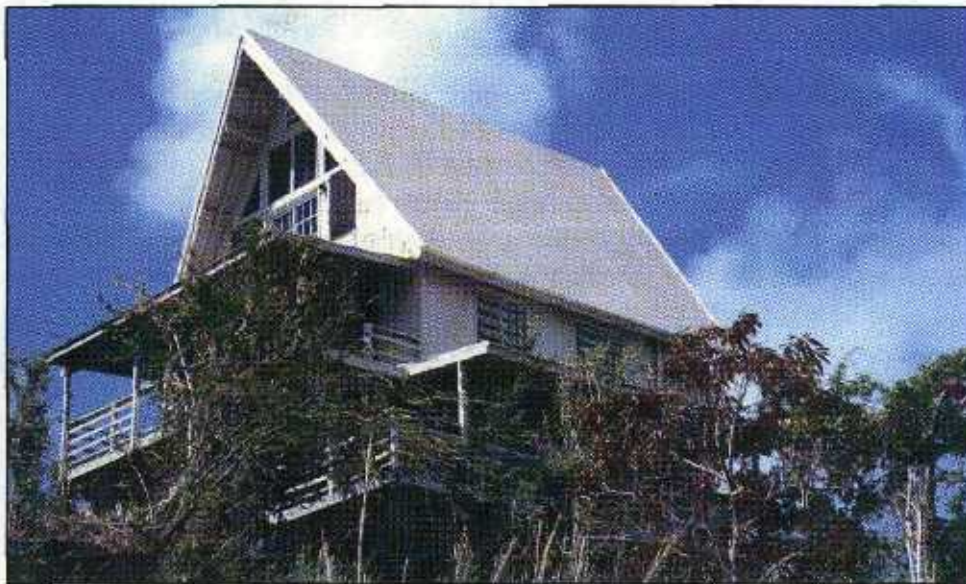
FIGURE 8-3 This wood-framed house is close to the house shown in Figure 8-2. The wind flow was essentially identical at these two sites, hence the successful performance of the one building is attributable to the attention given to design and construction. The value of mitigation is clearly illustrated in these two starkly different cases.
