Risk Management Of The Yodogawa River During The Hanshin-Awaji Earthquake

Ken-ichi Shimada

Director of Yodogawa River Work Office, Kinki Regional Construction Bureau

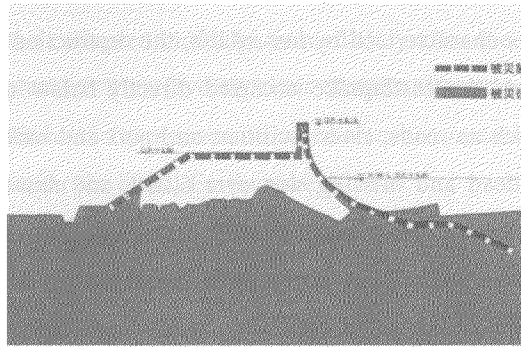
Fig.3-2 Cross Section View of Damaged Torishima Levee

Damage was severe at the downstream areas near the focus. In particular, the waterfront areas of Torishima, Konohana-ku, Osaka City on the left riverbank were depressed for a length of over 2 km and to a maximum depth of 3 meters.

Longitudinal profiles of the depressed levee are shown in figure 3-2. Even after the earthquake, the levee at the lowest point was still at an elevation of OP + 3.5 m, and leaks were not found in the structure, so it was not feared that secondary disasters such as sea water flooding or collapse of the structure might occur. Damaged conditions of the Torishima Levee is shown in photographs 3-1 through 3-3. In areas adjacent to damaged levees traces of mud pumping were noted at a number of points. These were noted not only within the levee structure but also in the river bed. Such traces of the mud pumping within the depressed levee structure were also observed in excavation inspections. In Torishima district, a super embankment was being constructed next to the damaged levee before the earthquake occurred. Various gauges were buried in ground in order to monitor variations appearing in the ground due to construction of the embankment. A rapid rise of pore water pressure was recorded in these gauges. For this reason, it can be presumed that the ground was liquefied in this area due to strong earthquake motion.

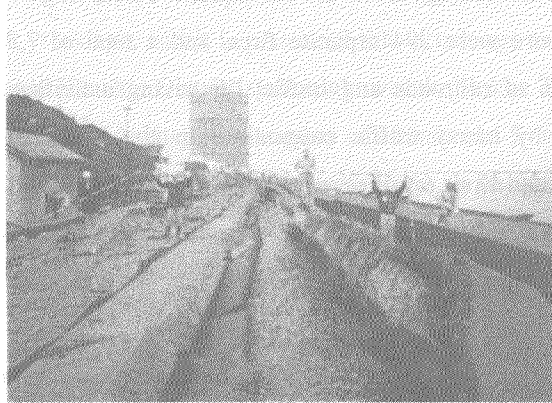
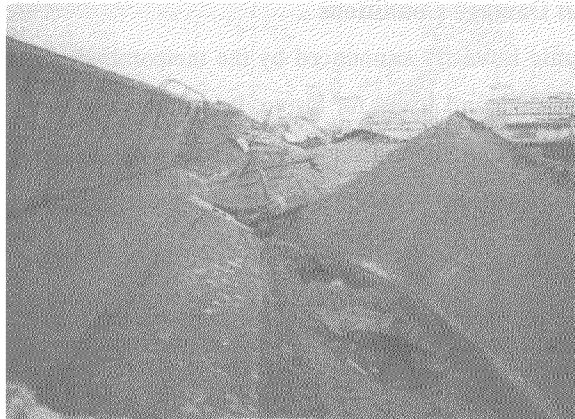
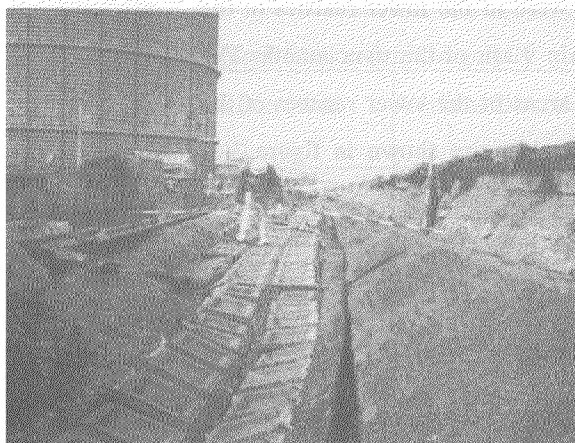
Photo3-1~3 Damaged Conditions of the Torishima Levee

One of major factors causing damage to the levee was the liquefaction of the ground. The ground in the lower reaches of the Yodogawa river consists of loose sand alluvial deposits 10 meters thick. Since this sand layer was liquefied due to the strong shocks, it can be presumed that the levee settled because of loss of bearing support. Therefore, it was considered necessary to take steps to prevent ground liquefaction to preclude similar failures from repetition. Such measures were discussed by a technical committee formed of personnel with academic backgrounds.
