# 2 *Site Observations*

## 2.1 ASSESSMENT TEAM APPROACH

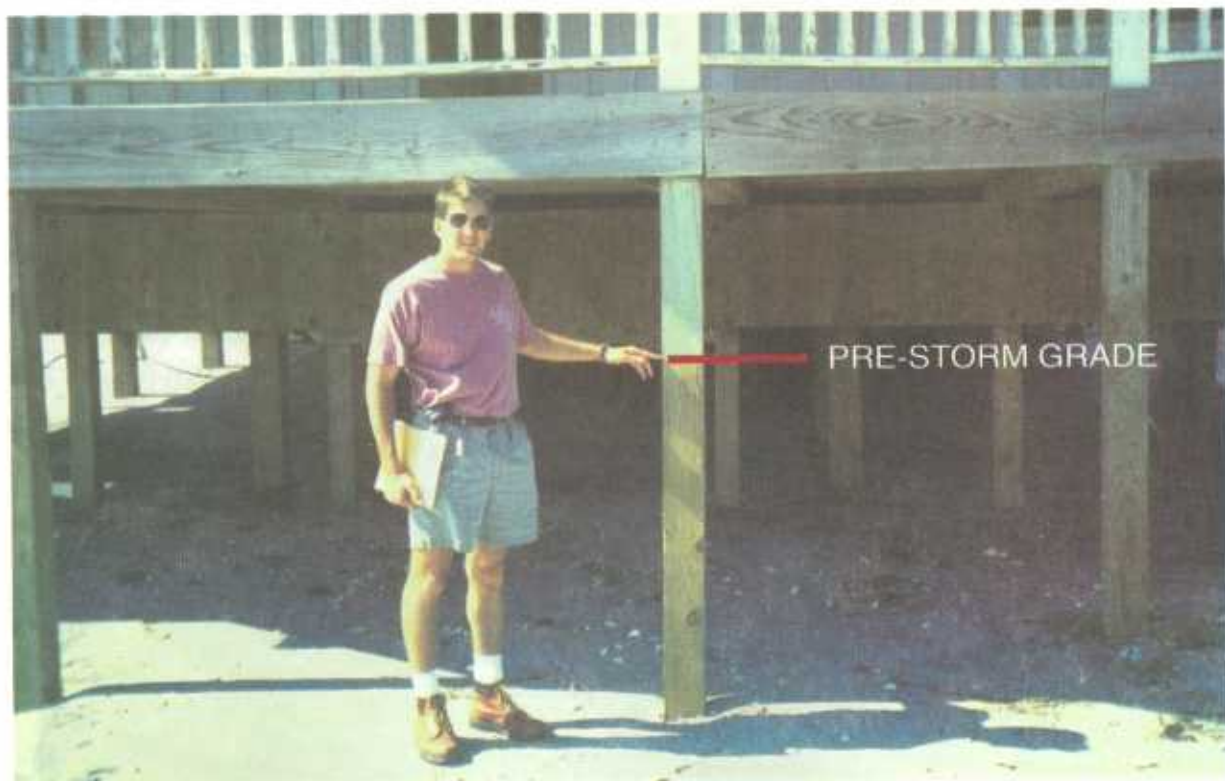
Coastal areas from Cape Fear to Cape Lookout experienced significant erosion and scour. In many locations, especially from Topsail Beach to North Topsail Beach, localized frontal dunes were eroded and the beach profile was lowered 2 to 3 feet. Erosion beneath oceanfront homes averaged 4 to 6 vertical feet (see Figure 2-2). In addition, erosion and localized scour at vertical foundation members was observed to have occurred.

*Figure 2-2* Erosion resulted in significant loss of supporting sand, averaging 4 to 6 feet, under oceanfront buildings.

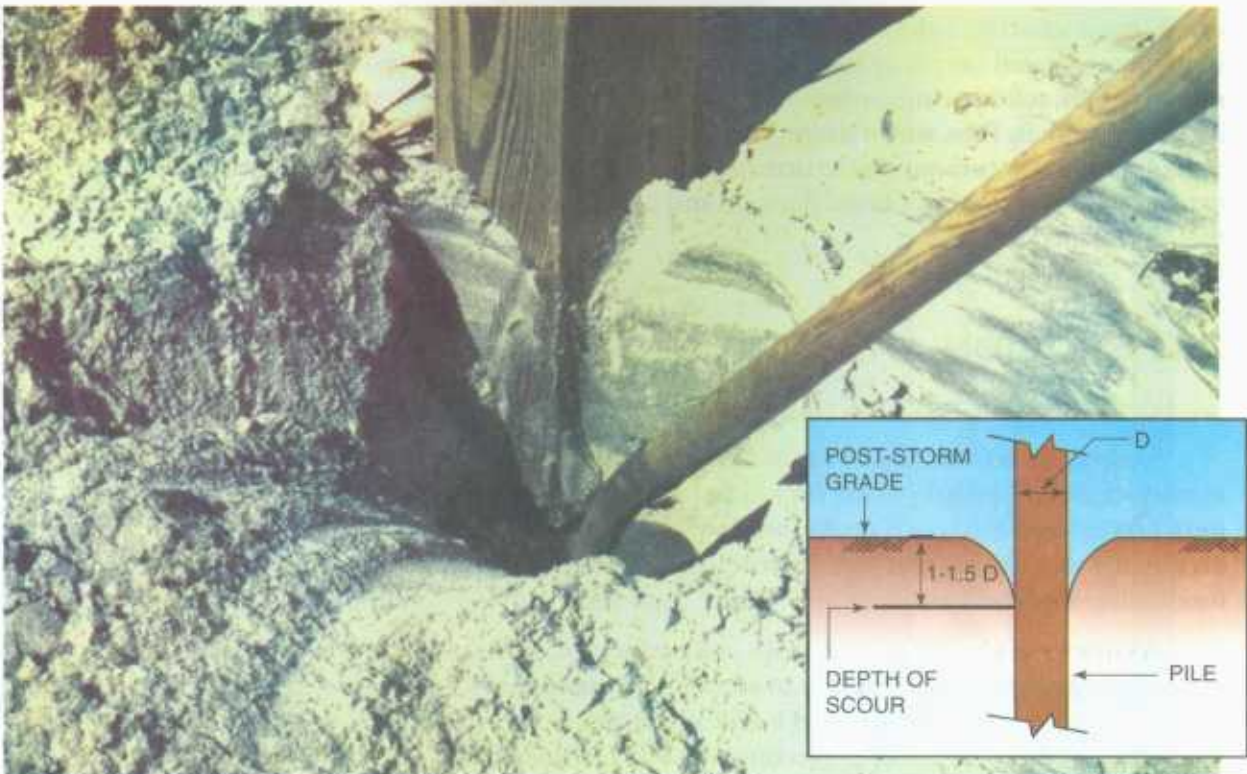
A cursory study of localized scour was performed during the site investigation. Sand surrounding pilings was excavated to identify the maximum localized scour that occurred. From changes in sand color, texture, and bedding, the team determined that, in general, localized scour occurred to a depth of approximately 1 to 1.5 times the diameter or width of the piling (see Figure 2-3). The depth of scour around 8-inch-diameter round pilings and 8-inch x 8-inch square pilings supporting oceanfront structures was measured to be approximately 10 to 11 inches.

Figure 2-3 Determination of localized scour from changes in sand color, texture, and bedding.

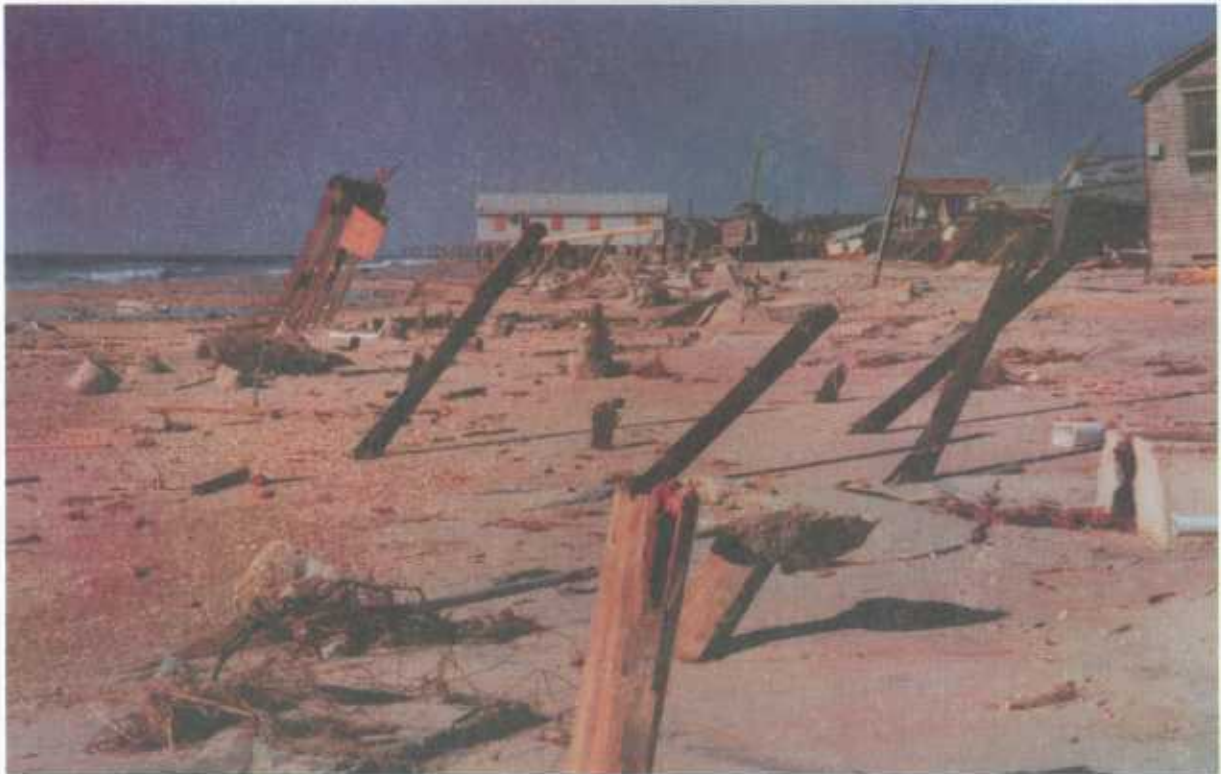
Erosion and scour were commonly observed to total 5 to 7 vertical feet at oceanfront homes in the area from Topsail Beach to North Topsail Beach. This erosion and scour, added to the long-term erosion rate of an average 1 to 2 feet a year, left many homes unable to withstand the loads imposed by flood and wind forces acting simultaneously (see Figure 2-4).

*Figure 2-4 Loss of the frontal dune and the resulting erosion and scour left many coastal houses unable to resist wind and flood loads acting simultaneously.*

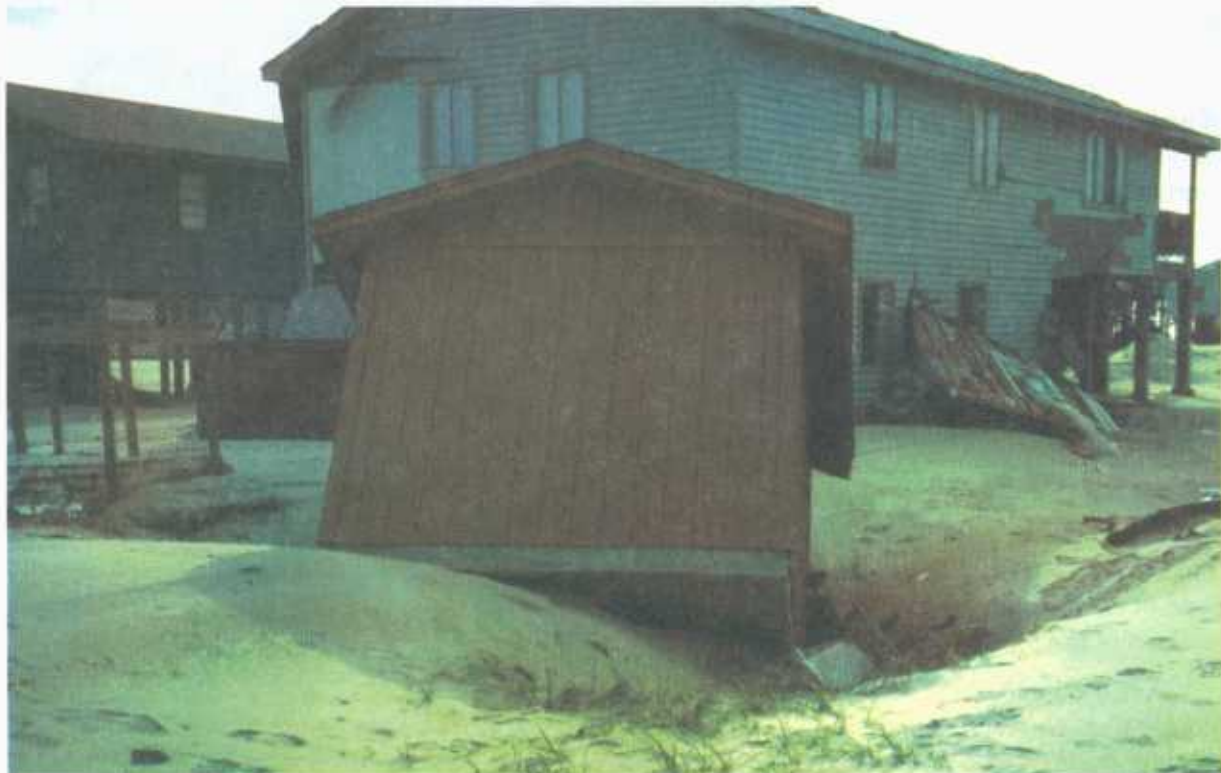
No evidence of general erosion was observed in the areas around landward structures, but evidence of localized scour around pilings and other obstructions was plentiful (see Figures 2-5 and 2-6). In general, scour did not result in the failure of the piling foundations of landward structures. However, scour around the vertical members supporting air conditioner platforms and building extensions such as decks, porches, and roof overhangs occasionally decreased the ability of the vertical members to withstand flood forces and led to their collapse.

*Figure 2-5 Overwash of barrier islands generated high-velocity flows that caused extensive scour adjacent to large objects.*
