2.3 BUILDING FOUNDATION SYSTEMS

2.3.1 PILING EMBEDMENT FOR STRUCTURAL SUPPORT

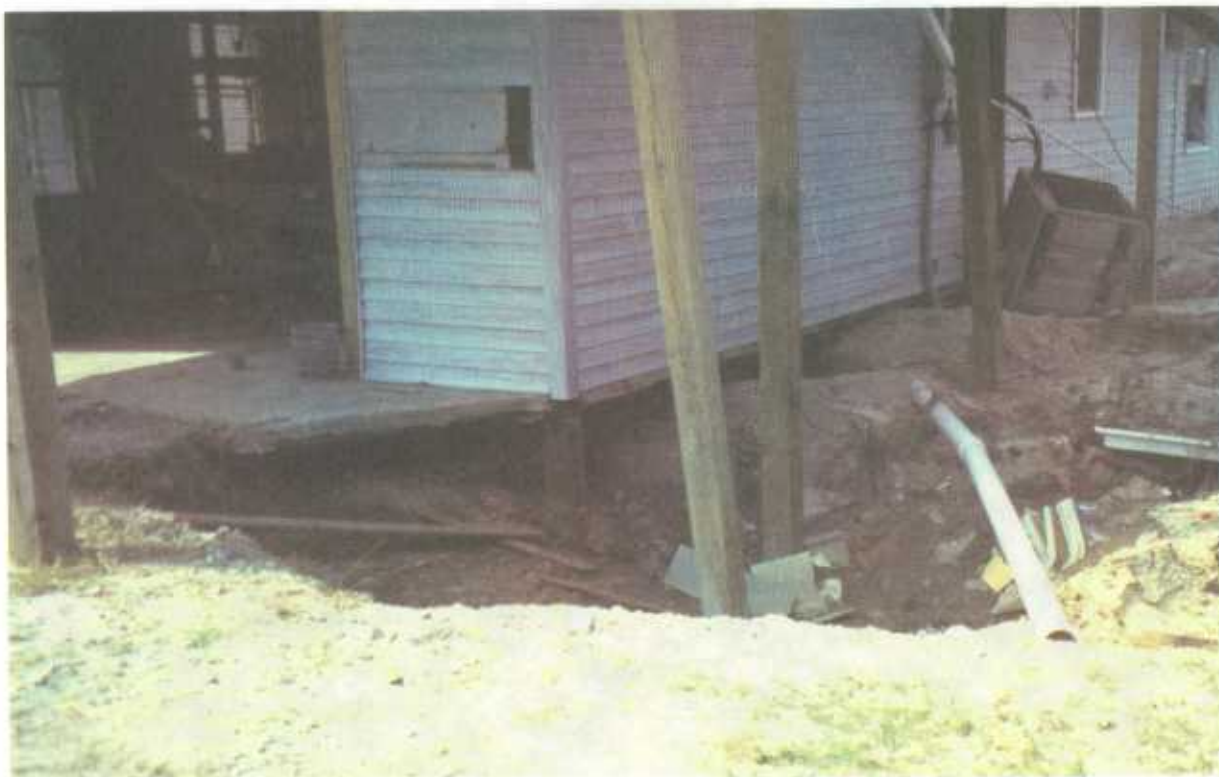
Figure 2-6. *The disruption of velocity flows by large, non-breakaway objects generated extensive scour that undermined vertical foundation members and slabs-on-grade.*

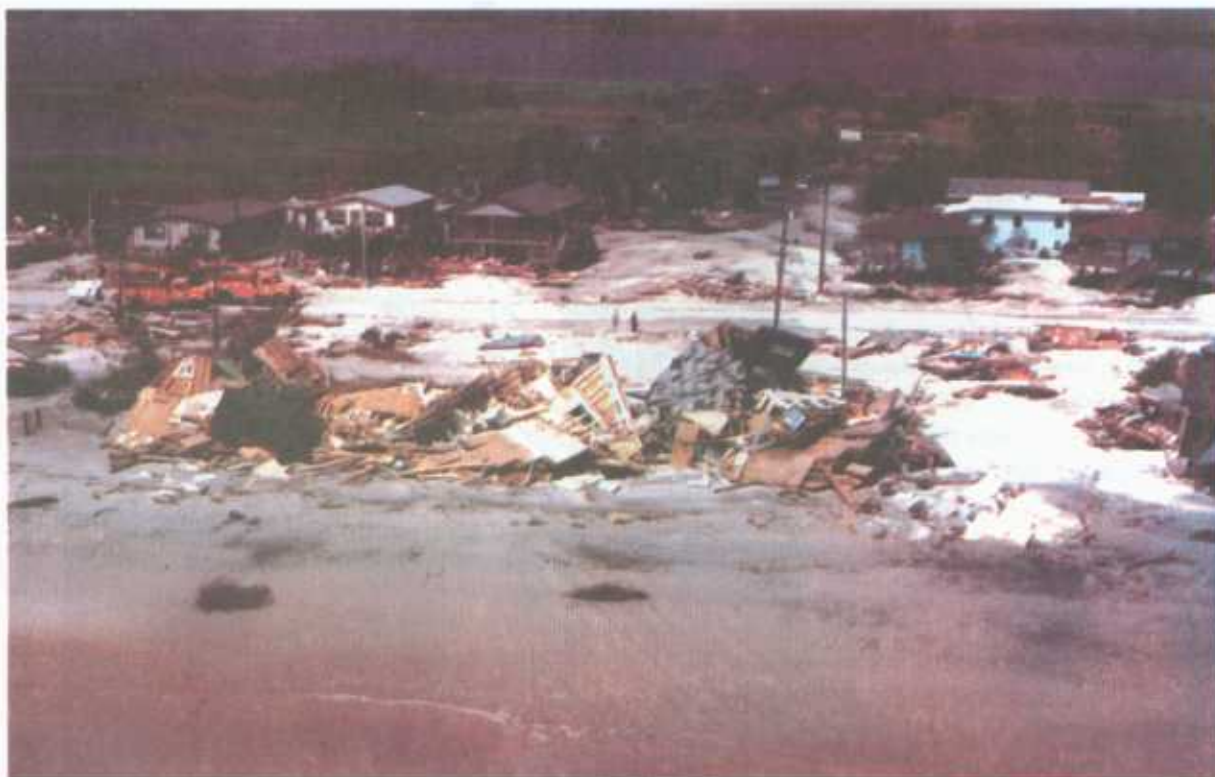
Lack of sufficient embedment of vertical structural foundation members may well have contributed to the collapse of over 100 oceanfront residential buildings (see Figure 2-7). Of those that did not collapse, many were found to be leaning (see Figure 2-8). The majority of these structures met the pre-1986 requirement for an 8-foot embedment of pilings and columns (measured from existing grade). Many front-row houses were placed near or on the landward slope of the frontal dune, where the ground elevations were often 8 to 9 feet m.s.l. As a result, the bottoms of the pilings or columns were at approximately 0 feet m.s.l. (see Figure 2-9)

Figure 2-7 Over 100 oceanfront houses were washed off their foundations or completely destroyed.

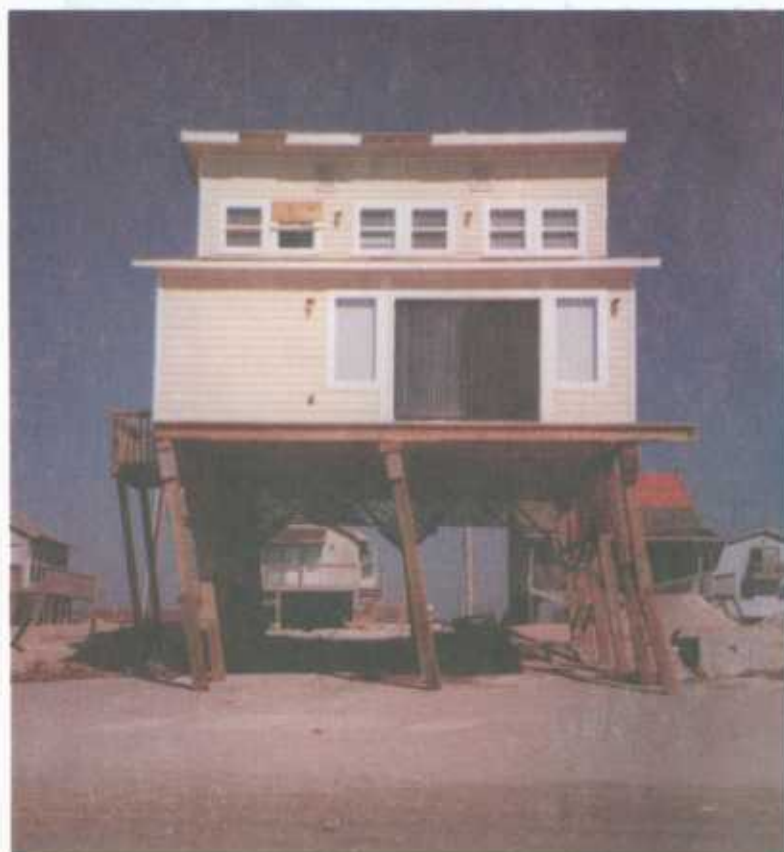
Figure 2-8 Many oceanfront houses built prior to current (1986) North Carolina State Building Code requirements were found to be leaning or destroyed.

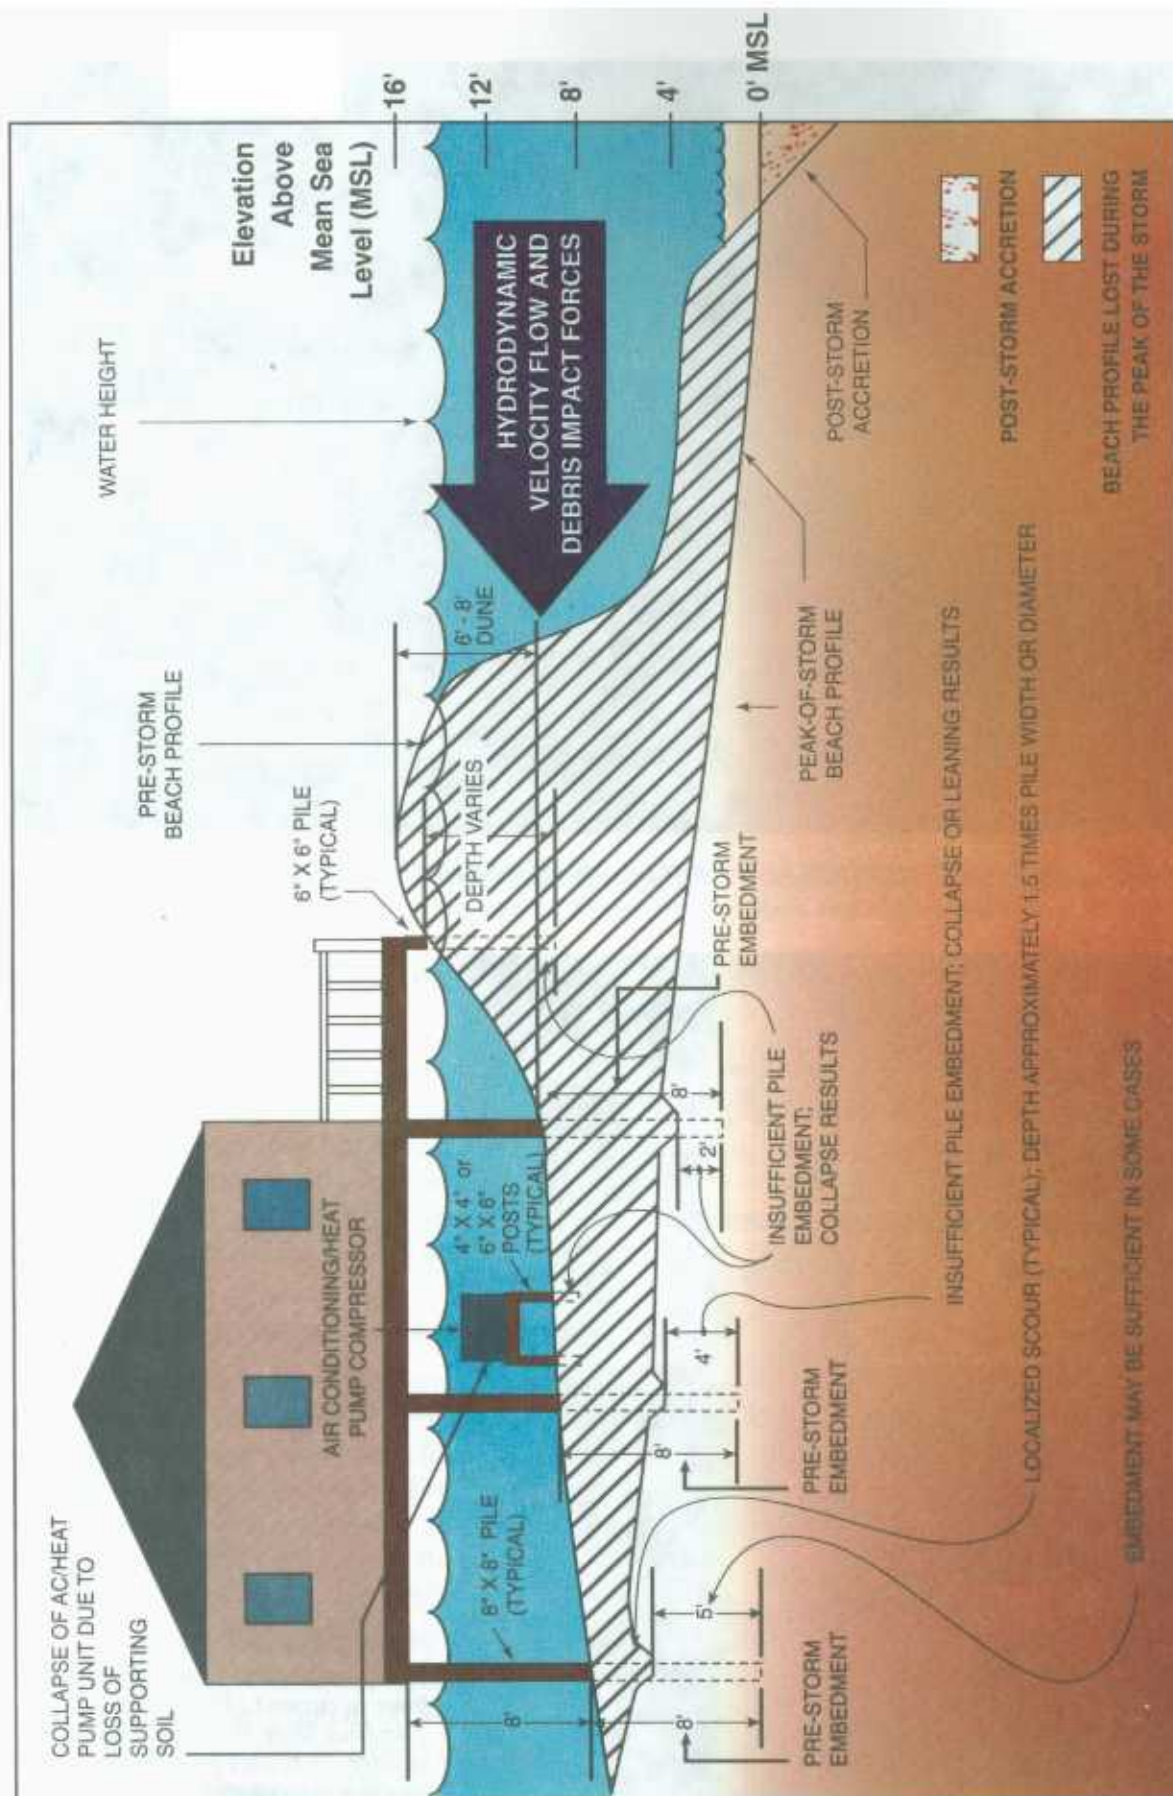
Figure 2-9 Typical collapse mechanism of post-FIRM building based on pre-1985 embedment requirements in North Carolina coastal areas.

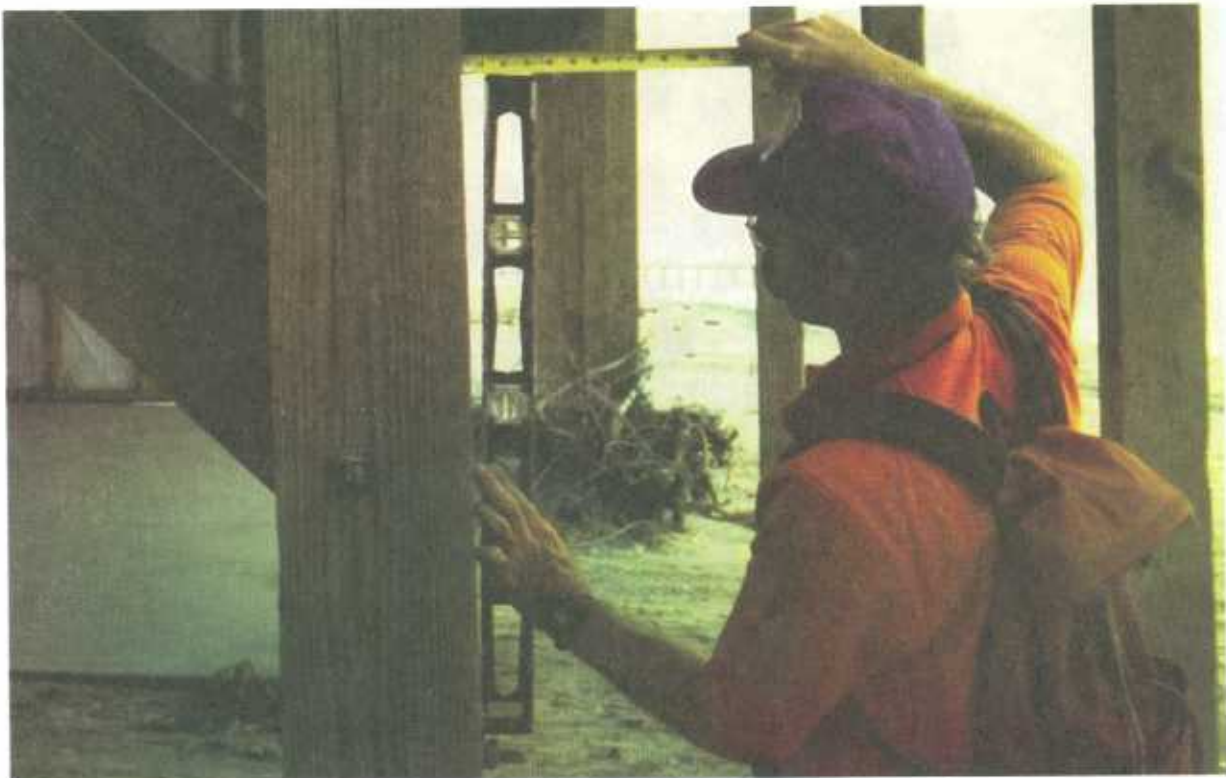
Although post-1986 oceanfront structures generally performed better than oceanfront structures built prior to 1986, several foundations supporting oceanfront structures that were observed to be leaning were suspected of being post-1986 (see Figure 2-10). The remaining embedment depth of the foundation members beneath these structures was not determined by the BPAT; however, for example, with a pre-storm grade of 11 feet m.s.l., erosion of approximately 6 vertical feet to an elevation of approximately 5 feet m.s.l., and localized scour of an additional 1 vertical foot, the vertical foundation members should still have been embedded approximately 9 feet below grade during the height of the storm. This depth should have been sufficient to prevent leaning in many cases. One possible explanation is that the pilings under these leaning structures did not meet the current embedment depth requirement.

Figure 2-10 One of several buildings observed to be leaning landward that were suspected of having been constructed to current North Carolina State Building Code requirements.

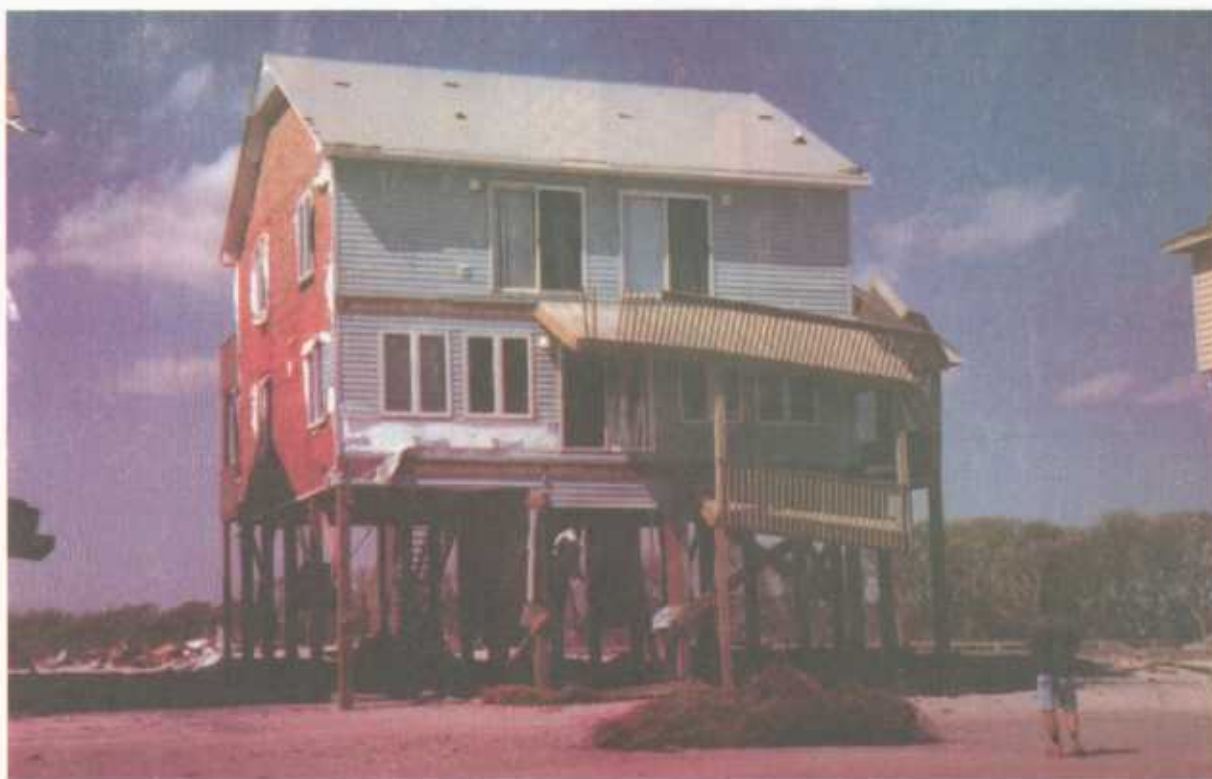
Lack of sufficient embedment of vertical foundation members for decks, porches, and roof overhangs attached to oceanfront and landward residential buildings resulted in the collapse of several hundred of these building extensions (see Figure 2-11).

Figure 2-11 The BPAT observed several hundred decks and porches that collapsed as a result of insufficient foundation support.

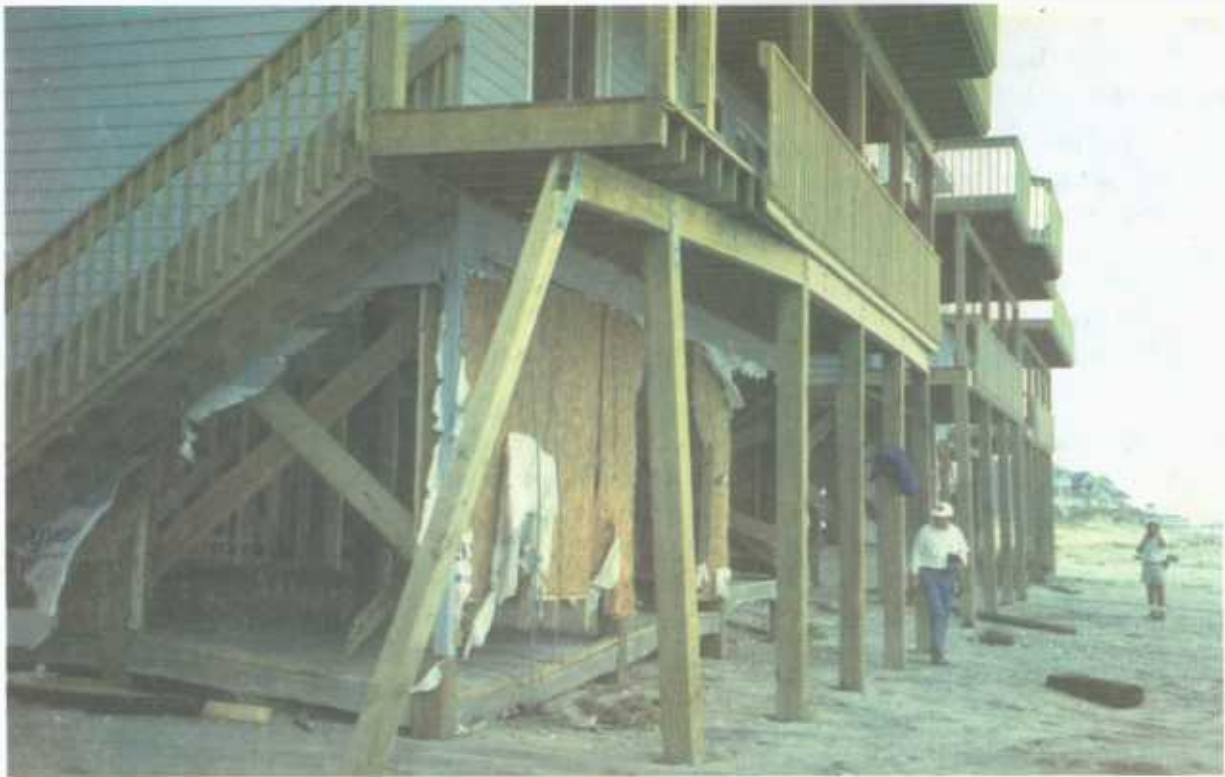
Vertical foundation members supporting unroofed decks did not have to meet the pre-1986 State Building requirement for 8-foot piling embedment, nor do they have to meet the post-1986 requirement for 16-foot embedment. Vertical foundation members for covered porches and roof overhangs are supposed to meet the criterion applied to the foundation members for the main structure. The BPAT found that vertical foundation members for decks, porches, and roof overhangs were often embedded to a depth of only 2 to 6 feet below existing grade (see Figure 2-12).

Figure 2-12 Example of building constructed to current North Carolina State Building Code requirements with insufficient embedment of piles/columns under two-story deck.

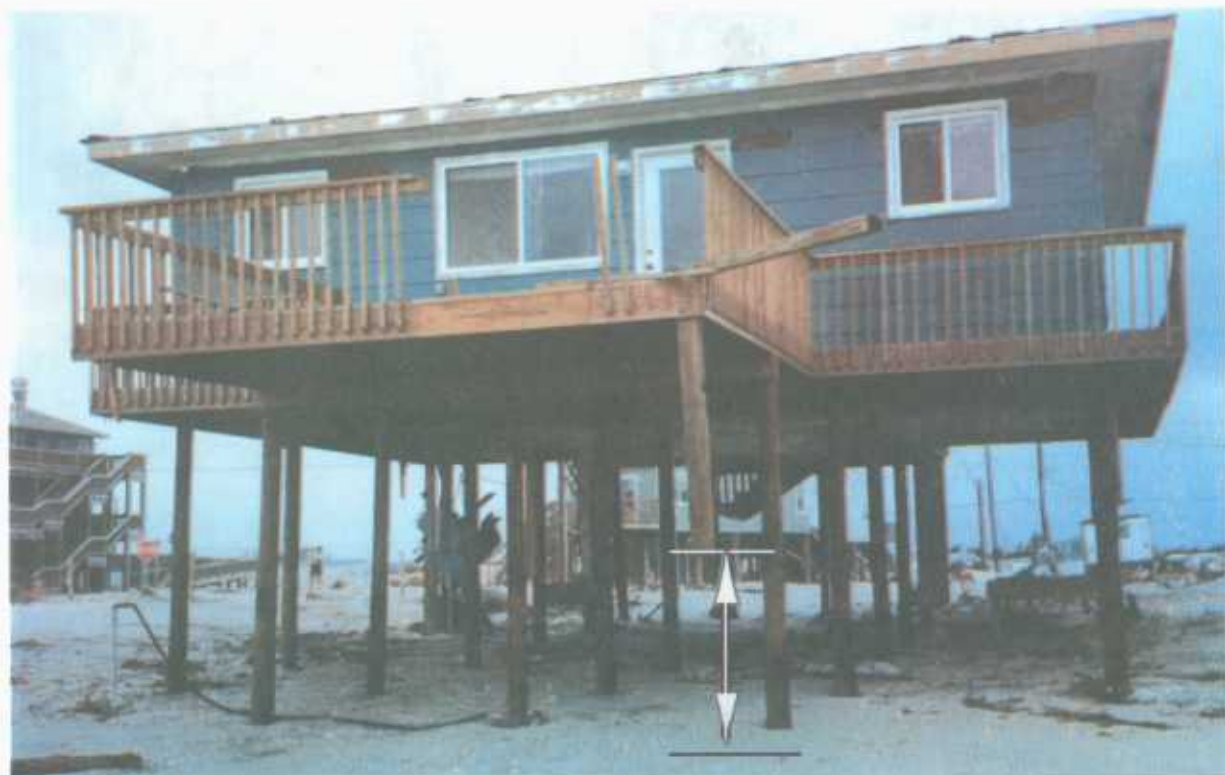
Figure 2-13 Embedment of deck supports into frontal dune was often shallow. After erosion of the dune, the bottom of the support for this deck was left several feet above grade.

Since these supports are usually seaward of main structures, they are subject to amounts of storm surge, velocity flow, wave action, vertical erosion, and localized scour at least as great as those that affect the main structure (see Figure 2-13).

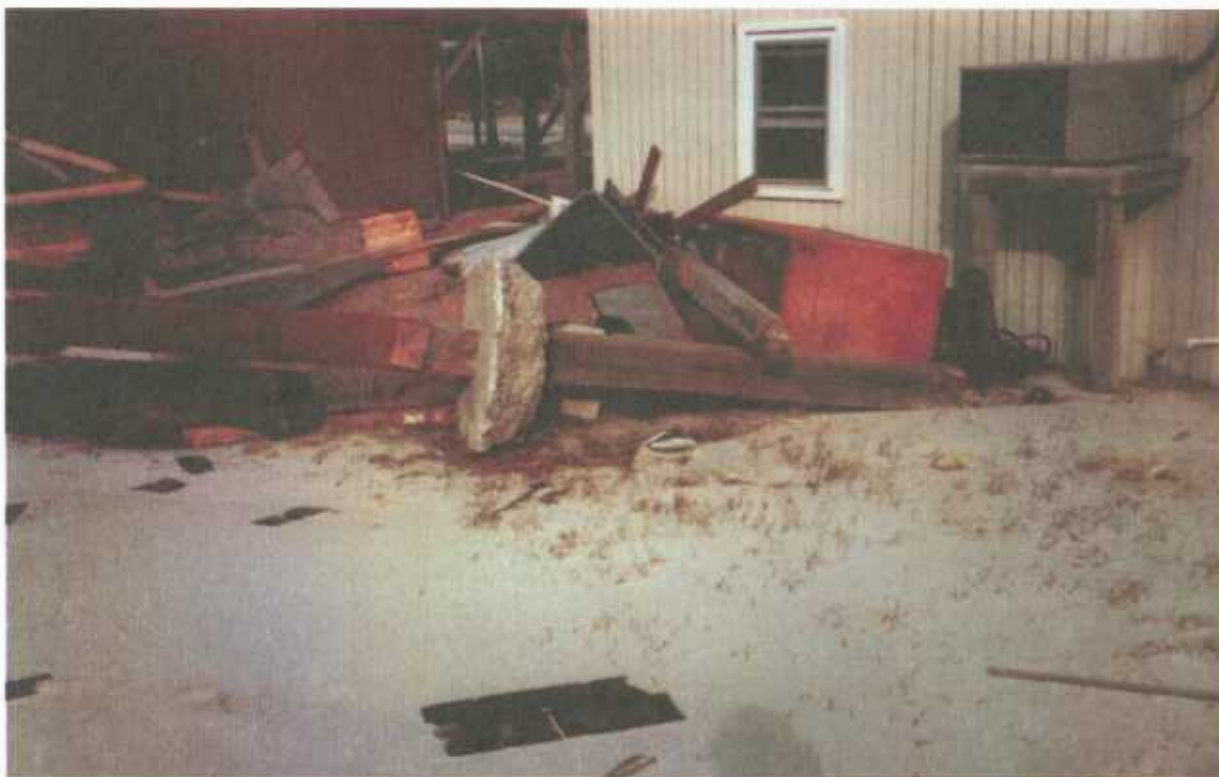
In the areas where decks, porches, and roof overhangs were observed, erosion was approximately 7 vertical feet, to an elevation of approximately 4 feet m.s.l. Localized scour of an additional vertical foot would result in total loss of embedment to an elevation of 3 feet m.s.l. during the peak of the storm (see Figure 2-9). When vertical foundation members lost their ability to support the structure above, the deck, porch, or roof overhang often collapsed, damaging the structure to which it was attached and becoming waterborne debris that was then carried into the main structure or nearby structures (see Figure 2-14). This damage may have contributed to the collapse of some buildings.

Figure 2-14 Storm-generated debris impacted nearby structure.

Debris observed by the BPAT included 8-inch x 8-inch pilings up to 20 feet long (see Figure 2-14), round 6-inch diameter posts, septic tank sections (see Figure 2-17), materials from collapsed adjacent houses, the remains of collapsed decks (from the house impacted and from adjacent and other nearby oceanfront houses — see Figure 2-18), and portions of collapsed fishing piers. An extreme example of debris impact is shown in Figure 2-19. Although debris impact generally was not suspected of causing significant failure of vertical foundation members, it did damage foundation cross-bracing, as discussed in Section 2.3.6.

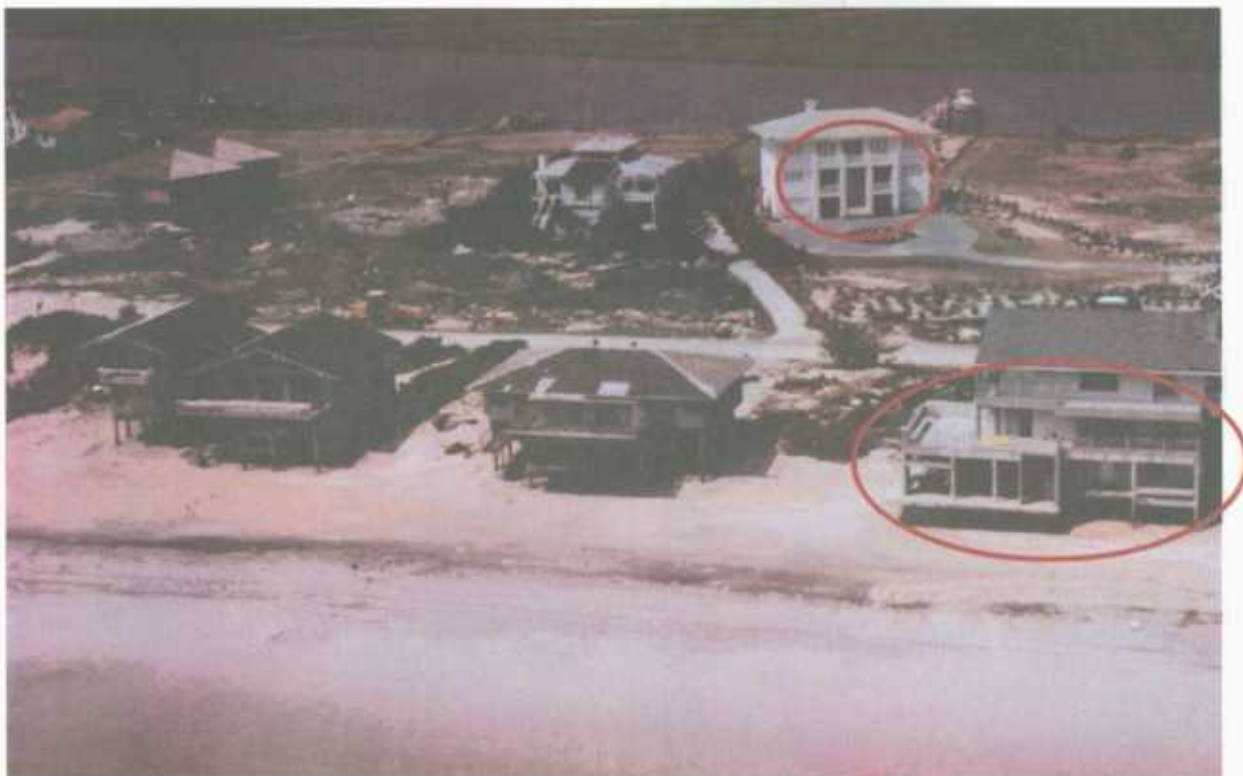
Figure 2-15 As shown by this post-Fran photograph taken at Figure Eight Island, North Carolina, a current architectural trend is the construction of multistory decks supporting roof overhangs.

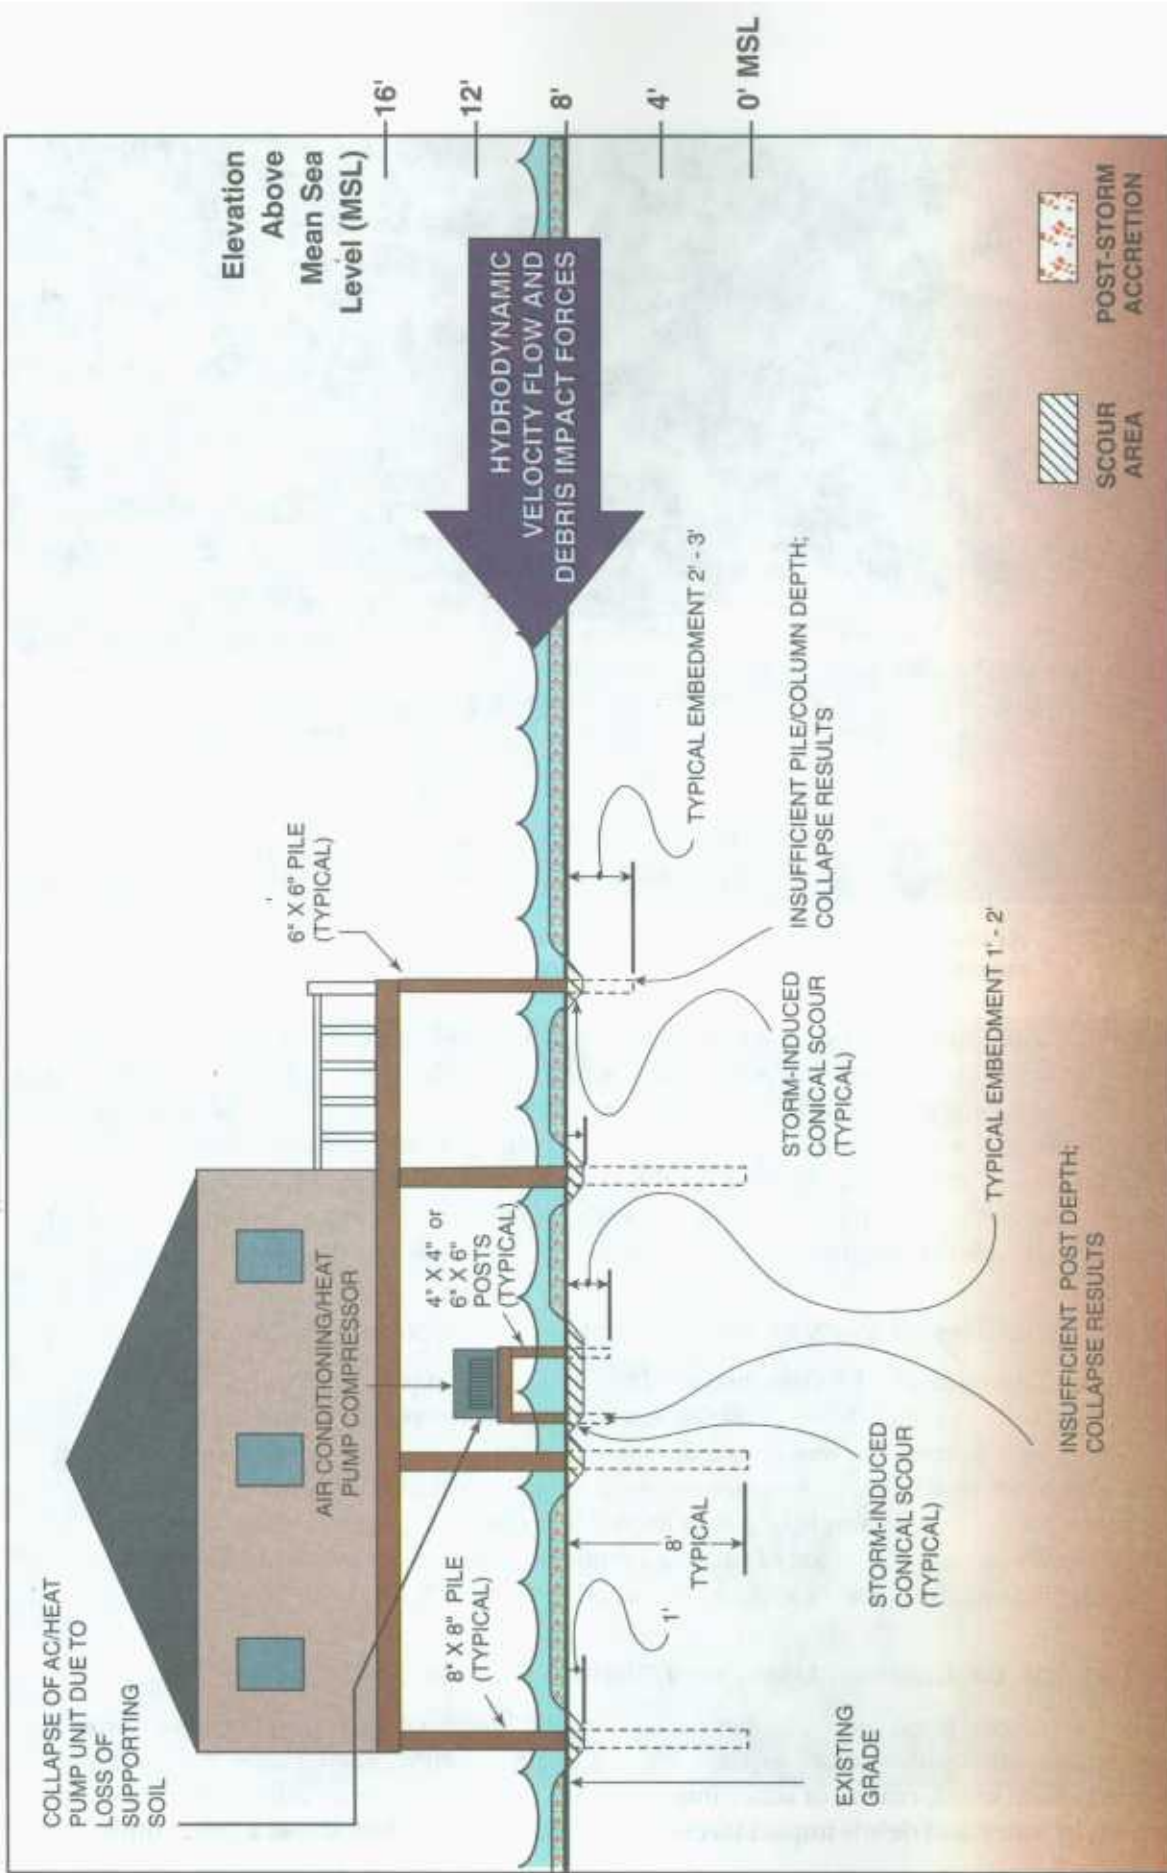
supporting soil due to scour often left vertical foundation members of decks, porches, and roof overhangs unable to resist the velocity flow, wave action, and debris impact forces that occurred in coastal areas (see Figure 2-16). Vertical foundation members were found to not be embedded to the same depth as the main building supports. It was reported that the North Carolina State Building Code requires vertical supports for the main structure outside of a V Zone to be embedded 8 feet below existing grade, but that no such requirement was enforced for building extensions such as decks and, in some instances, porches and roof overhangs.

Figure 2-16 Typical failure of deck / roof overhang and air conditioning / heat pump compressor platform for landward home.
