2.3.5 ELEVATION OF BUILDINGS

2.3.6 CROSS-BRACING BELOW ELEVATED BUILDINGS

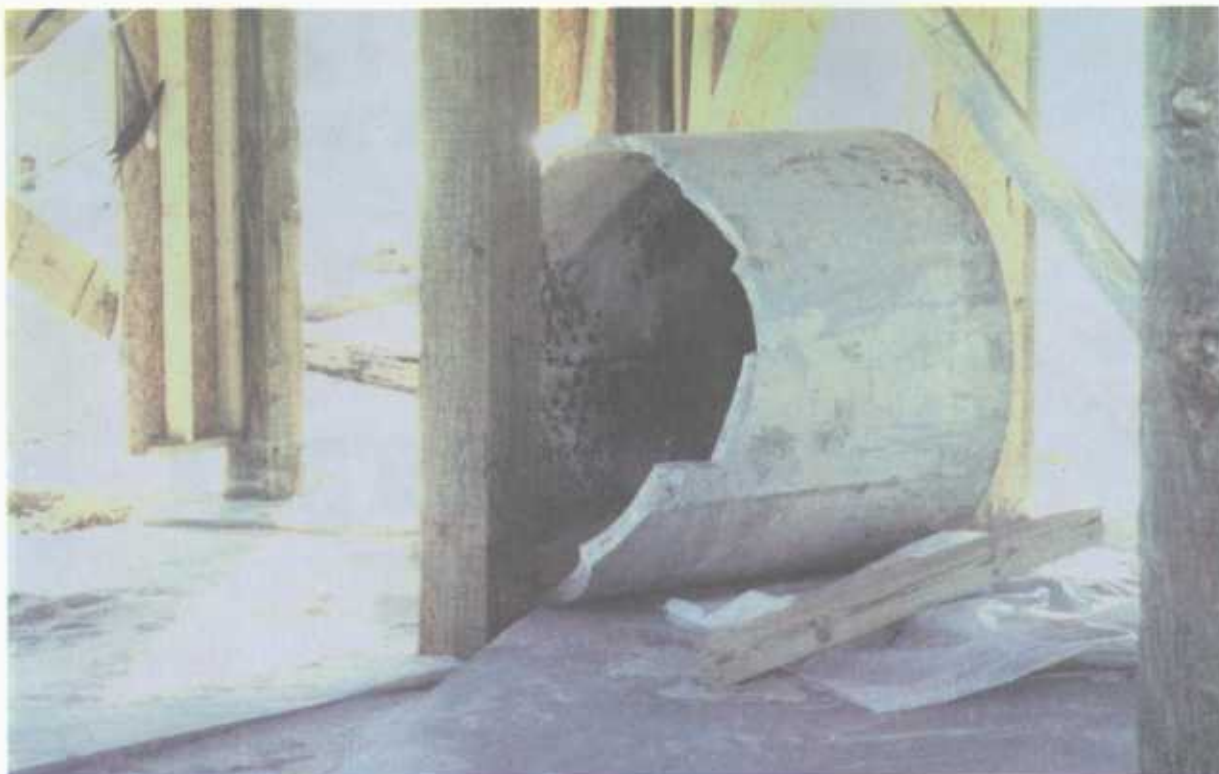
Figure 2-17 Precast concrete ring section of septic tank became waterborne debris, impacting building foundation members.

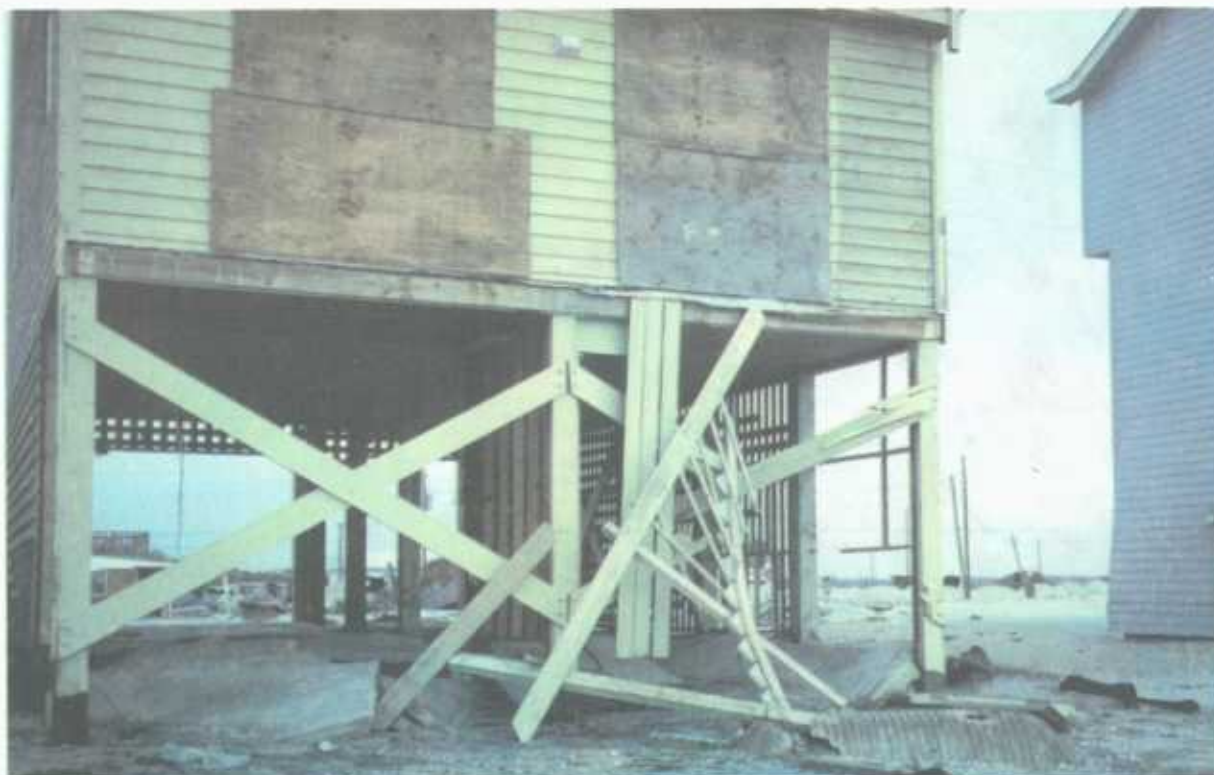
Figure 2-18 Impact of debris from a damaged deck appeared to have broken cross-bracing.

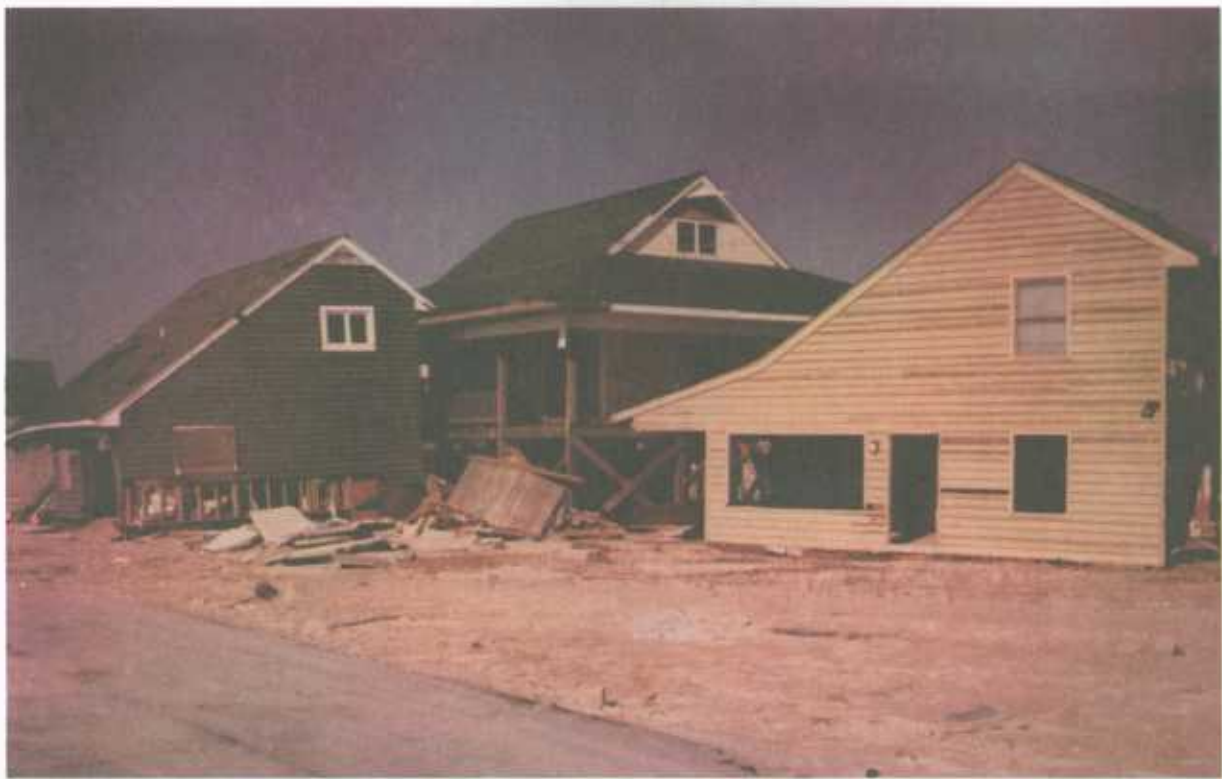
Figure 2-19 Example of extreme impact — two houses floated and pushed into another house.

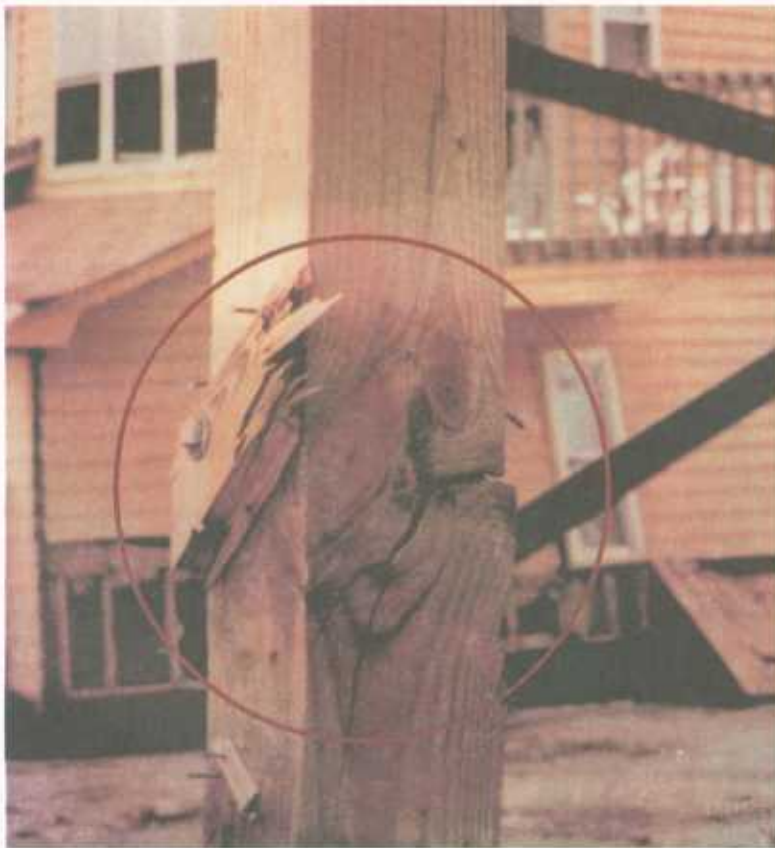
Figure 2-20 Example of broken piling. The piling broke at the location of several knots (circle), where cross-bracing was attached (note remaining bolt and piece of bracing).

piling whose strength was compromised by closely spaced knots. Failures of this type were not widely observed by the BPAT but, as indicated by Figure 2-20, are a potential problem that can lead to structure failure and even collapse.

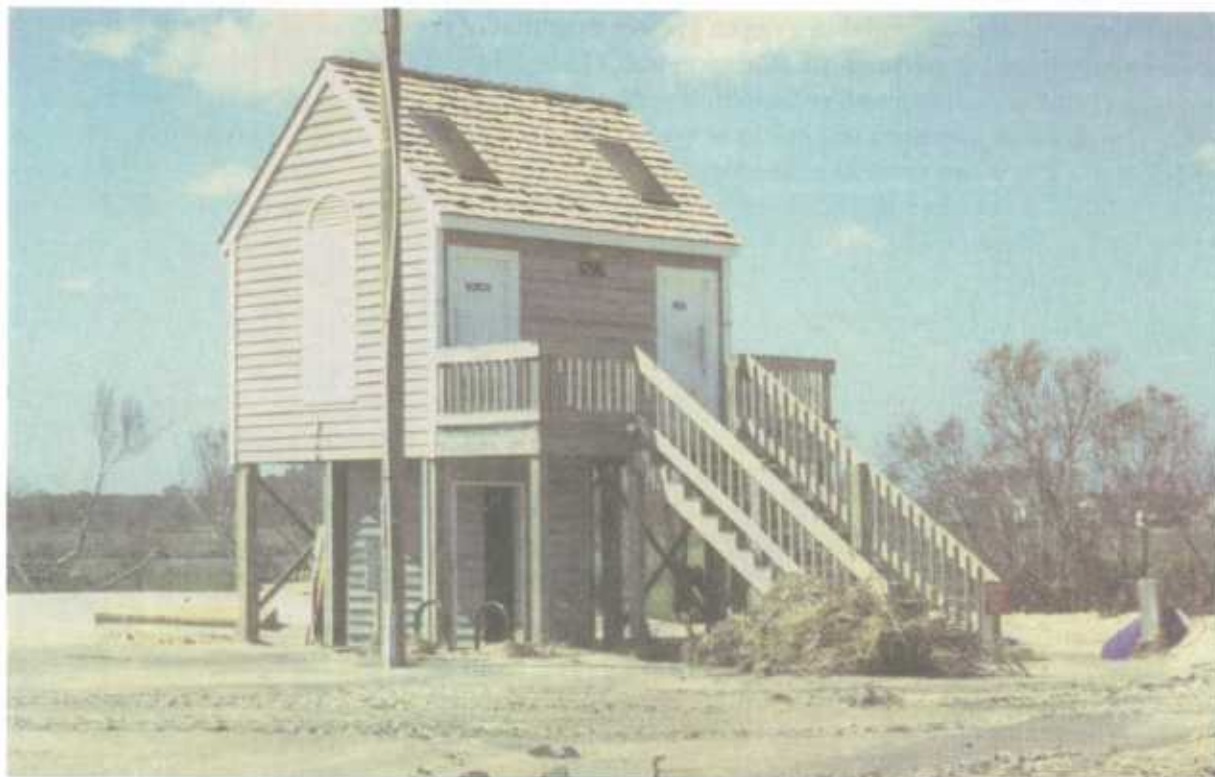
NFIP regulations require that structures in Coastal High Hazard Areas (V zones) be elevated so that the lowest horizontal structural member of the lowest floor is at or above the BFE shown on the FIRM in effect at the time of construction. In the areas visited by the BPAT, structures in V zones appeared to have been built in compliance with this requirement. For structures in A zones, the NFIP regulations require that the lowest floor be elevated to or above the BFE; no requirements are imposed for structures in B, C, and X zones. Although elevating on open foundations with lowest horizontal structural members at or above the BFE is not required outside of V zones, this practice was widely observed in A, B, C, and X zones on the barrier islands within the study area (see Figure 2-21).

Figure 2-21 Survival of this properly elevated North Carolina State Park public rest room demonstrates the State's commitment to proper construction in coastal areas.

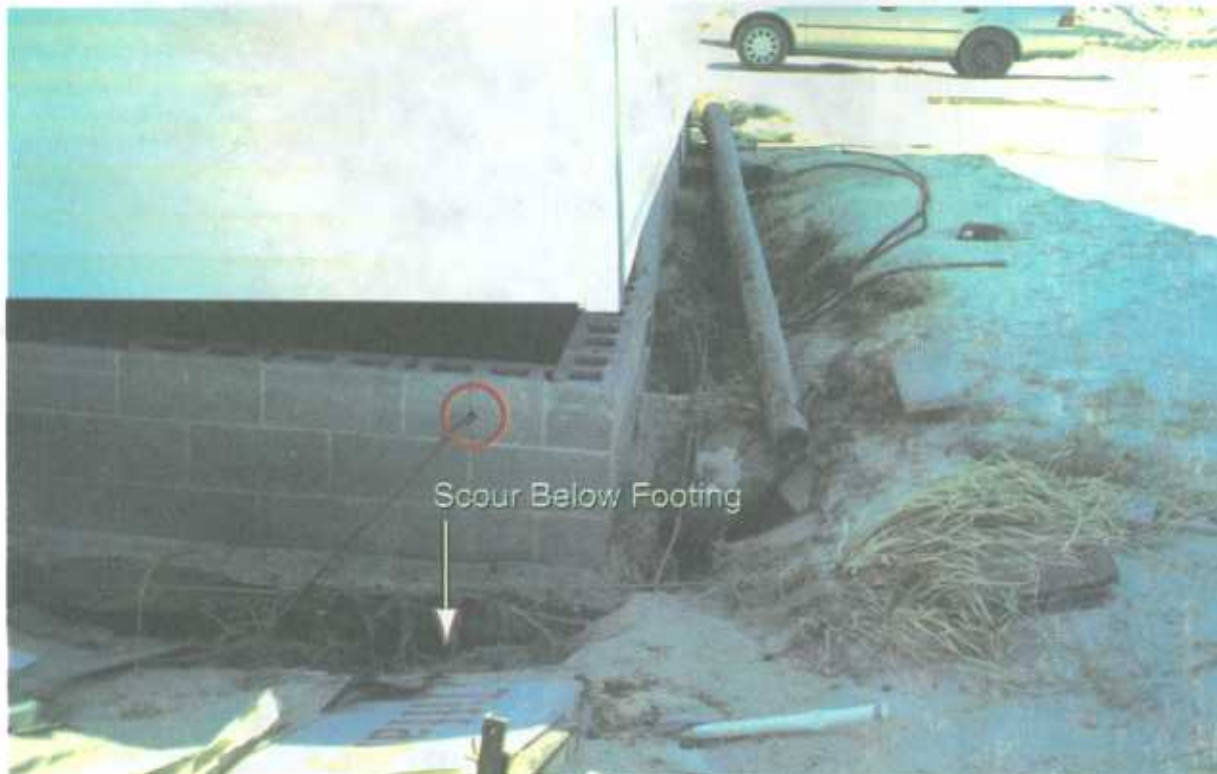
Figure 2-22 Collapse of footing and foundation wall under elevated wood-frame building. Collapse resulted because obstruction of flow by building caused scour to extend below the bottom of the footing (arrow). Note propane gas line (circled) extending through foundation wall.

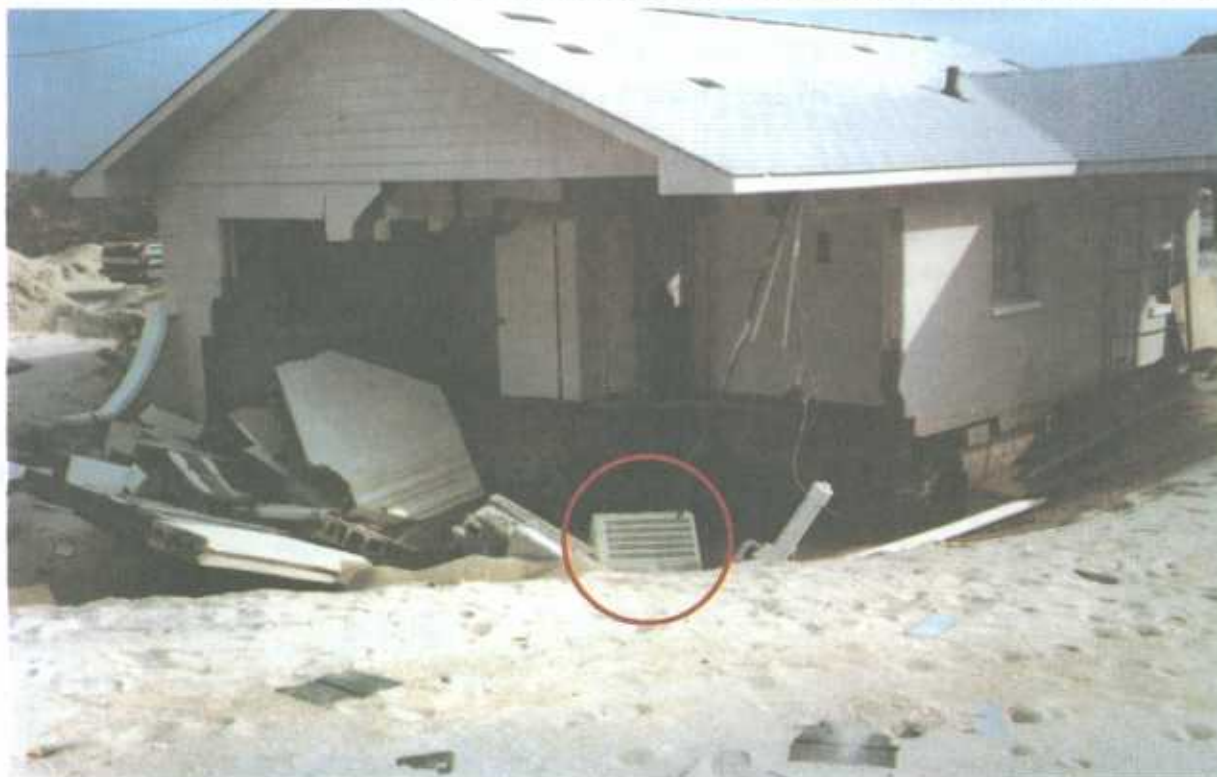
Figure 2-23 Catastrophic failure of landward building constructed on masonry wall and slab-on-grade foundation. Failure resulted because obstruction of flow by building caused extensive scour. Note compressor collapsed into scour hole.

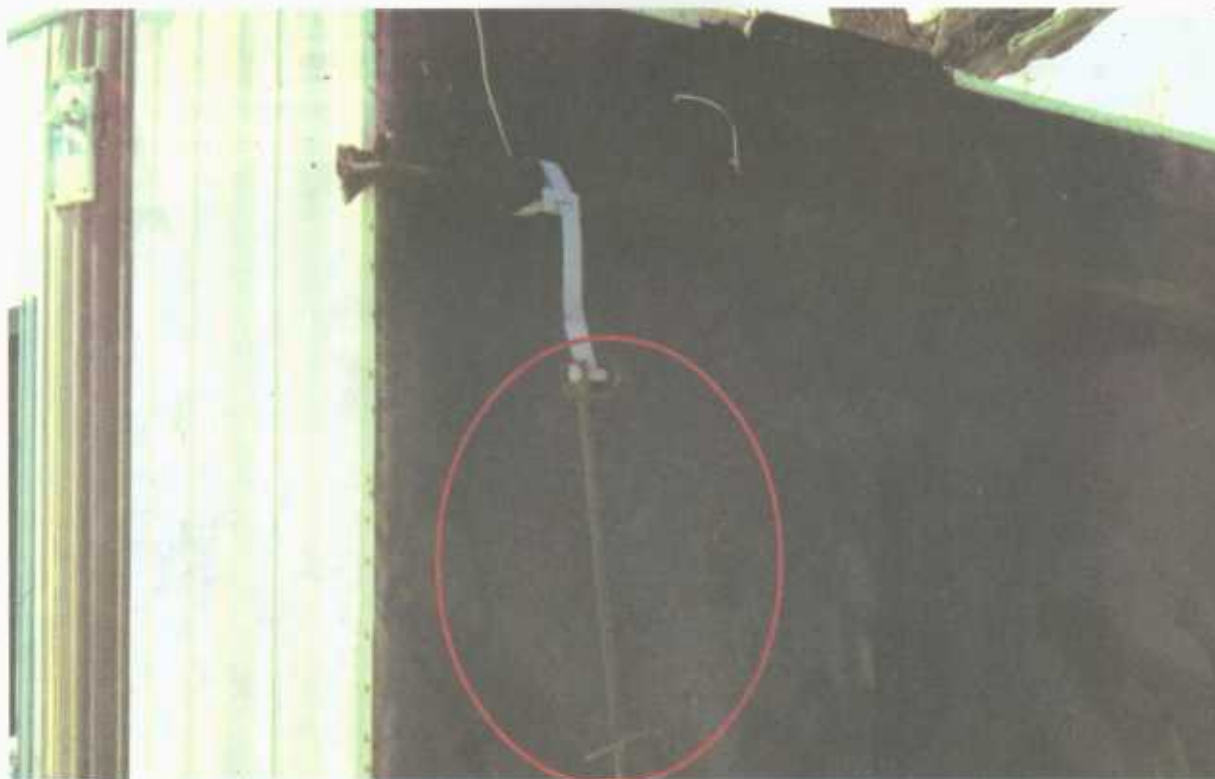
Many manufactured homes and RVs were significantly damaged by Hurricane Fran. The vast majority of manufactured homes and RVs were anchored on top of dry-stack masonry block piers and anchored with metal straps and helical anchors (2 feet long with 3-inch helical plates) embedded into the sand (see Figure 2-24). While most were exposed to relatively shallow flood depths (1 to 3 feet), many were moved 50 feet or more laterally and flipped over by wind forces acting alone or in conjunction with flood forces (see Figures 2-24 and 2-25).

Figure 2-24 Permanently installed RV overturned as a result of anchor pullout. Anchor (circled) is 2 feet long.

- Pullout of the anchor due to soil saturation. All anchors observed had been embedded in sand. During flooding conditions, sand can quickly become saturated and thereby lose its capacity to resist pullout of the helical anchor plates. Because anchors that had pulled out were observed to have small-diameter helical plates and shallow embedments, it is assumed that soil saturation played at least a contributing role in anchor pullout.

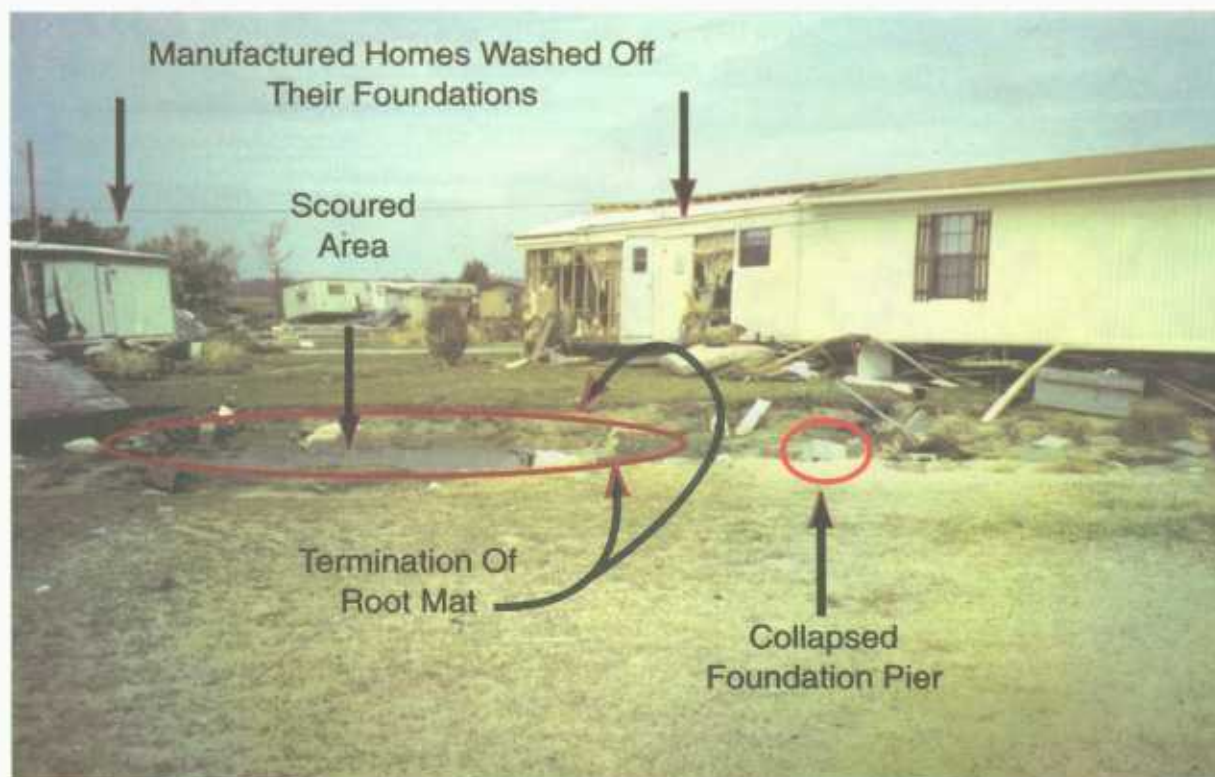
The team observed depressions from 1 to 2 feet deep left by localized scour within the original footprint of the structure (see Figure 2-25). The scour may have been caused by numerous factors, including a discontinuity between the stabilizing root mat provided by grass surrounding the site and the corresponding loss of unprotected sand beneath the home, the creation of a large obstruction by the solid skirt surrounding the foundation system, and localized scour around the dry-stack masonry piers supporting the structure.

Figure 2-25 Localized scour beneath pre-storm footprint of manufactured home. Note the collapsed dry-stack block foundation and termination of root mat, which otherwise would have helped stabilize the adjacent ground.

- Collapse of the supporting dry-stack masonry foundation due to localized scour. When the foundations gave way, the unit fell onto the ground, exposing the seaward face to the full force of the velocity flow and debris impact.

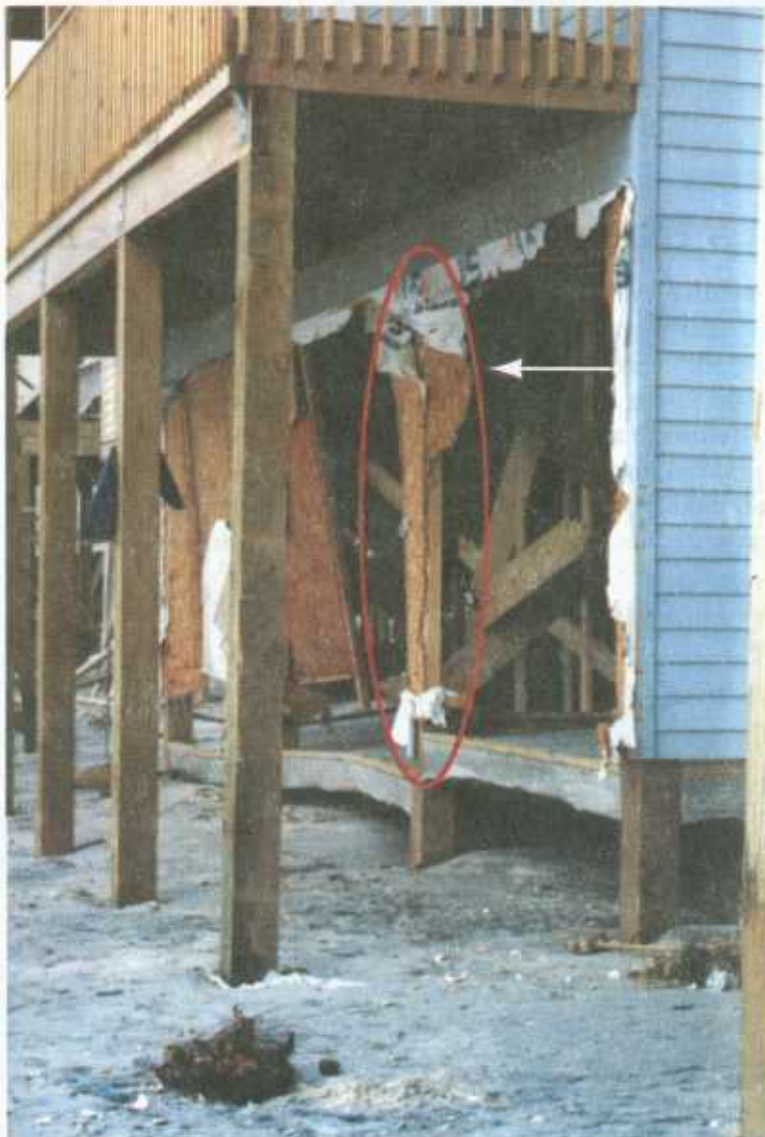
On some structures, exterior sheathing consisting of oriented strand board (OSB) had been installed over breakaway wall panels in such a way that it traversed adjacent panels and the faces of intervening vertical foundation members. Sheathing installed in this fashion is not in conformance with breakaway wall designs recommended by the NFIP. It interferes with the function of the breakaway panels because it must fail before the panels can break away (see Figures 2-26 and 2-27). The OSB installed across breakaway panels and foundation members did not appear to have caused structural damage; however, when acted on by flood forces, it can potentially place unnecessary and unanticipated lateral loads on vertical foundation members.

*Figure 2-26
Exterior sheathing of breakaway
wall spanned piling.
Note torn sheathing (arrow).*
