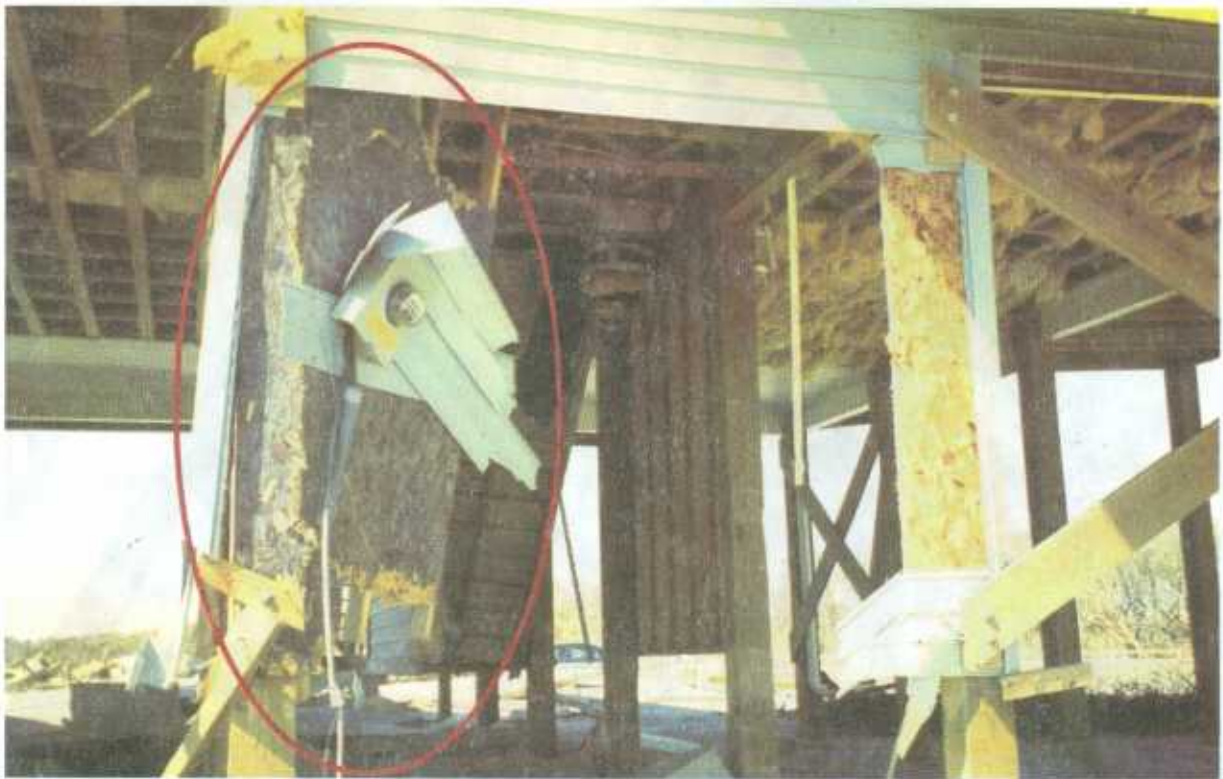
Figure 2-27 Breakaway wall panel failed to function as designed because continuous sheathing was installed across pilings. No structural damage was observed; however, note damage to utility components installed on breakaway wall panel.

The BPAT observed electric meter boxes, telephone service boxes, cable TV boxes, sewer service lines, and domestic water service feeds all mounted on breakaway wall panels (see Figures 2-27 and 2-36). Utilities placed through breakaway wall panels included telephone and cable TV lines, the electric feed from the back of the meter box to the electric panel box, and water service feeds (see Figure 2-37). Under the effects of flood forces, these utilities either were torn out or prevented breakaway wall panels from breaking away cleanly. Another deficiency observed was the placement of utilities adjacent to or near breakaway wall panels (see Figure 2-38). These utilities were damaged when flood forces caused the panels to break away.

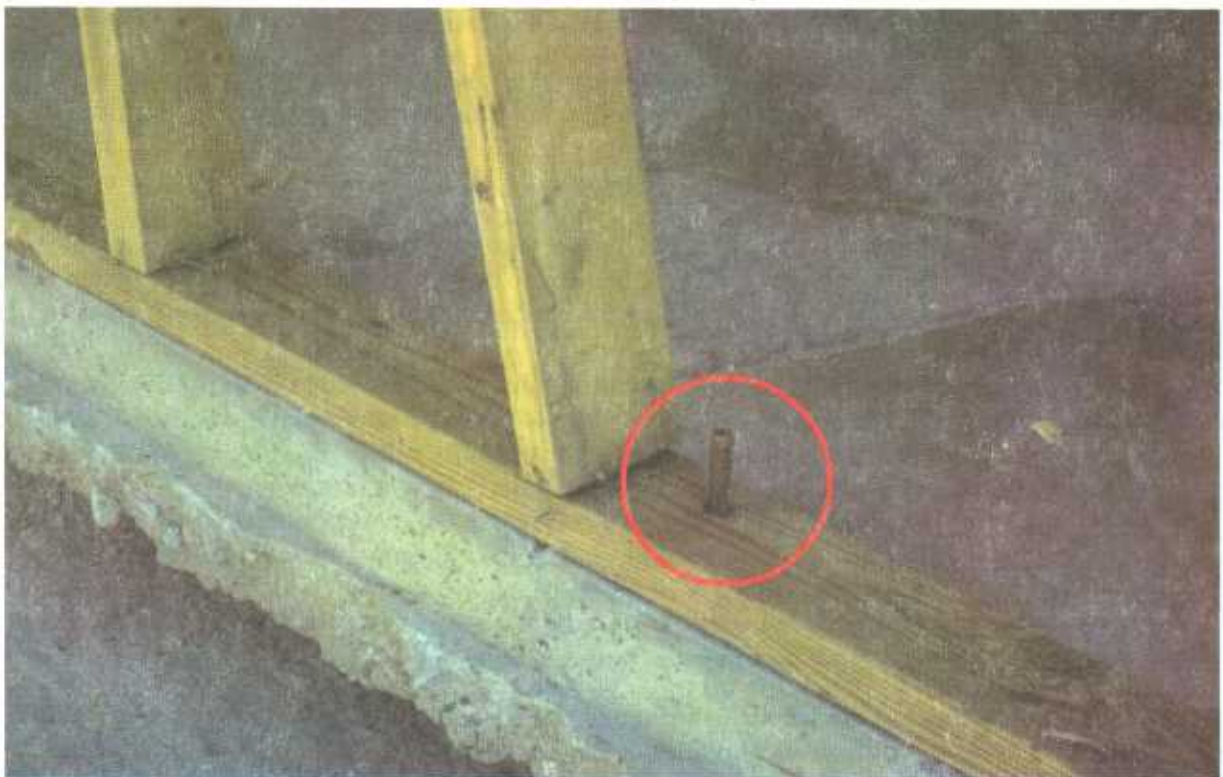
Figure 2-28 Use of anchor bolts through the sill plate of a breakaway wall is improper. Even though this bolt does not have a nut and washer, it prevented the wall from breaking away laterally.

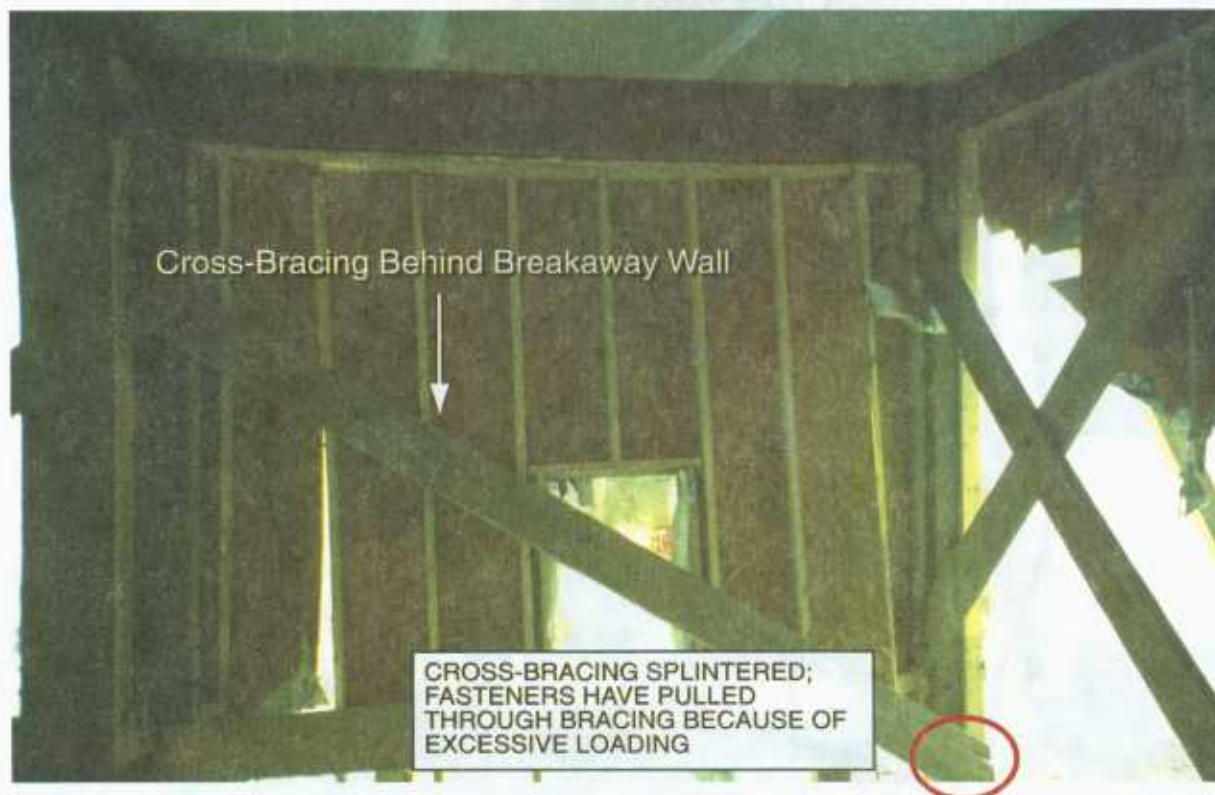
Figure 2-29 Improper installation of breakaway walls (on the seaward side of cross-bracing) resulted in failure of cross-bracing. Note breakaway wall pushed against cross-bracing.

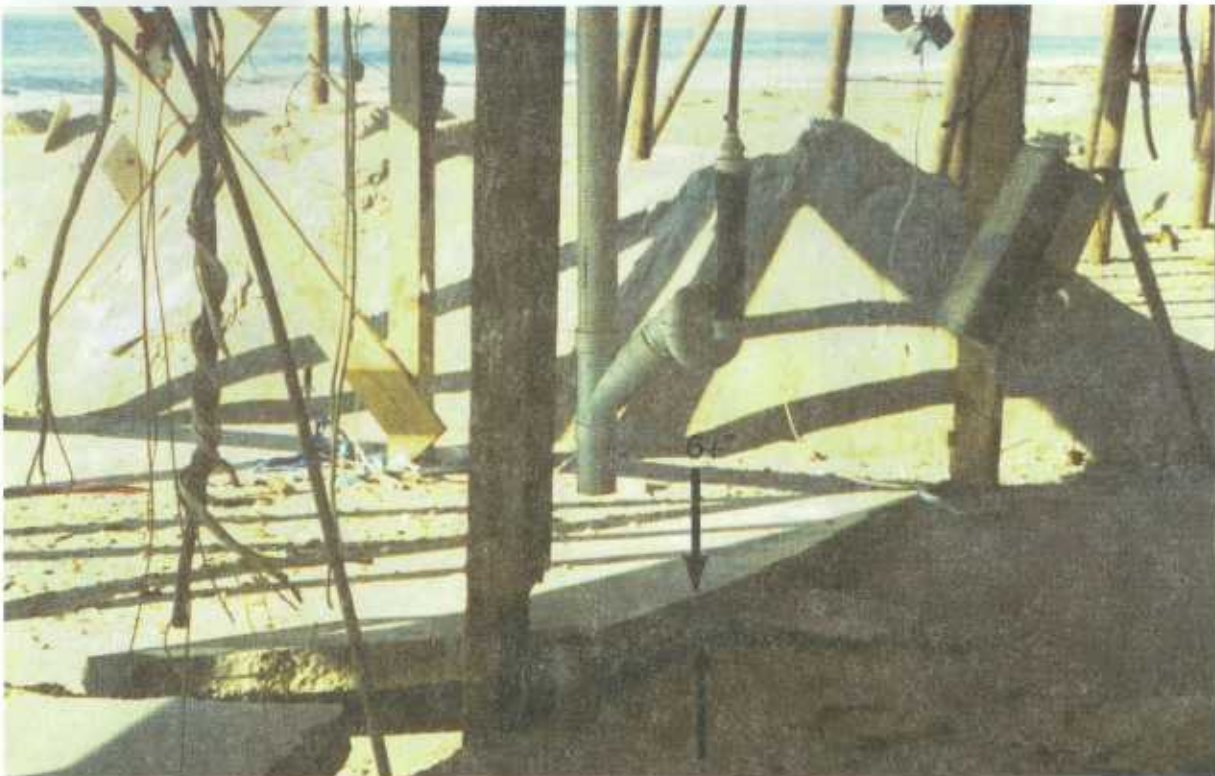
- The thicker the slab, the greater the force needed to break the slab and therefore the greater the load transferred to the building foundation system until the slab breaks free of the foundation (see Figure 2-30).
- The thicker the slab the more it weighs per square foot of surface area. When a thicker slab breaks apart, the sections weigh more than those of the same size from a thinner slab and they create greater impact loads when they are thrown up against the building foundation by velocity flow and wave action.

Figure 2-30 Example of unnecessarily thick slab.

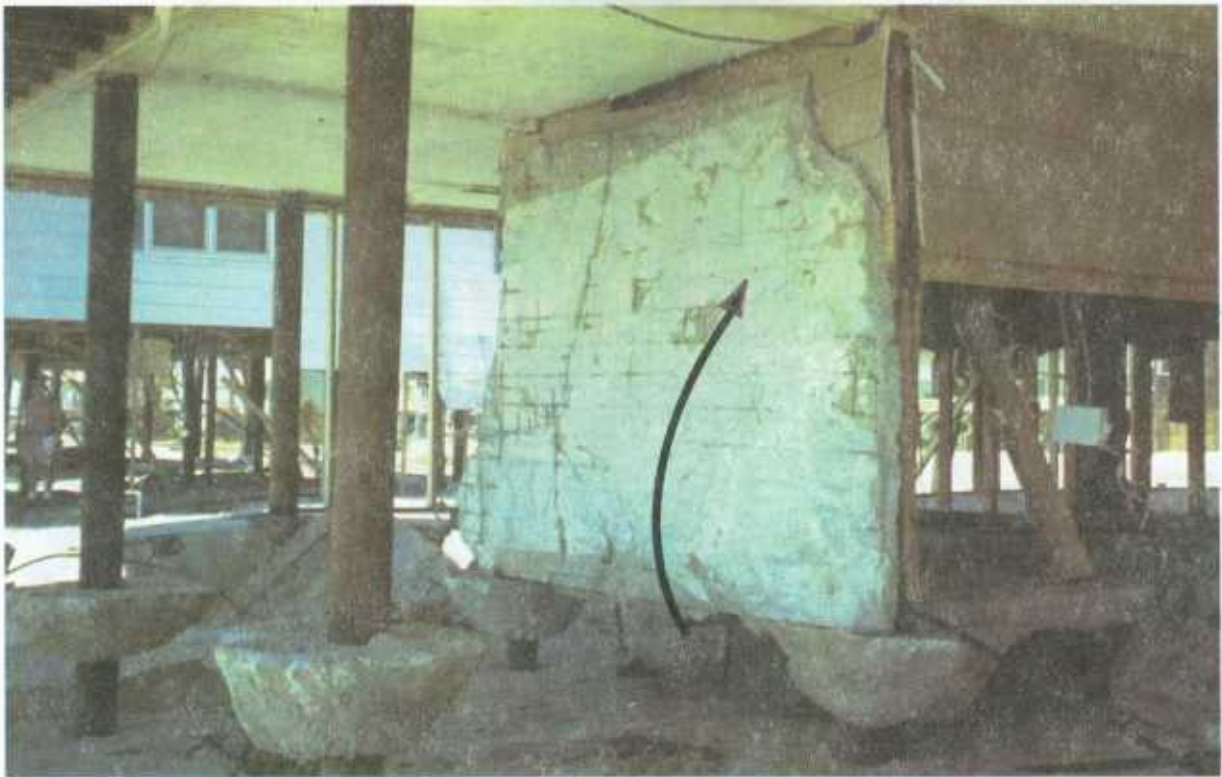
The problems associated with slab joints involved the number of contraction joints and the effect of reinforcing wire mesh. In the slabs beneath many structures, the number of contraction joints was observed to be insufficient to make the slabs frangible. When the slabs broke up, the pieces were too large and generated unnecessary impact loads on the foundation system. Occasionally, the lack of an adequate number of contraction joints prevented the slab from breaking up. Figure 2-31 shows a large, unbroken section of a below-building slab-on-grade that was flipped up, probably by wave action, and came to rest against two vertical foundation members. The flipped slab created an obstruction that increased the flood loads on the foundation. In fact, the vertical foundation members behind the slab in Figure 2-31 were found to be leaning landward.

Figure 2-31 Concrete slab-on-grade flipped up, probably by wave action, came to a rest against two foundation members, generating large, unanticipated loads on the foundation. Note slab is supported on concrete collars around piles and contains wire mesh.

The BPAT observed that concrete collars were often poured around foundation pilings in conjunction with the construction of below-building concrete slabs (see Figures 2-14 and 2-31). Although intended to provide stability, these collars presented a large obstruction to flow, thereby increasing flood loads on, and scour around, the pilings to which they were attached. The increased scour resulted in a loss of sand supporting the foundation (see Figure 2-31). As shown in Figure 2-14, collars did not prevent piling failure.

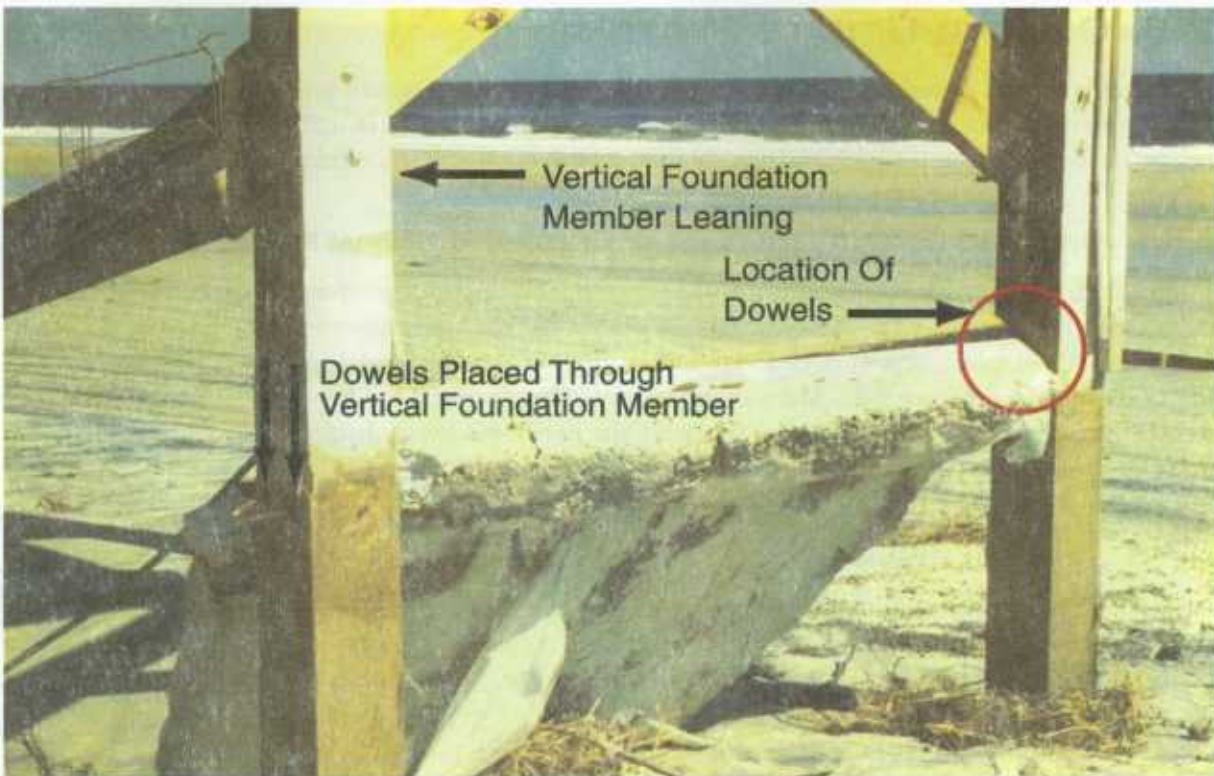
Some engineers and architects may have specified, or contractors chose to use, dowels to connect concrete slabs-on-grade to vertical foundation members. The dowels, intended to help prevent the differential settlement of the slabs, were inserted into or through the vertical foundation members before the slab was poured. They caused serious problems when the slabs broke apart under flood loads. The dowels made it more difficult for the slab to break into small pieces and separate cleanly from the vertical foundation members. Even when the slabs broke into small pieces, the dowels acted like pins in a hinged connection, keeping the slab connected to the vertical foundation members (see Figure 2-32). As a result, unnecessary and unanticipated flood loads were transferred to the vertical foundation members.

Although the BPAT was unable to define a cause-and-effect relationship, several buildings with this slab-to-foundation pin detail were found to be leaning. The team members believe that the inability of the slab to break free of the vertical foundation members was at least partially responsible for the failure of the vertical foundation members to remain plumb.

Figure 2-32 *Use of steel dowels to tie slabs to vertical foundation members prevented the proper breakup of slab. A portion of the slab was left attached to the piling, resulting in large, unanticipated loads on foundation members. Note leaning vertical member, on right.*

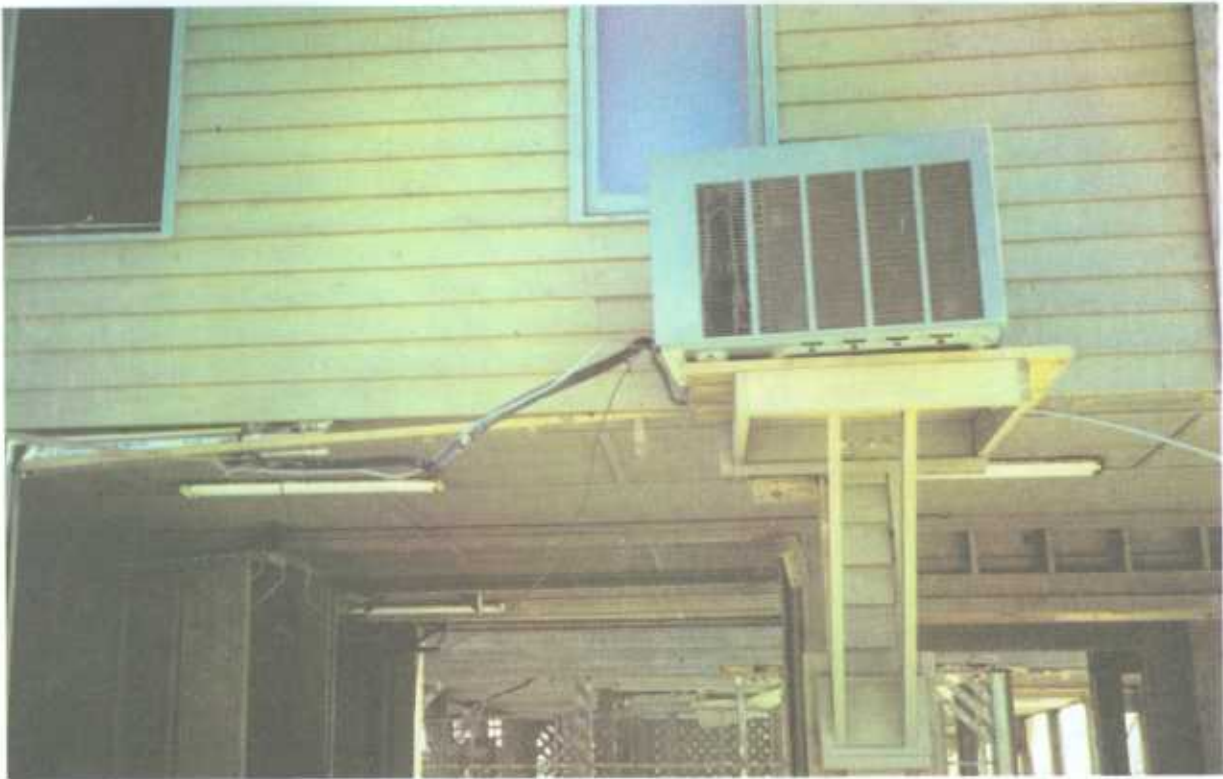
When post-supported platforms adjacent to oceanfront houses collapsed, the cause was almost always erosion and scour combined (see Figure 2-33). Erosion in the areas where the platforms were set was generally 2 to four 4 feet in depth, often exceeding the embedment depth of the support posts. Cantilevered platforms, which do not depend on vertical support members, escaped the scour- and erosion-induced damage incurred by post-supported platforms. Compressors installed on adequately elevated cantilevered platforms were not subject to flood-related damages, including inundation, but were still subject to wind damage when they were not adequately anchored (see Figure 2-34).

Figure 2-34 Although the air conditioning/heat pump compressor platform on this oceanfront house was adequately elevated with cantilever bracing, the compressor was almost pushed off the platform by wind because of the lack of the necessary attachment.

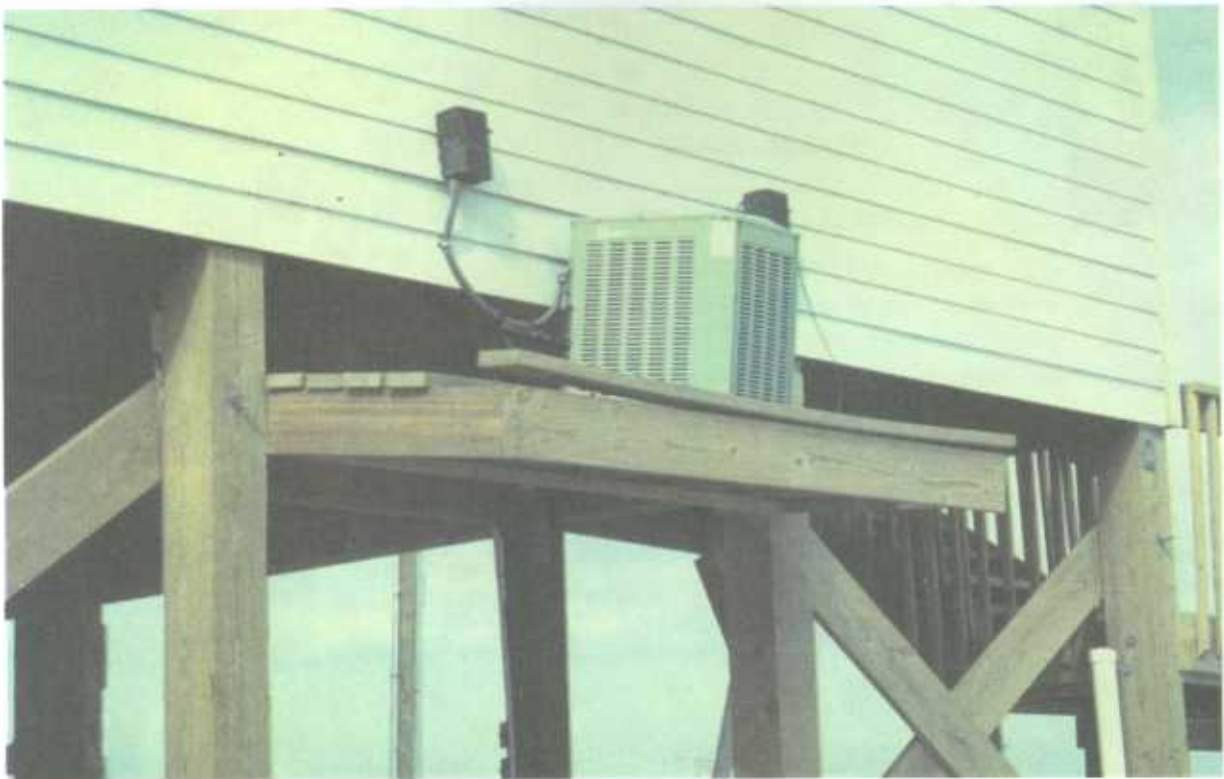
Many of the post-supported compressor platforms adjacent to homes landward of the oceanfront row collapsed as a result of localized scour due to velocity flows (see Figures 2-23 and 2-35). Localized scour of approximately 1 foot in depth was generally observed. Where posts were embedded only 1 to two 2 feet, localized scour allowed the velocity flow and debris impact forces to dislodge the platform. Platforms with properly embedded posts performed much better. Often, the only damage sustained by landward residential buildings was the loss of the compressor unit due to water or wind damage.

Figure 2-35 Air conditioning / heat pump compressor platform leaning because scour caused loss of two supporting posts.

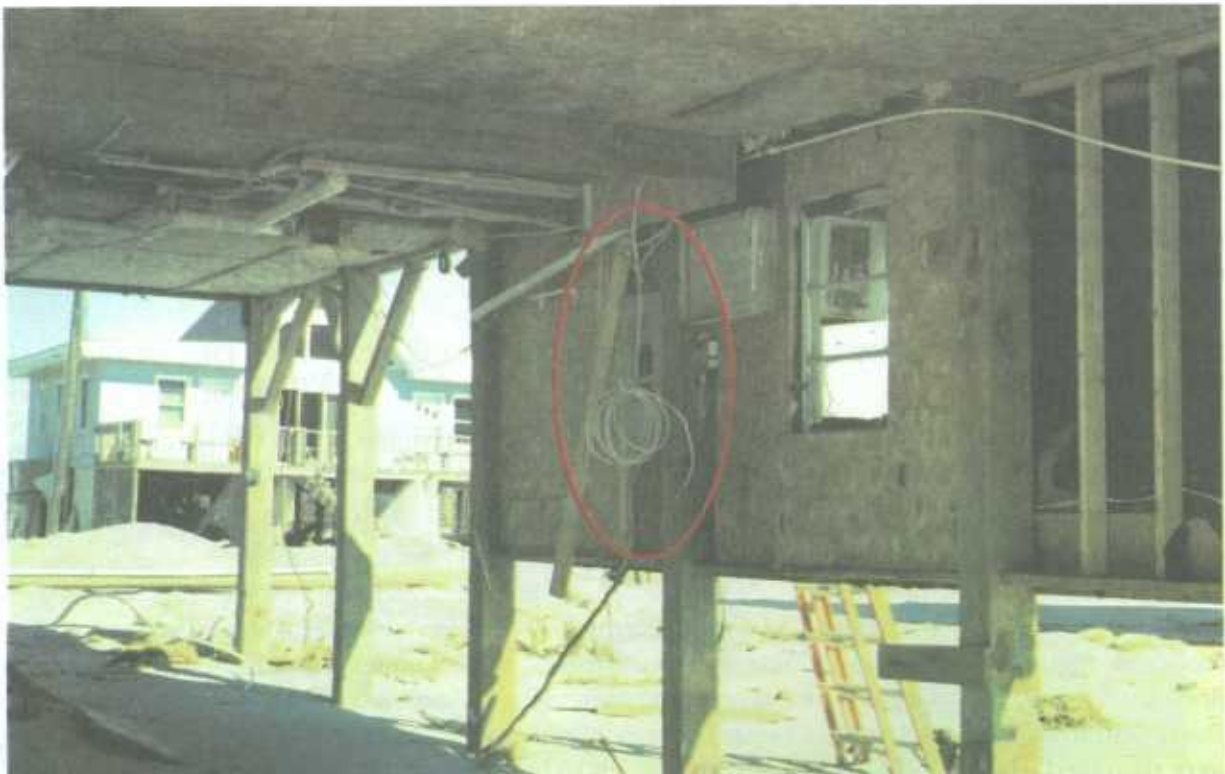
Figure 2-36 Example of utility component (electric panel box) installed on a breakaway wall panel.

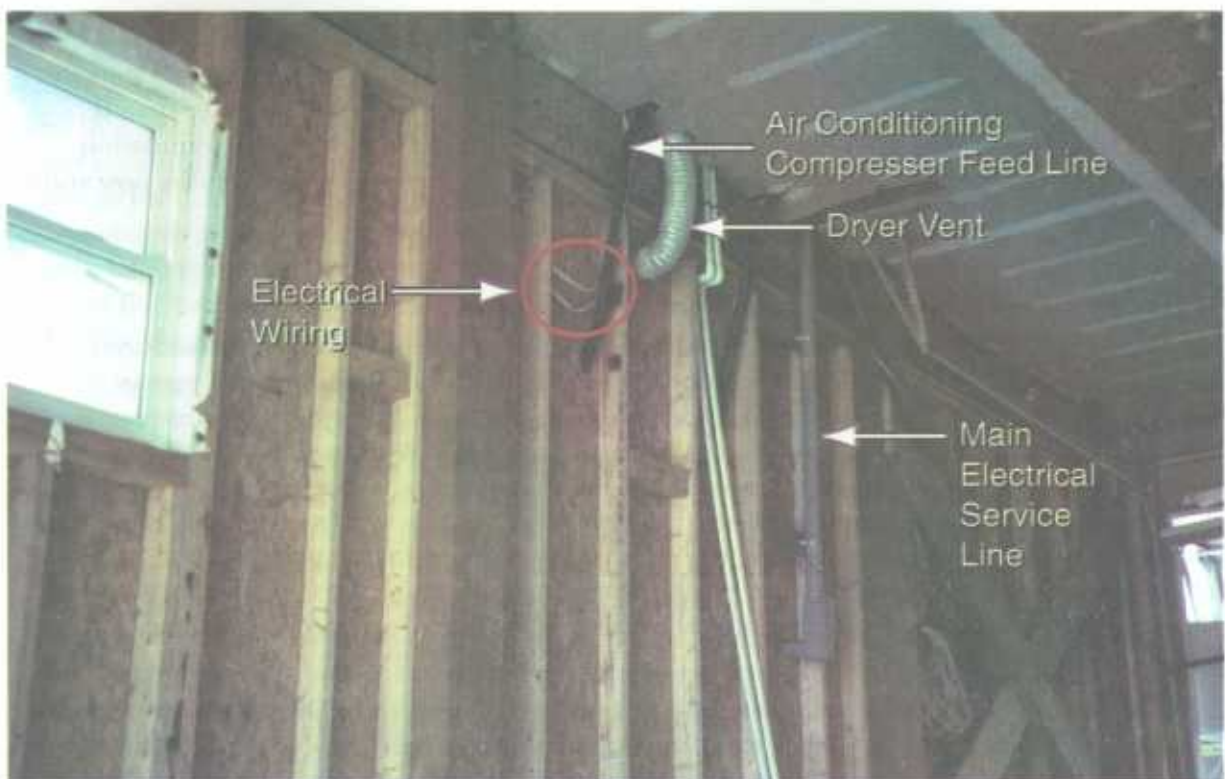
Figure 2-37 Utility components (dryer vent, air conditioning compressor feed line, main electrical service line out of meter box, and electric wiring) penetrating breakaway wall panel.

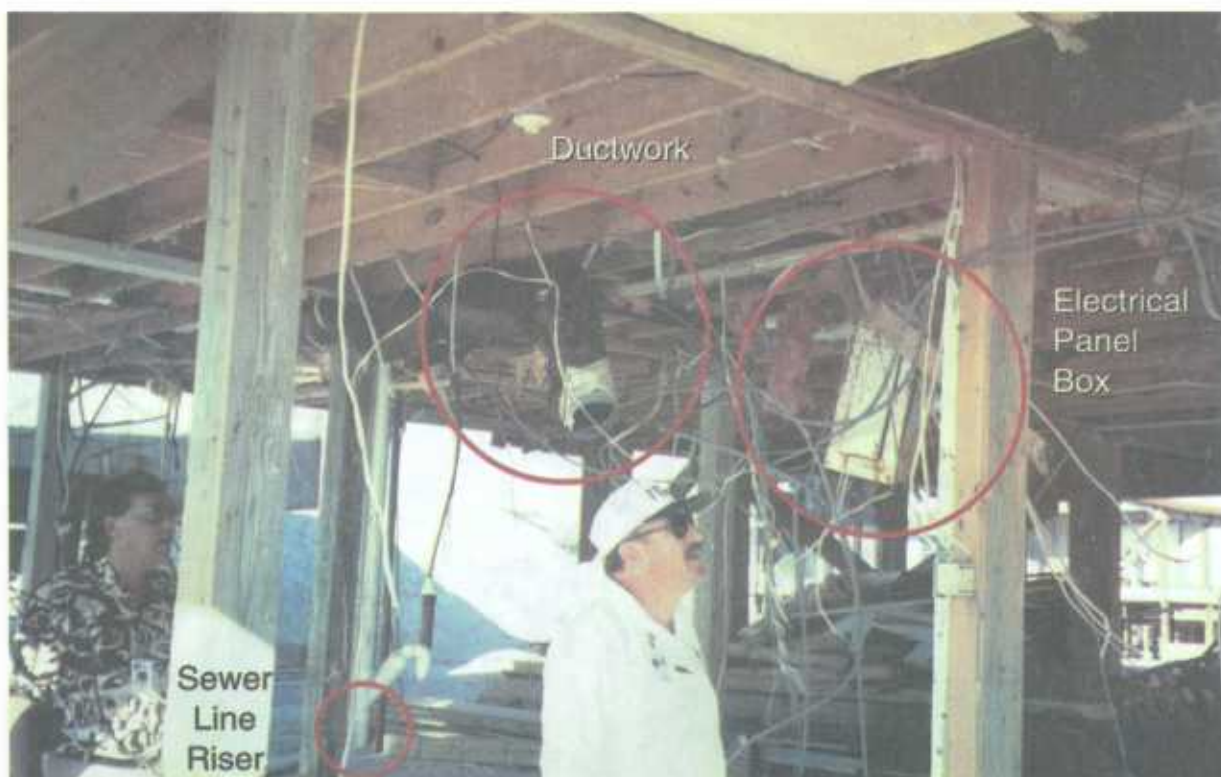
Figure 2-38 These utility components (wiring, electric panel box, ductwork, and sewer line) were installed adjacent to breakaway wall panel and were damaged when the walls broke away. Note broken sewer line riser pipe on seaward side of piling.

Utilities on the vast majority of structures were found to be in locations exposed to velocity flow and debris impact, e.g., mounted to vertical foundation members on sides other than the landward side (see Figure 2-38). Utilities installed on the landward side of vertical foundation members generally survived since the foundation member shielded them from velocity flow and debris impact.

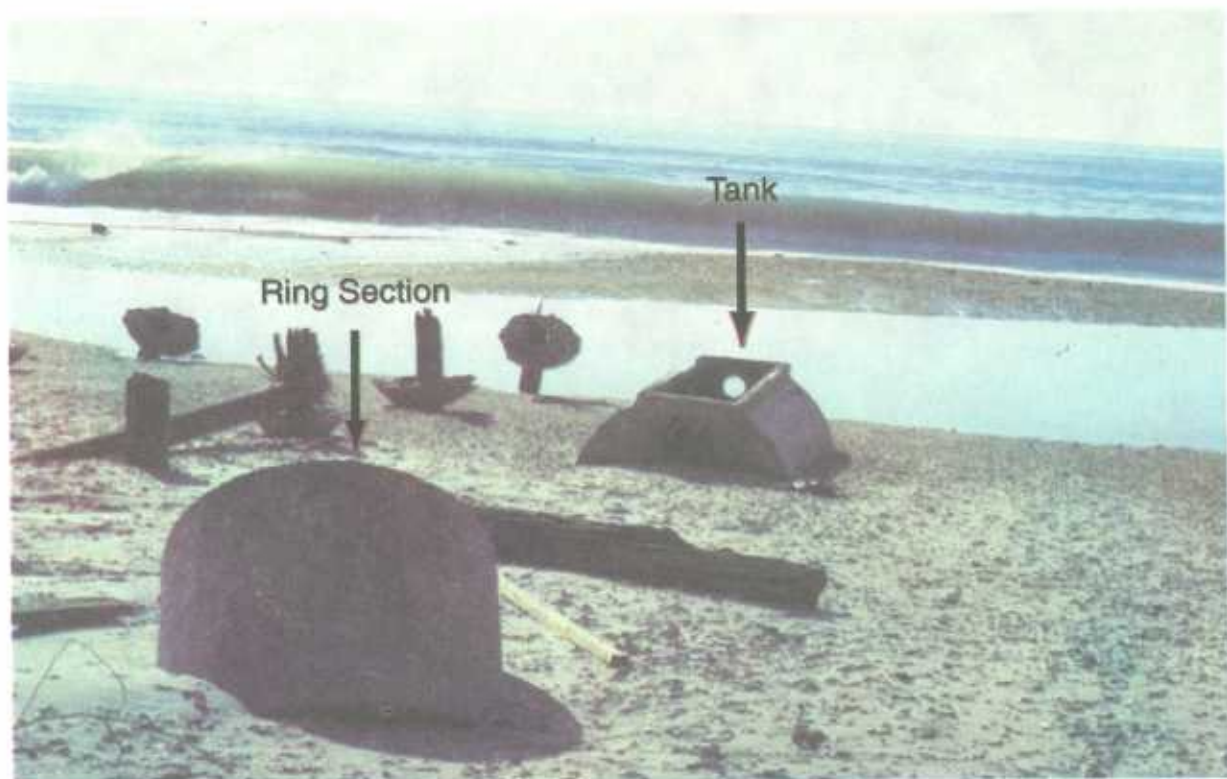
Septic tanks installed near oceanfront homes were often left exposed by storm-induced erosion and scour (see Figure 2-39). Occasionally, thin-walled septic tanks made of precast concrete rings were observed to have become waterborne debris. Concrete ring sections were found dislodged and under elevated structures (see Figure 2-17). When a tank was exposed, the sewer line from the home was usually severed. On many exposed tanks there were openings where the access lid was missing and where the connection to the sewer line from the house was exposed when the pipe broke away. The openings allowed sewage to leak out and flood water and debris to enter the tank. Homes that were otherwise not significantly damaged had been posted "Unoccupiable" by the local building official because of the lack of an operating sanitary disposal system.

Figure 2-39 Oceanfront erosion and scour unearthing and damaging septic tanks and systems. Note precast ring section and precast tank.

The State of North Carolina has established regulations concerning the installation of septic tanks and leach fields in areas subject to coastal flood hazards. When a new building is constructed, the tank and leach field must be installed on its landward side. When repairs to an existing septic system located on the seaward side of a building become necessary for any reason, the tank and leach field must be moved to the landward side of the building.
