2.7 DRY FLOODPROOFING IN COASTAL A ZONES

2.8 WIND DAMAGE

2.9 CORROSION OF STRUCTURAL METAL COMPONENTS

2.11 BUILDING PERFORMANCE SUCCESSES

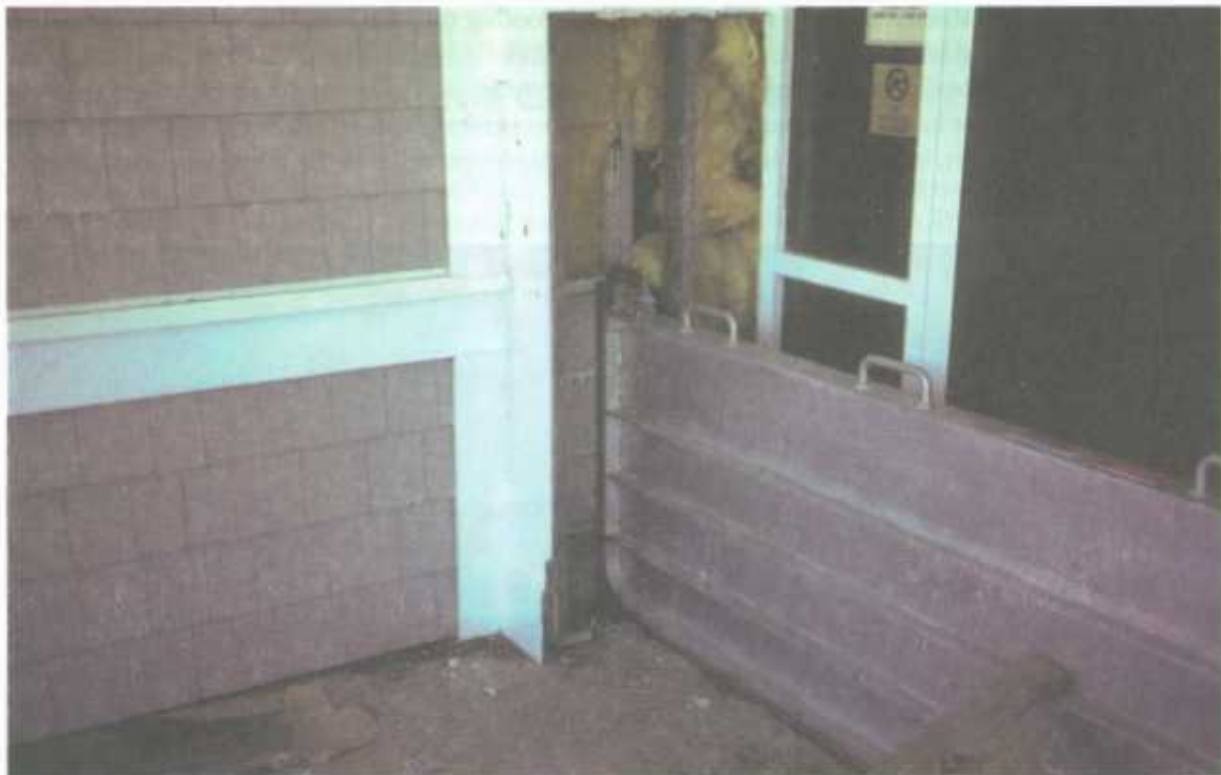
Figure 2-40 Engineered flood shield installed over opening to large dry floodproofed commercial building.

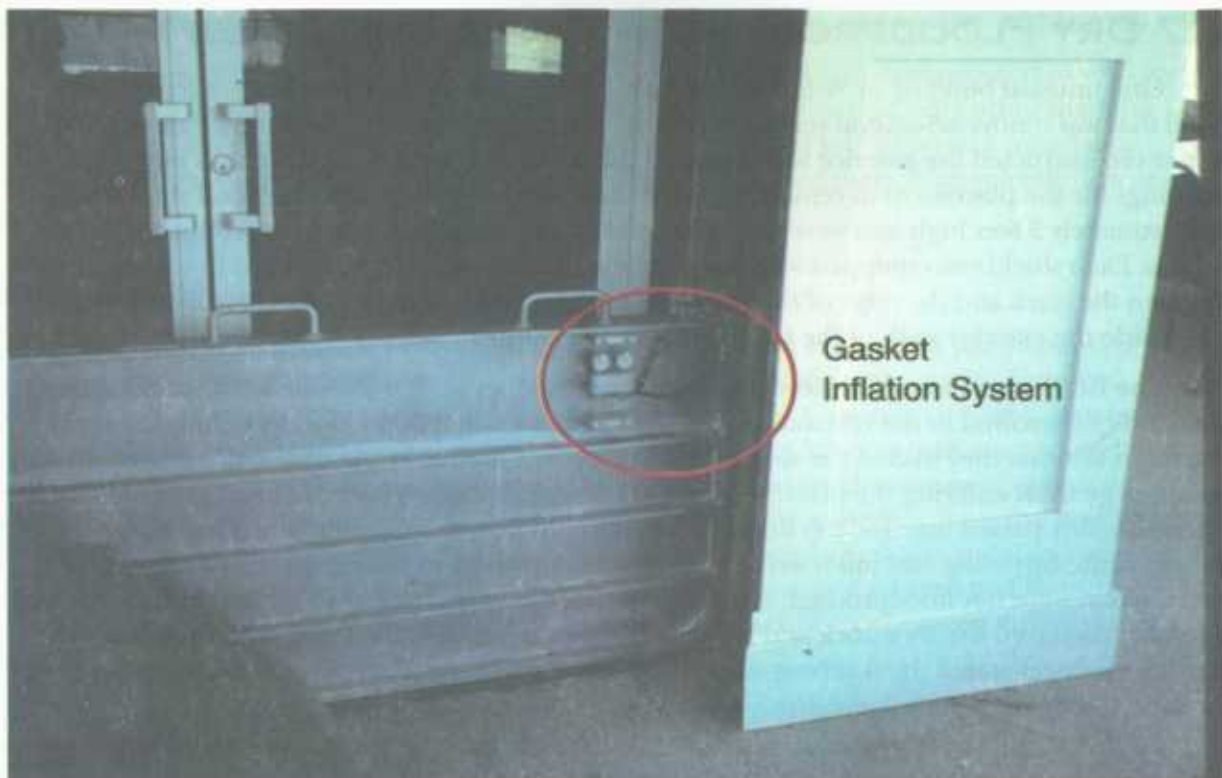
Figure 2-41 Buildings that are floodproofed require extensive engineering detailing. Note that this flood shield is sealed with a pneumatic gasket.

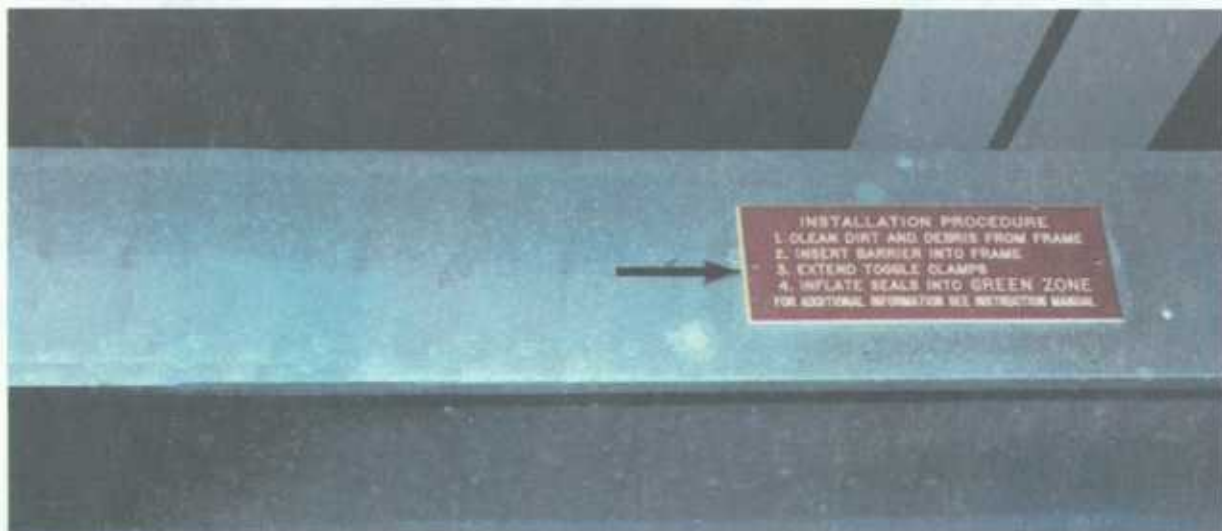
Although flood shields and other elaborate floodproofing measures can be quite effective, they often require extensive human intervention to function properly (see Figure 2-42). It should be noted that very few floodproofed buildings in coastal A zones are known to be subject to wave action. Floodproofing in areas known to be subject to wave action presents special challenges that must be addressed in the design, installation, and operation of the components of the floodproofing system.

Figure 2-42. Dry floodproofing often requires extensive human intervention. Note the detailed instructions affixed to this flood shield.

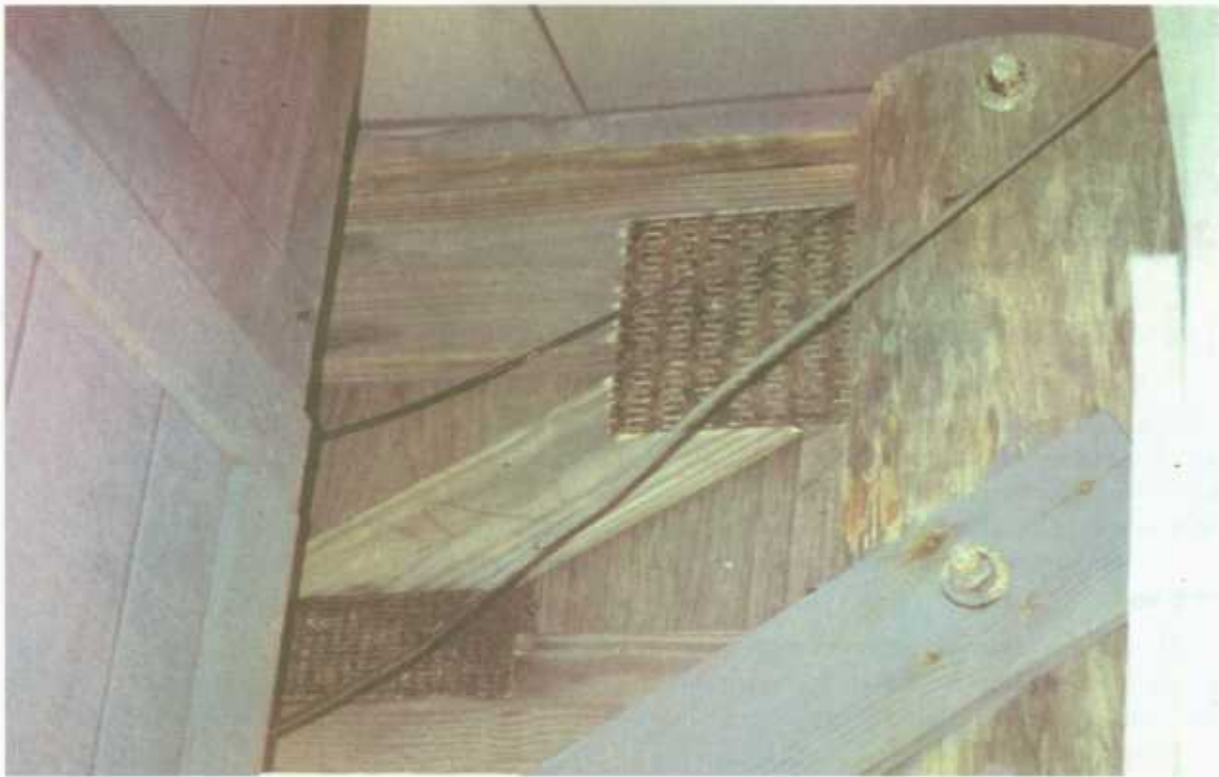
Examples of such components are shown in Figures 2-43, 2-44, and 2-45. The presence of rust indicates an obvious loss of galvanization on metal components observed in both oceanfront and landward structures in the study area and may indicate that the connectors are nearing the end of their useful life.

Figure 2-43 Corrosion of galvanized floor truss plates was observed in many buildings.

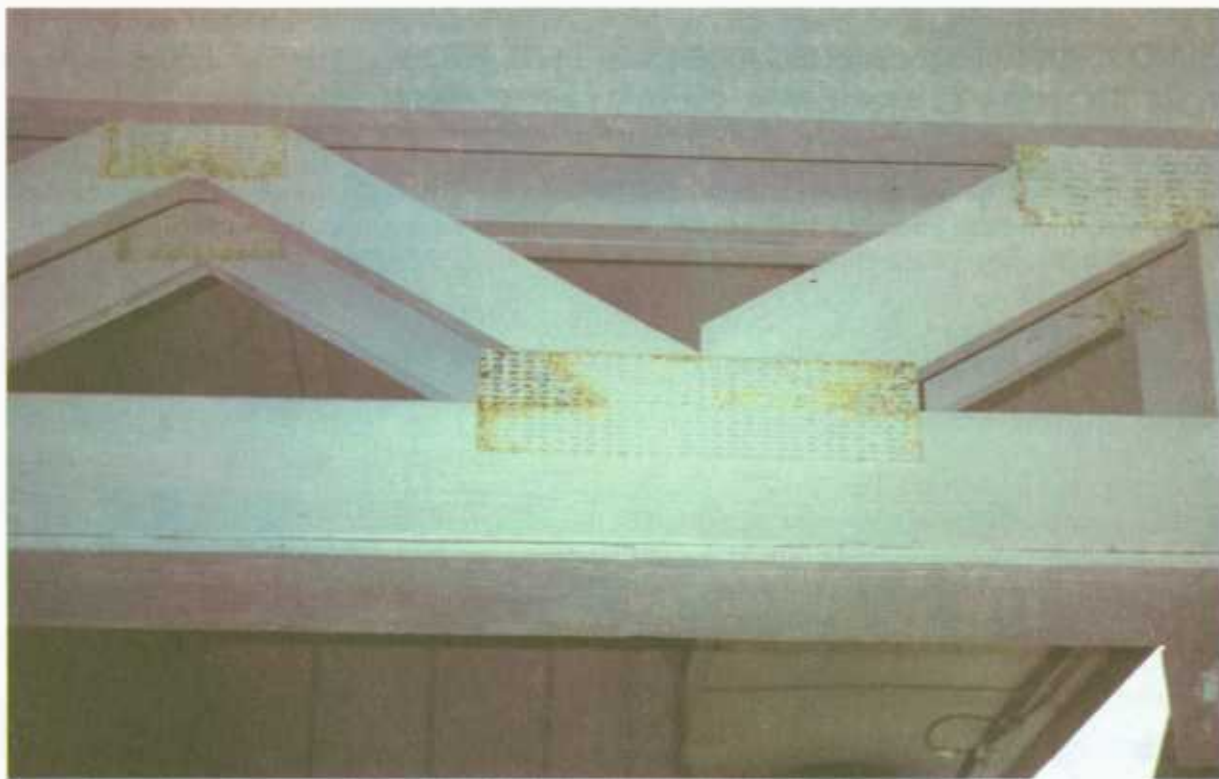
Figure 2-44 Corrosion of galvanized floor truss plates was observed in many buildings. Note that painting does little to slow the process of corrosion in coastal environments

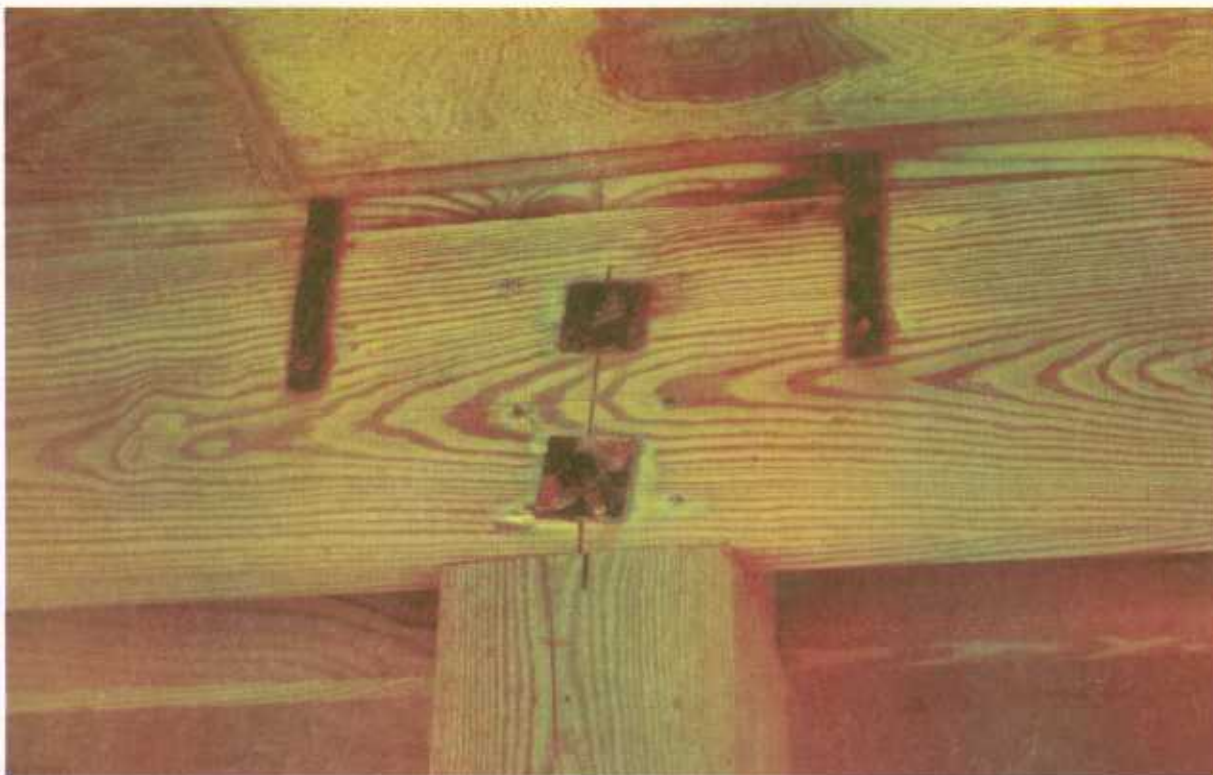
Figure 2-45 Corrosion of hurricane straps and steel plates was also observed in many locations.

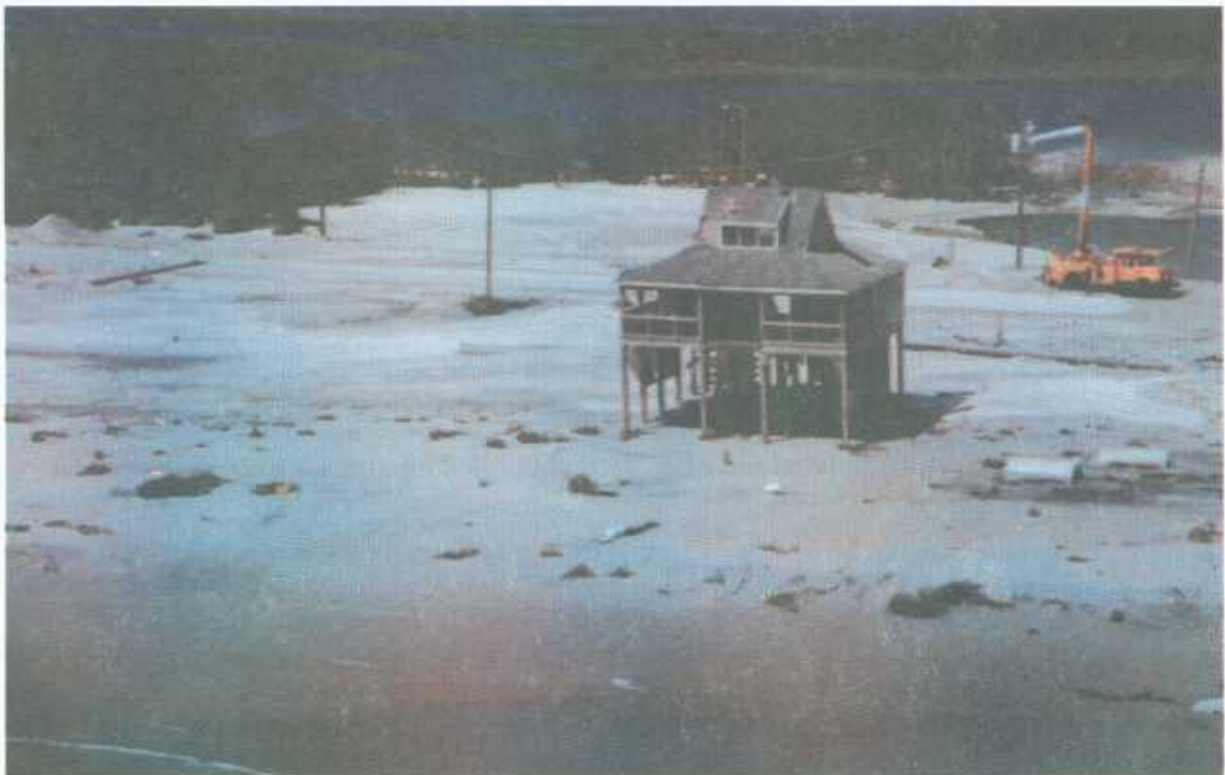
Figure 2-46 While this house experienced 6 feet or more of vertical erosion and scour, as well as the loss of breakaway wall panels, the foundation and superstructure performed as designed.

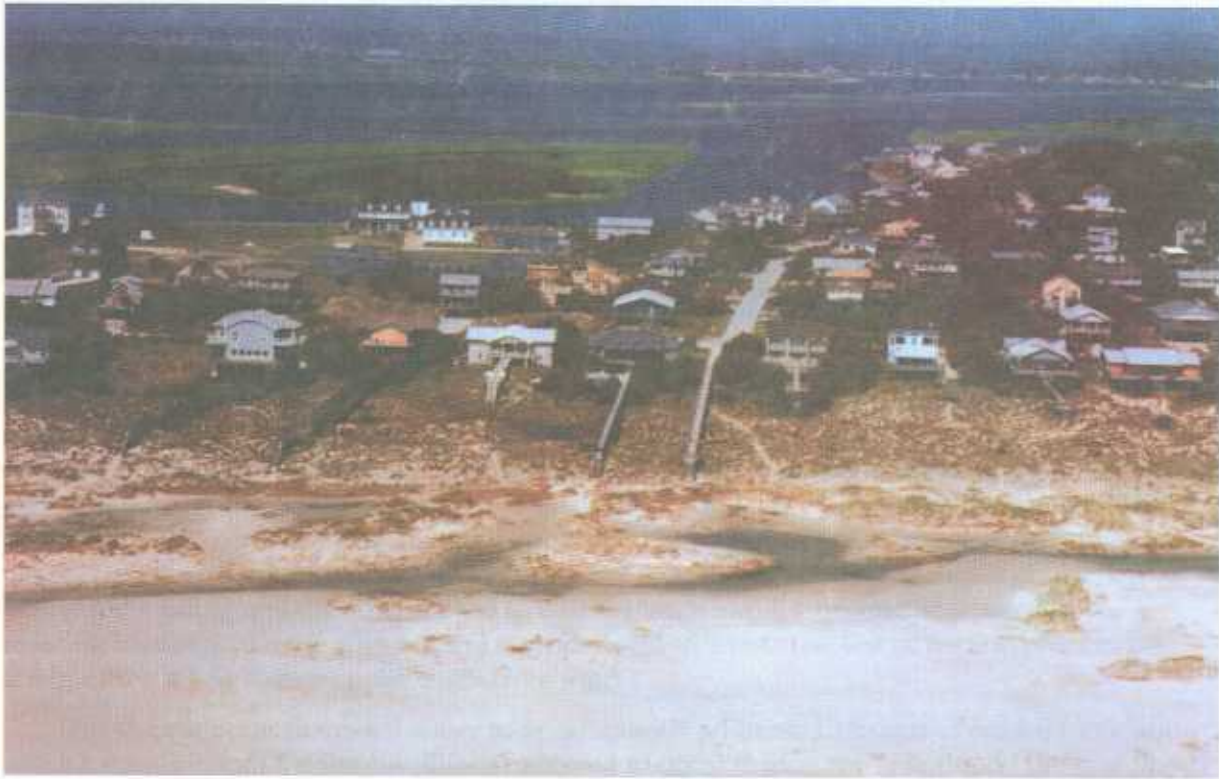
Figure 2-47 As shown by this post-Fran photograph taken at Emerald Isle, North Carolina, proper elevation and setback from the oceanfront in conjunction with substantial protection afforded by dunes resulted in little or no flood damage to the oceanfront row of buildings.

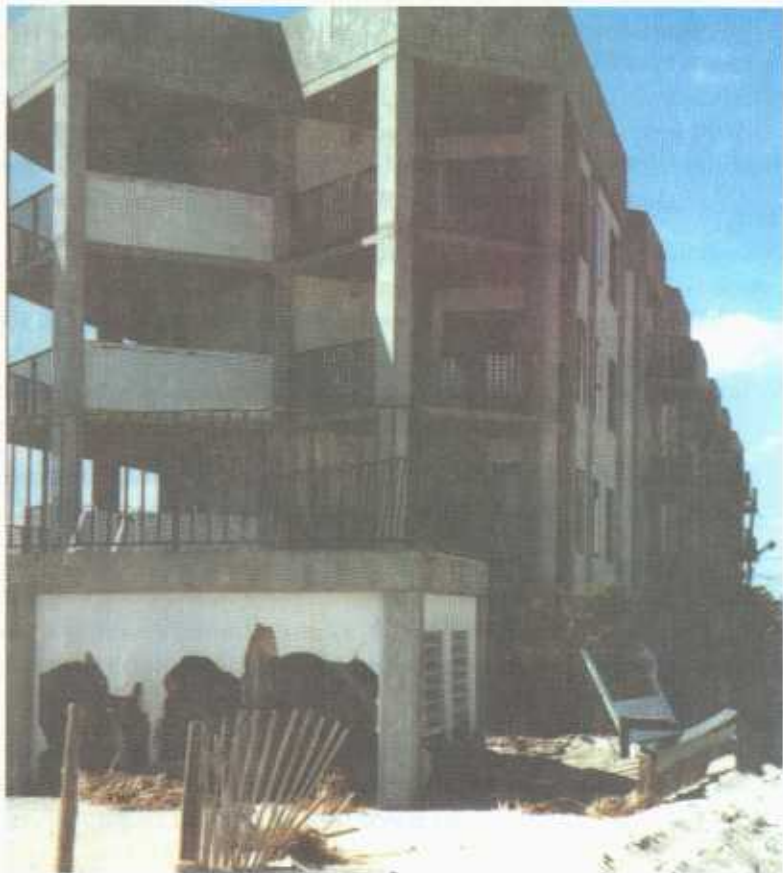
Figure 2-48 This large, engineered oceanfront structure performed as designed.
