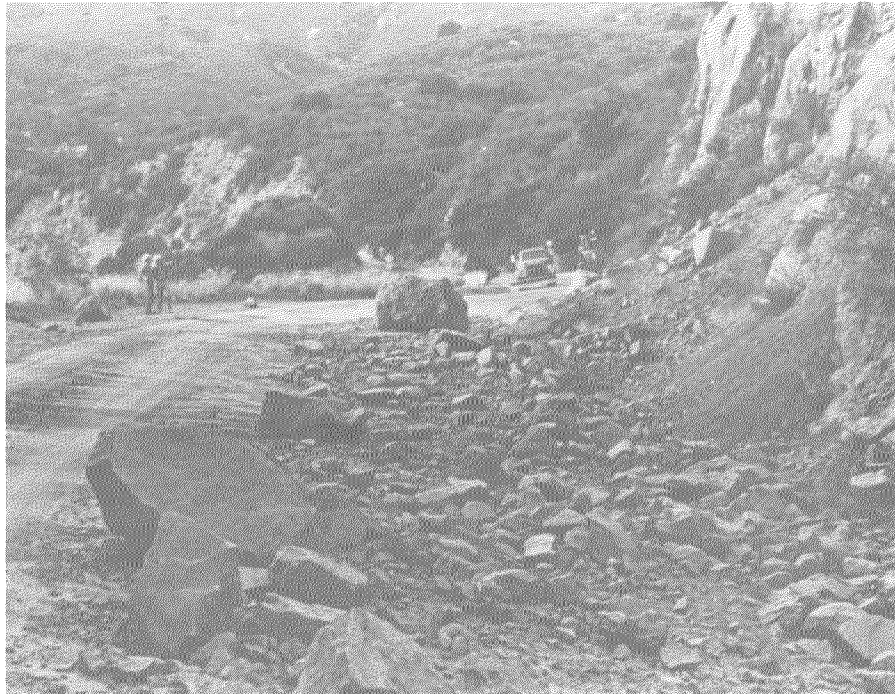
Fig. 5.3                      Rockslide on California State Highway 154, near San Marcos Pass (see Fig. 1.3 for location). (Santa Barbara News-Press photo. Reproduced by permission).

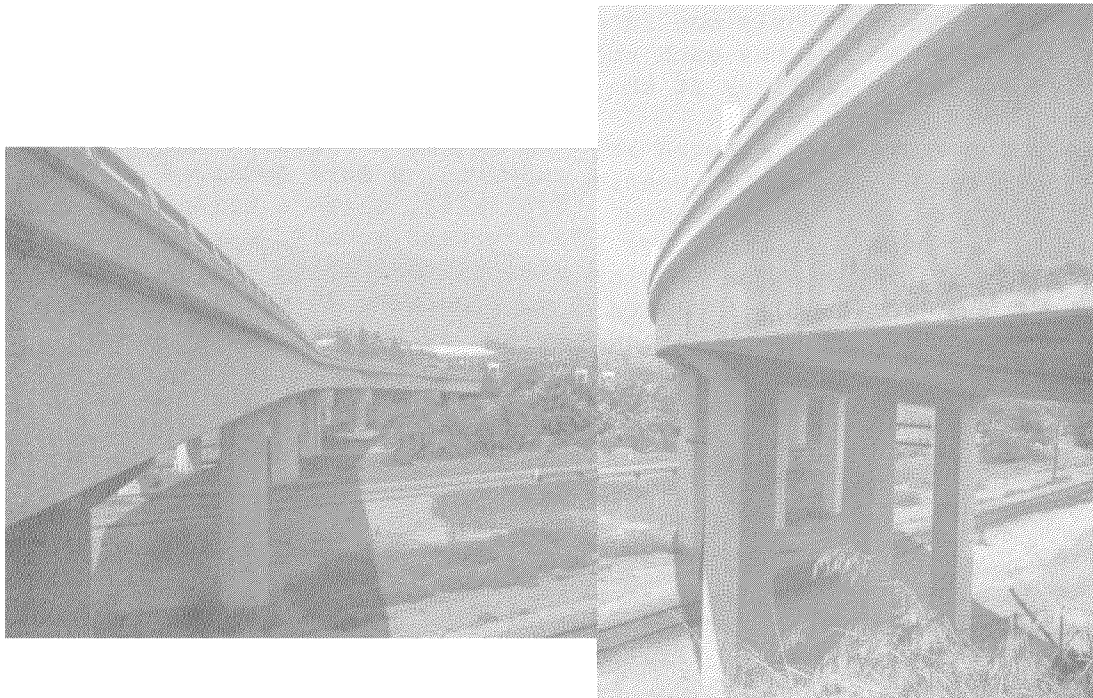
Fig. 5.4                      Ward Memorial Boulevard bridges over U.S. Highway 101 (see Fig. 1.2 for location). View looking north from southern abutment.

As mentioned, the most significantly damaged bridges were the two adjacent Ward Memorial bridges. The damage to these bridges occurred at several places and was relatively minor. The bridges are visible in Fig. 5.4, which is a view north along the sides of the bridges, and in Fig. 5.5, which is a view south. The bridges share a common abutment at their southern ends. The bridge on the left in Fig. 5.4 is 660 feet long and consists of eight spans. The spans are continuous reinforced concrete box girder structures except for two intermediate spans over Highway 101 which are single precast-prestressed concrete I girders. The bridge is supported by a series of two and three column bents that are sharply skewed. At the abutments, as well as at some of the precast-prestressed girder support points, the bridge deck rests on steel rocker bearings. The bridge on the right in Fig. 5.4 is 482 feet long and has six spans. The spans are continuous reinforced concrete box girder structures and there is only one intermediate hinge. The bents under this bridge have two columns each and are sharply skewed. The bridge deck rests on rocker bearings at the abutments.
