Fig. 5.5 Ward Memorial Boulevard bridges. View looking south towards southern abutment.

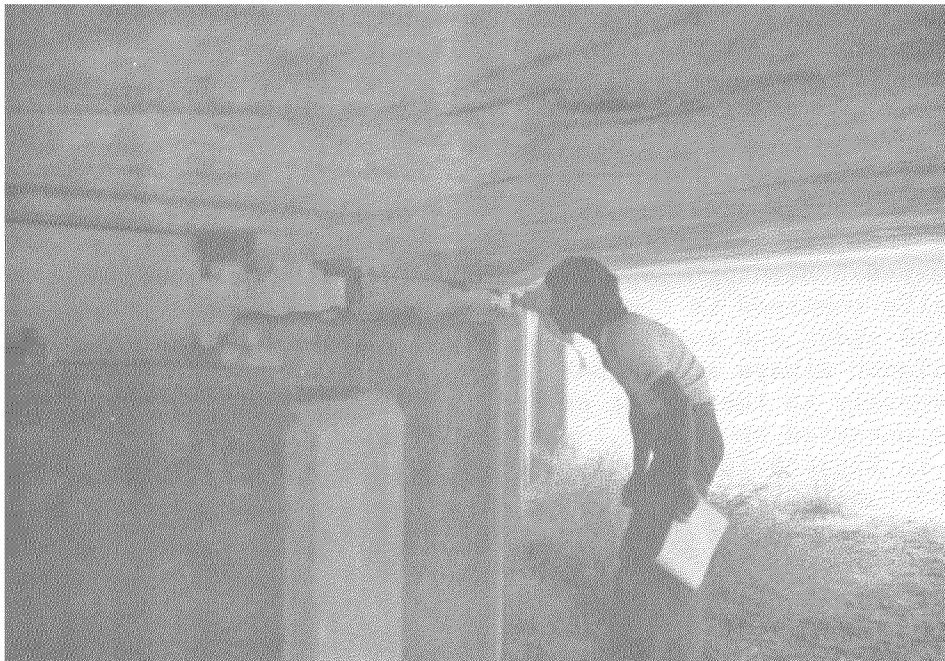
Fig. 5.6 Support of Ward Memorial Boulevard bridge deck at southern abutment. View shows piers capped by damaged rocket bearing assemblies under bridge on left in Fig. 5.5.

On both of the Ward Memorial bridges, some bolts holding the keeper plates were sheared at the southern-most abutment. More specifically, it was found that the bolts holding the keeper plates to the sole plates were sheared at the eastern ends of the bearings, as can be observed from Figs. 5.7 and 5.8. Some keeper plate bolts were also sheared at the northern abutment of the bridge on the right in Fig. 5.4, and at the intermediate supports of the bridge on the left in Fig. 5.4. Although the pattern of failure at these locations was more random than at the southern-most abutment, the overall evidence pointed to an earthquake induced clockwise rotation of both bridge decks when viewed from above. The magnitude of the permanent lateral shift at the southern abutment, measured between masonry and sole plates, was found to be more than one inch. The deck rotation caused the bridge decks to slam against the southern abutment thereby cracking the abutment backwalls, and cracking, spalling, and pushing away the wingwalls and curtain walls. A close-up of a broken curtain wall alongside the bridge on the left in Fig. 5.5 is shown in Fig. 5.9. The rotational motion also displaced the concrete bridge decks at the expansion joints. A typical example is shown in Fig. 5.10, which shows a view north from the southern abutment along the edge of the bridge on the right in Fig. 5.4. Figure 5.11 shows a wingwall that cracked due to the bearing action against it of the abutment backwall. There was also evidence of considerable longitudinal motion at the southern abutment as seen from Fig. 5.12 which shows the disengagement of an aluminum pipe railing at a sleeve joint in the vicinity of the deck expansion joint. The movement there must have exceeded 3" to cause the separation. The gaps between the expansion joints at the southern abutment were found to have widened indicating that the abutment backwalls were pushed towards the approach fill. In general, the shifting of the decks caused adjacent deck sections to impact at several expansion joint locations which cracked and spalled the concrete along the deck edges. An example is shown in Fig. 5.13.
