## 7. EARTHQUAKE EFFECTS ON BUILDINGS

### 7.1 General Features and Summary

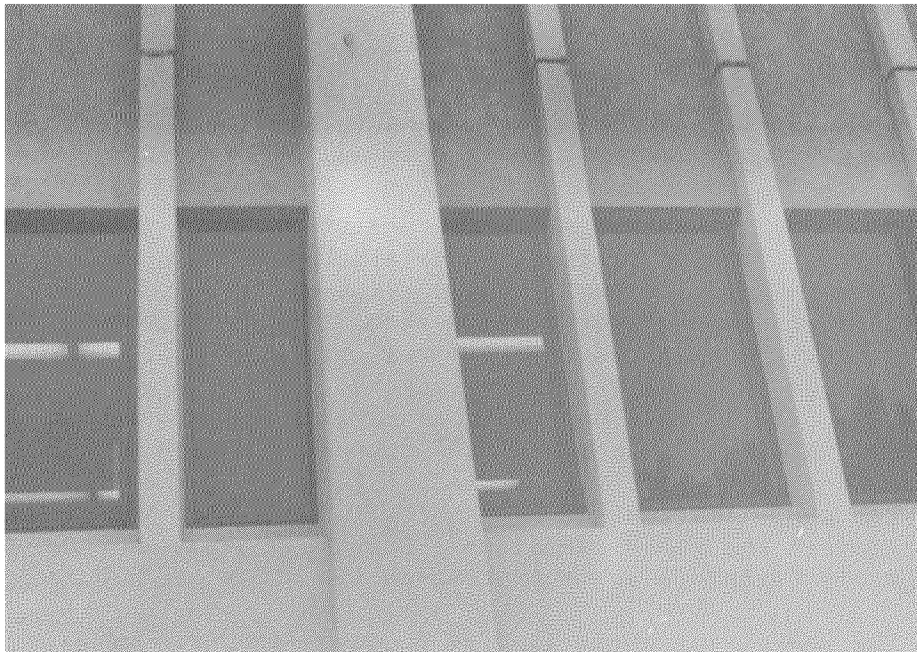
Fig. 7.2 Shear crack forming an X pattern in column in second story of Santa Barbara County Administration Building.
