### Biological Sciences II

### 7.3 Effects on Commercial and Residential Buildings

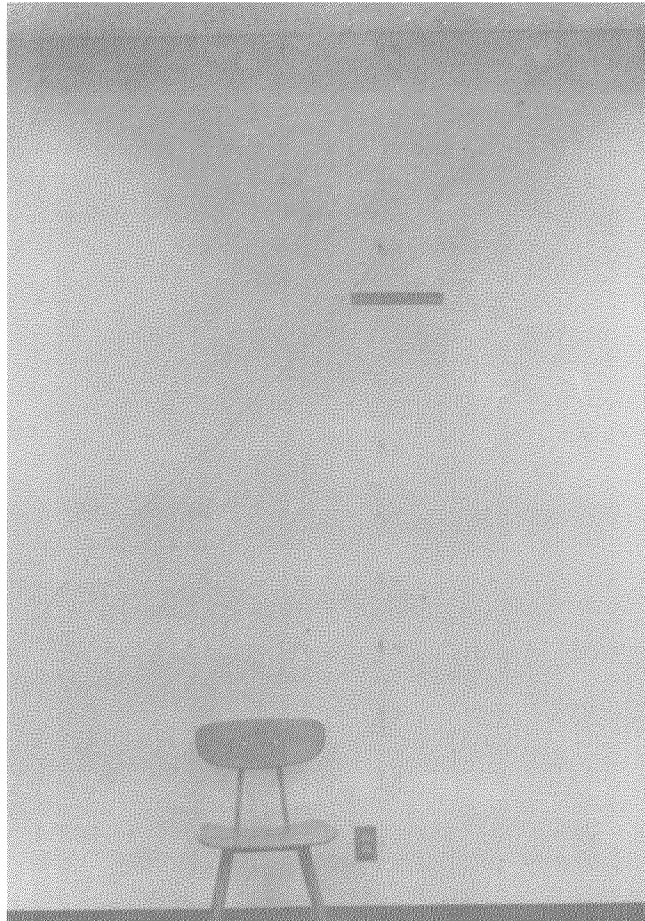
Fig. 7.27

cracking in all five stories. The cracks were often found to extend through the entire thickness of the walls. Shown in Figs. 7.27, 7.28 and 7.30 are some of the cracks in the north-south shear wall in the first story and in Fig. 7.29 in the east-west shear wall. Several parallel cracks extending diagonally from floor to ceiling occurred in each wall in the first story. On the third story considerable cracking also occurred in the header over a doorway in the north-south interior shear wall, as shown in Fig. 7.31. The cracks extended through the wall as indicated by the mirror image crack pattern on the other side of the doorway, shown in Fig. 7.32. Diagonal cracks also occurred in other portions of the north-south shear wall in the third story, as shown in Fig. 7.33. Similar cracks occurred in the second, fourth and fifth stories of the same north-south shear wall. Repairs by epoxy injection are planned.

Diagonal crack in north-south shear wall in first story of Engineering Building, UCSB. This crack extends through the thickness of the wall and is visible from the other side.

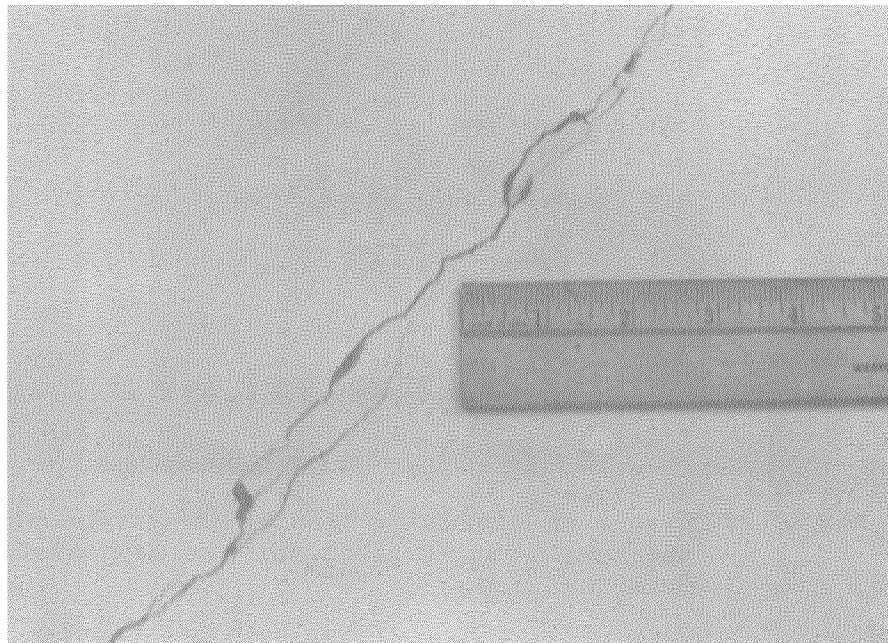
Fig. 7.28 Close up view of crack shown in Fig. 7.27.
