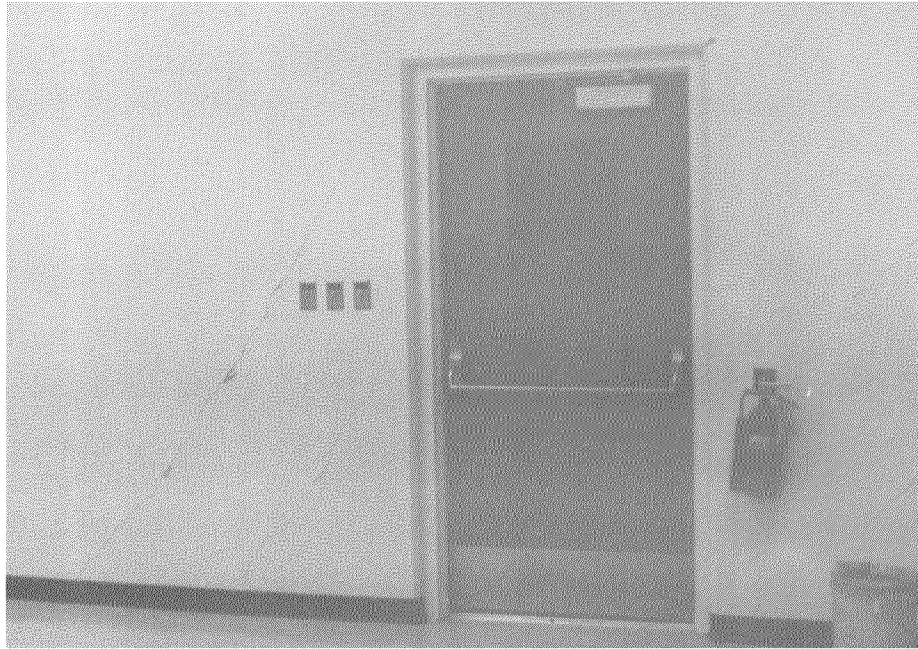
Fig. 7.29 Diagonal cracks in east-west shear wall in first story of Engineering Building, UCSB.

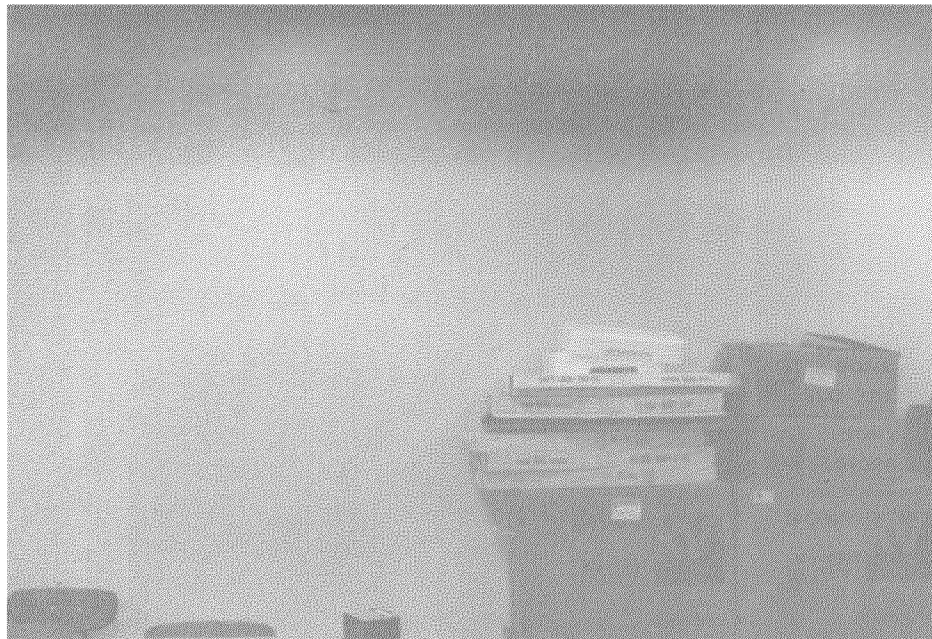
Fig. 7.30 Cracks in another portion of the north-south shear wall in the first story of Engineering Building, UCSB.
