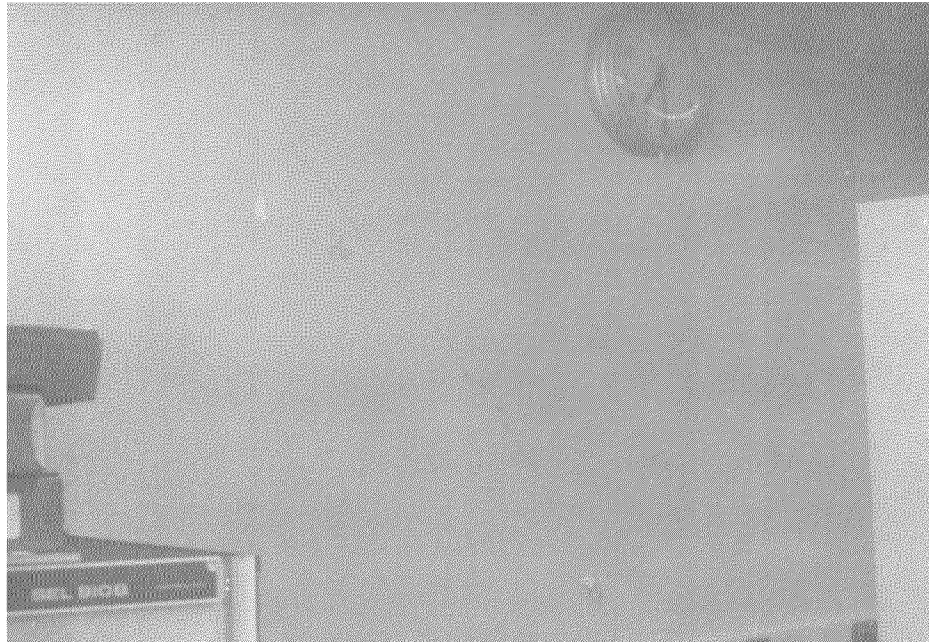
Fig. 7.33 Diagonal crack in north-south shear wall in third story of Engineering Building, UCSB.
