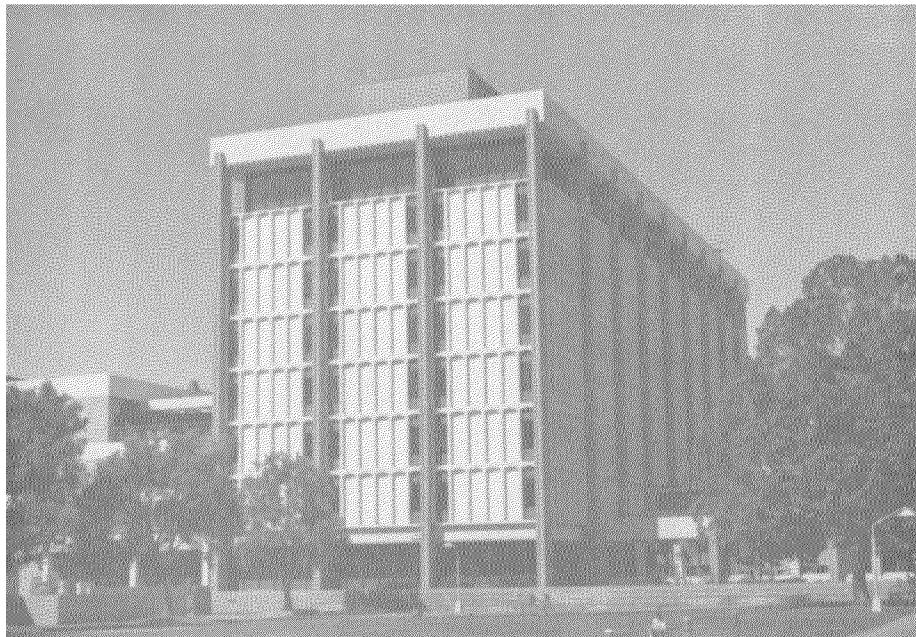
Fig. 7.38 Eight story Library III Building, UCSB. This building also sustained cracks in shear walls in lower stories.
