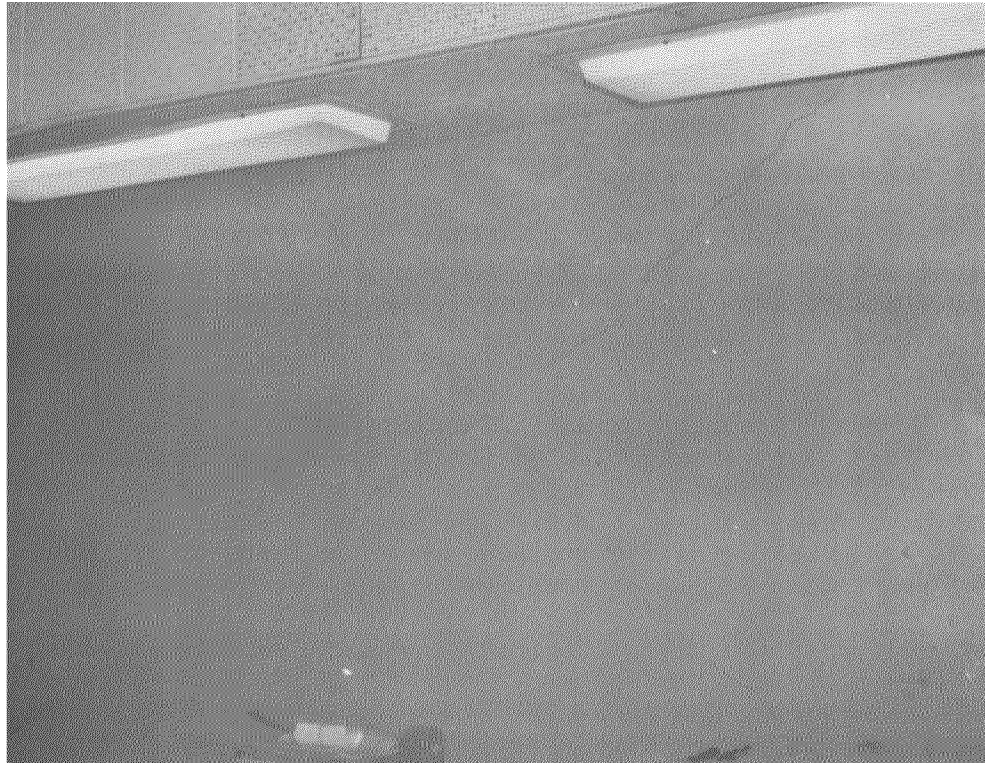
**Fig. 7.39** Pattern of X cracks in 10 inch thick R/C shear wall at east end of first story of Administration Building, Delco Electronics facilities.

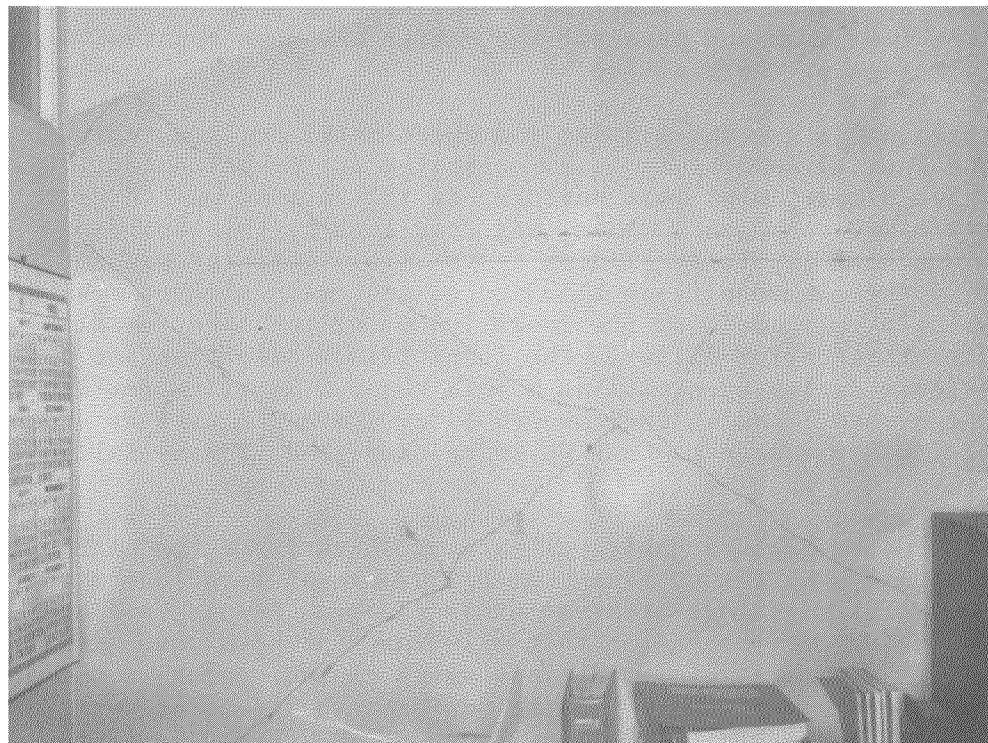
**Fig. 7.40** Pattern of X cracks in shear wall at west end in first story of Administration Building, Delco Electronics facilities.
