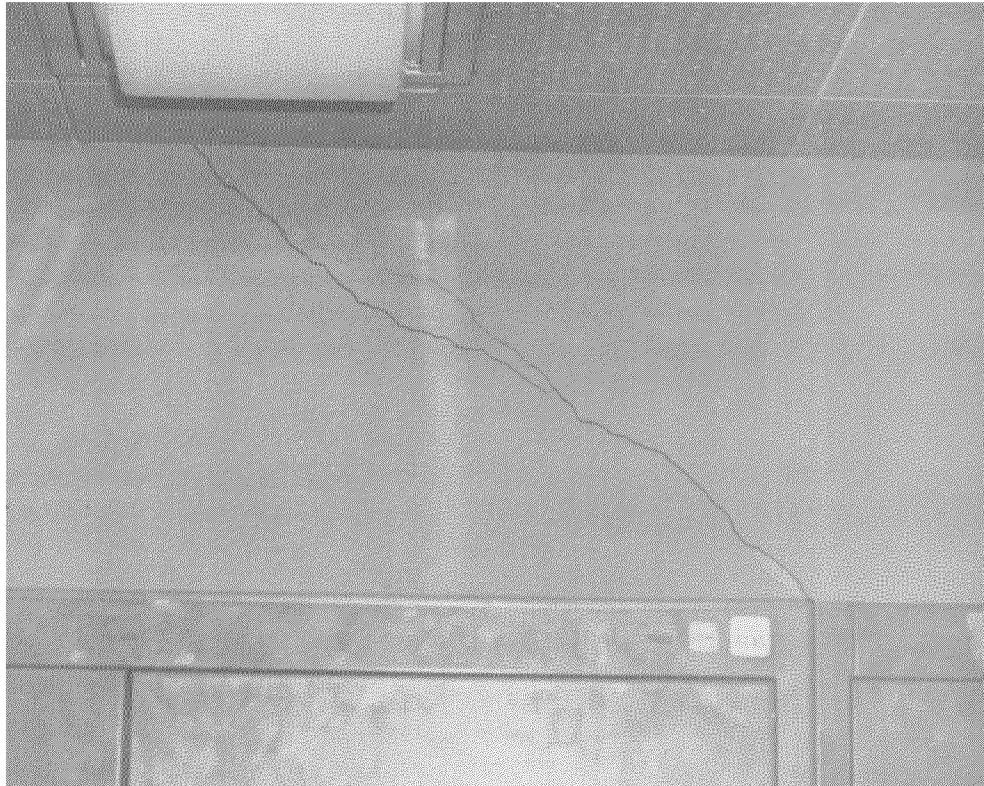
Fig. 7.41

Diagonal crack in shear wall near center stair tower in second story of Administration Building, Delco Electronics facilities.

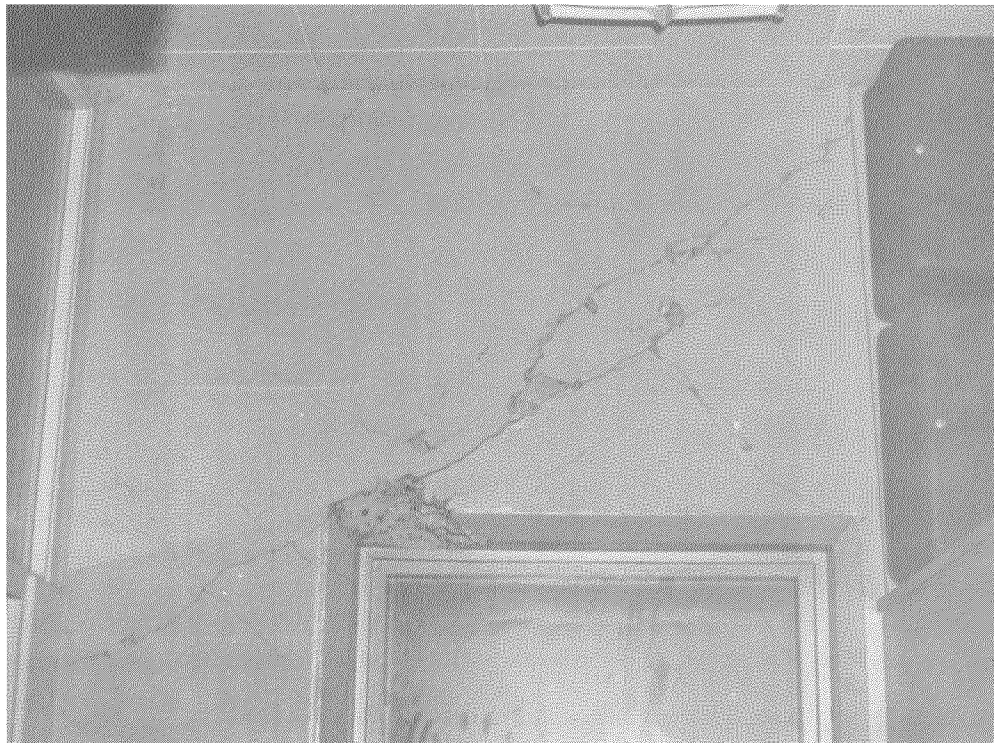
Fig. 7.42

Cracks in shear wall over doorway at west end in first story of Administration Building, Delco Electronics facilities.
