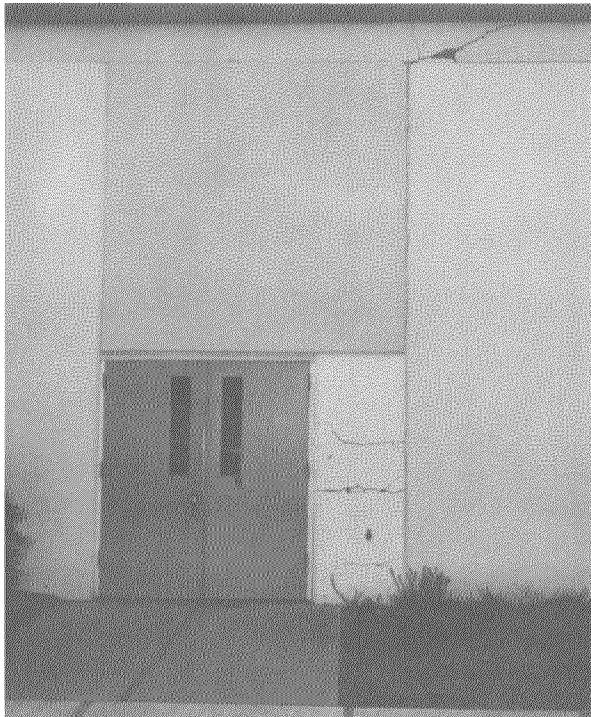
Fig. 7.45

Cracks at joints between panels and doors, Research and Development Building, Delco Electronics facilities.

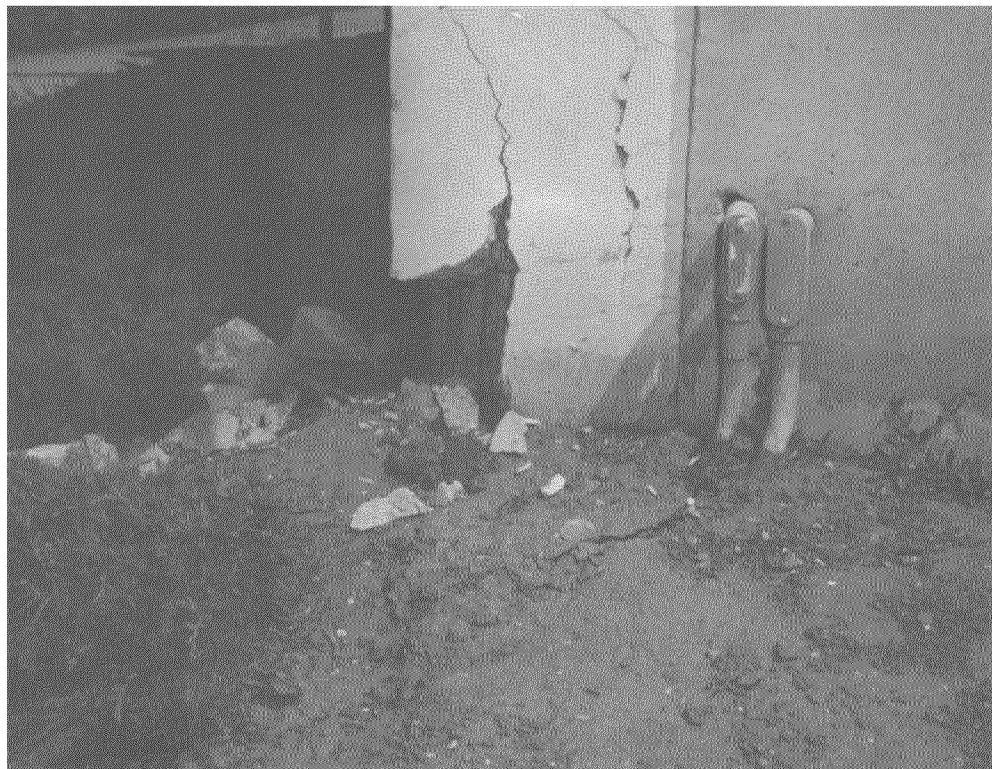
Fig. 7.46

Cracking and spalling of columns at southwest corner of Research and Development Building, Delco Electronics facilities.
