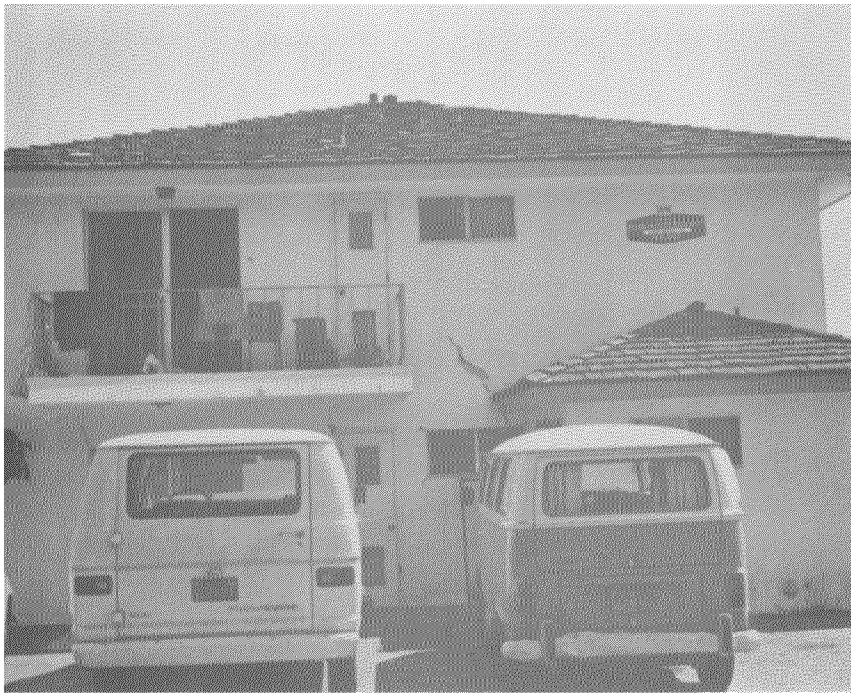
Fig. 7.50 Cracks in exterior plaster walls of two story residential building in Isla Vista.

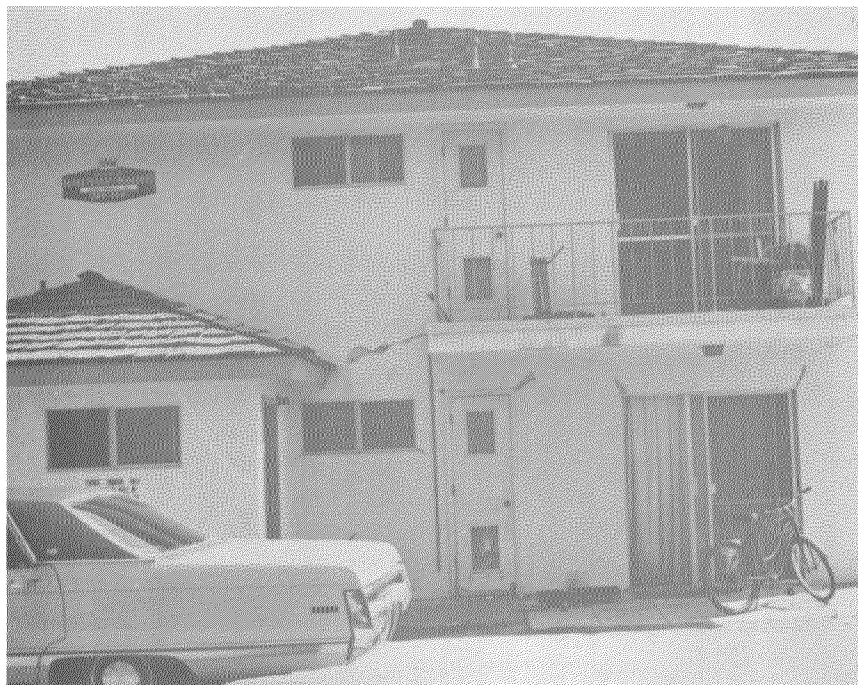
Fig. 7.51 Cracks in exterior plaster walls of two story residential building in Isla Vista.
