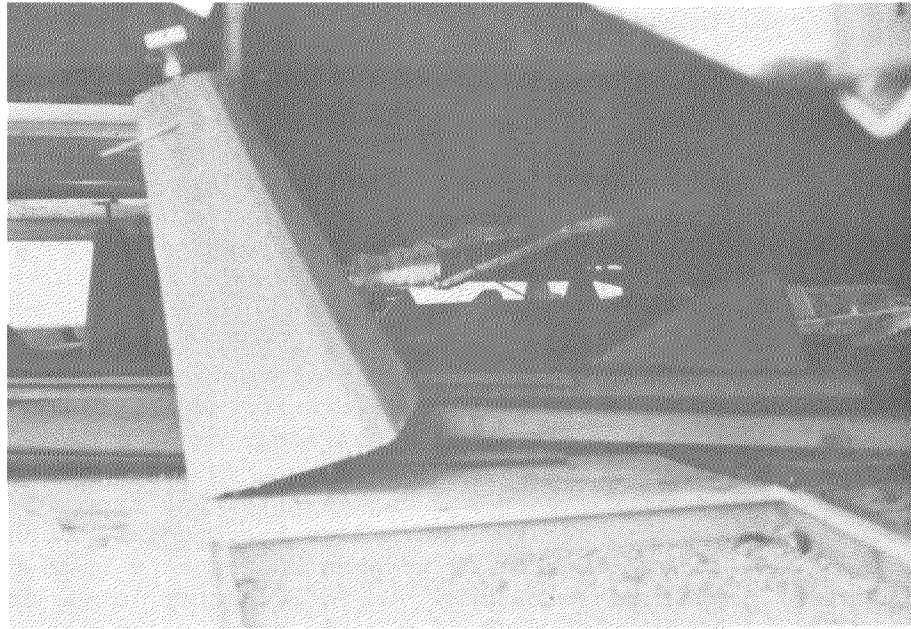
Fig. 7.58 View of overturned concrete piers under a mobile home which fell from its foundation.

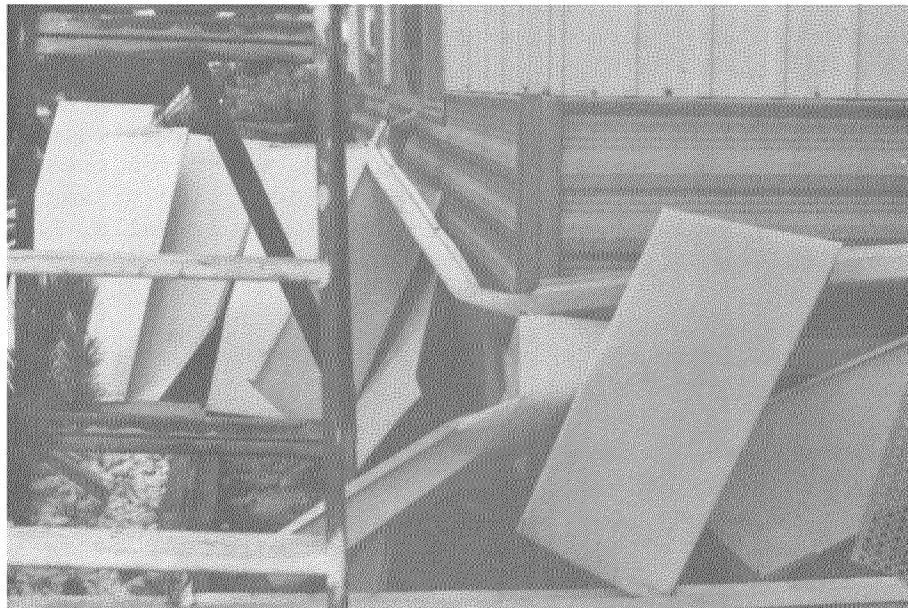
Fig. 7.59 Close up of fallen mobile home showing total horizontal shift of approximately 1 to 2 feet.
