Air traffic control tower, Santa Barbara Municipal Airport (view from south).

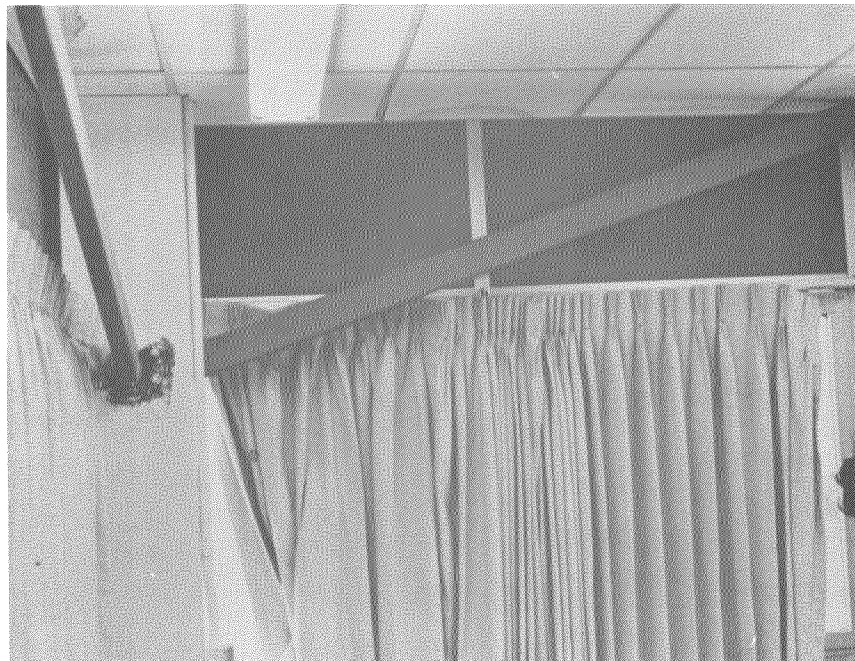
Fig. 7.61

Damage to joint between steel bracing tube and column in southeast corner, second story, air traffic control tower. Damaged tube runs north and south.
