North Hall, UCSB.

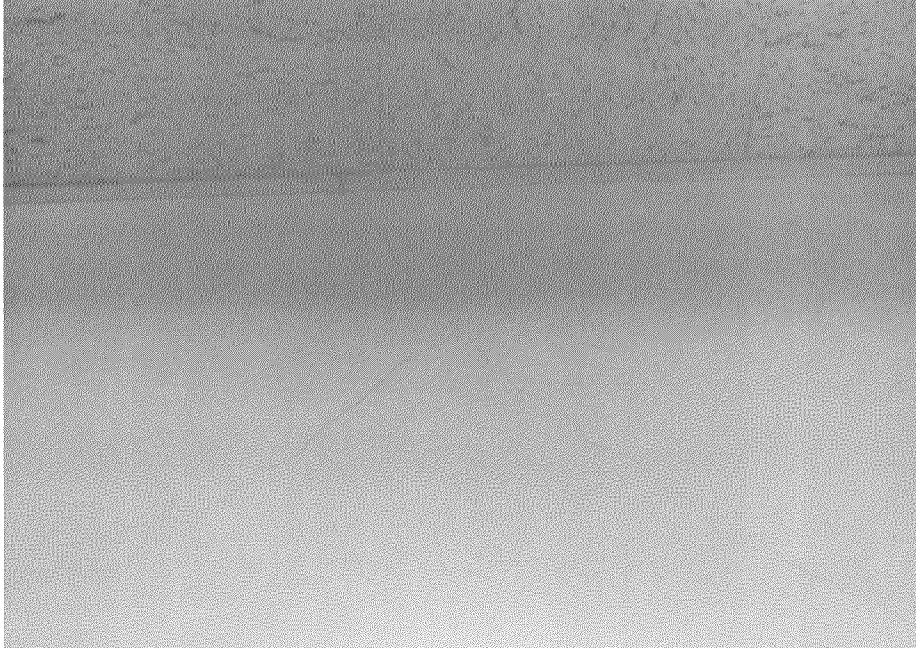
Structural damage to North Hall caused by the earthquake consisted of moderate cracking of the shear walls. Significant cracking occurred in all three stories of the newly constructed shear walls, with the most severe cracking occurring in the north-south walls in the first story. Very little cracking occurred in the original shear walls. The typical pattern of cracking to north-south shear walls consisted of primarily diagonal trending cracks of several feet in length, with some apparent X patterns as shown in Figs. 7.11-7.16. In the lower stories these cracks could often be identified on each side of the wall, indicating that the cracks extended through the entire thickness of these 6 inch shear walls. Some vertical cracks were occasionally observed parallel with the connection to the exterior columns.

Fig. 7.11 Typical pattern of X cracking of north-south shear walls in first story of North Hall.

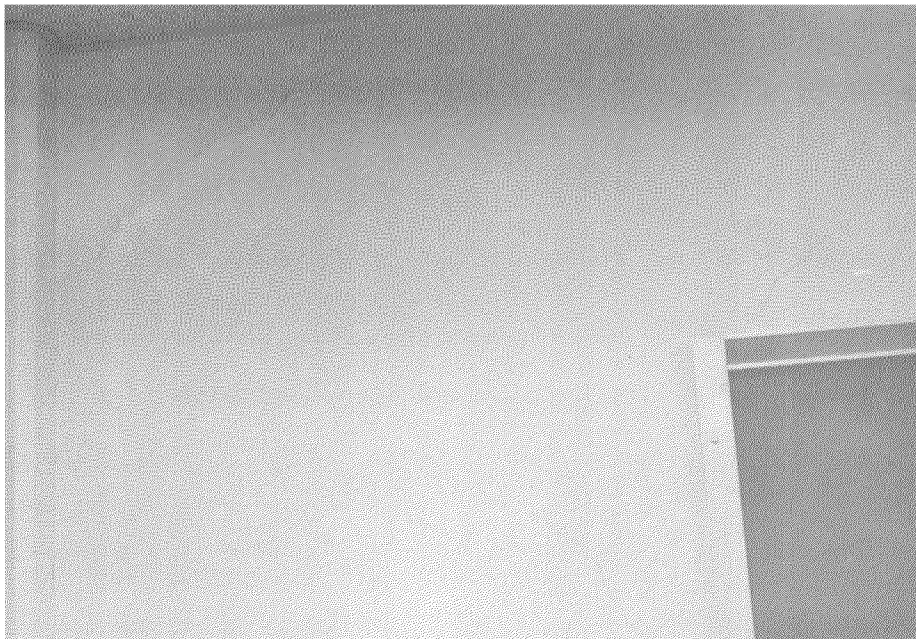
Fig. 7.12 Diagonal cracking of north-south shear wall in first story of North Hall. Vertical member at left is an interior column.
