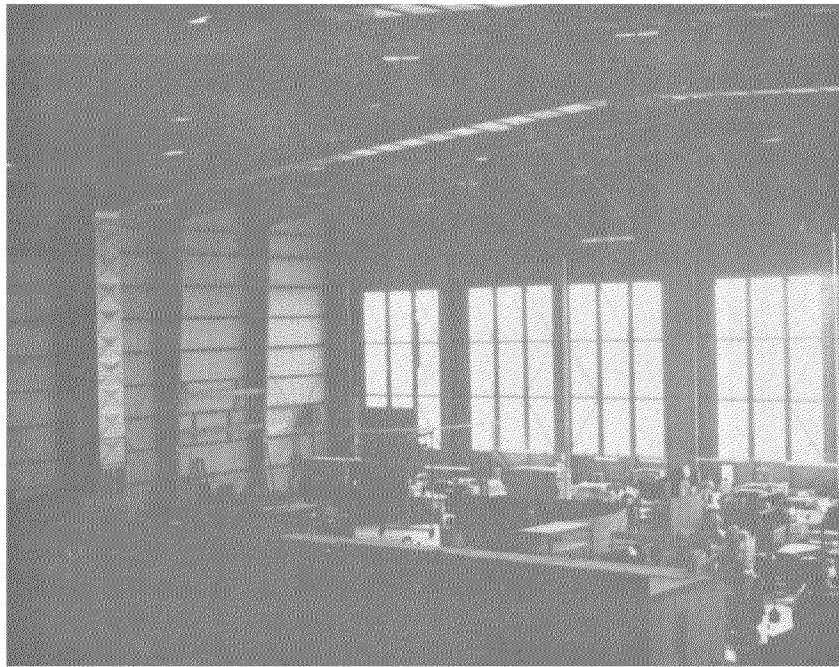
Figure 7.66 Interior of large hangar at facilities of Aero Spacelines, Inc., showing large sliding doors and damaged steel bracing which angles up to the roof from the rail at top of doors

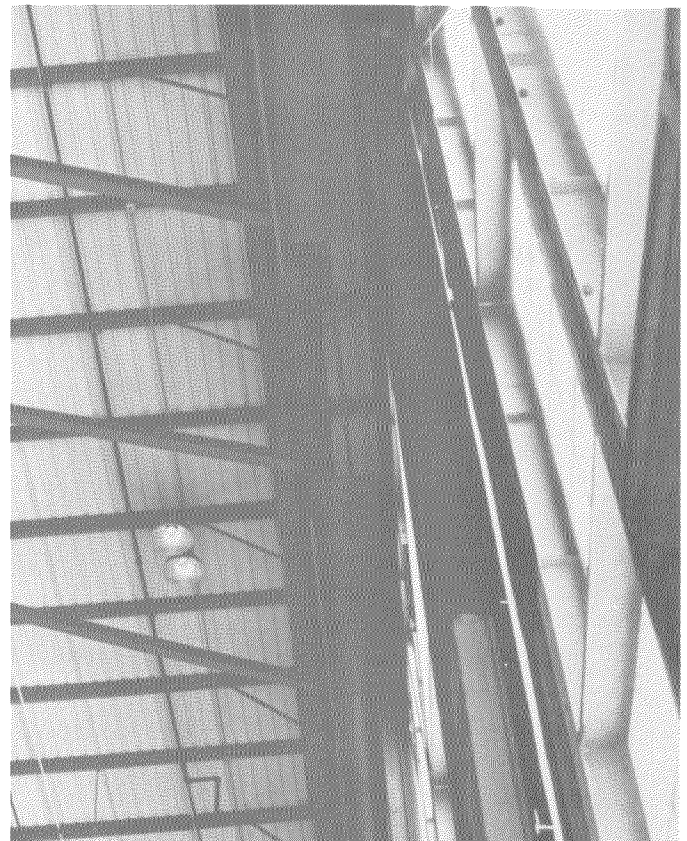
Figure 7.67 Close up from directly under damaged steel bracing of sliding doors shown in Fig. 7.66. Note separation of rail and bracing in center of picture
