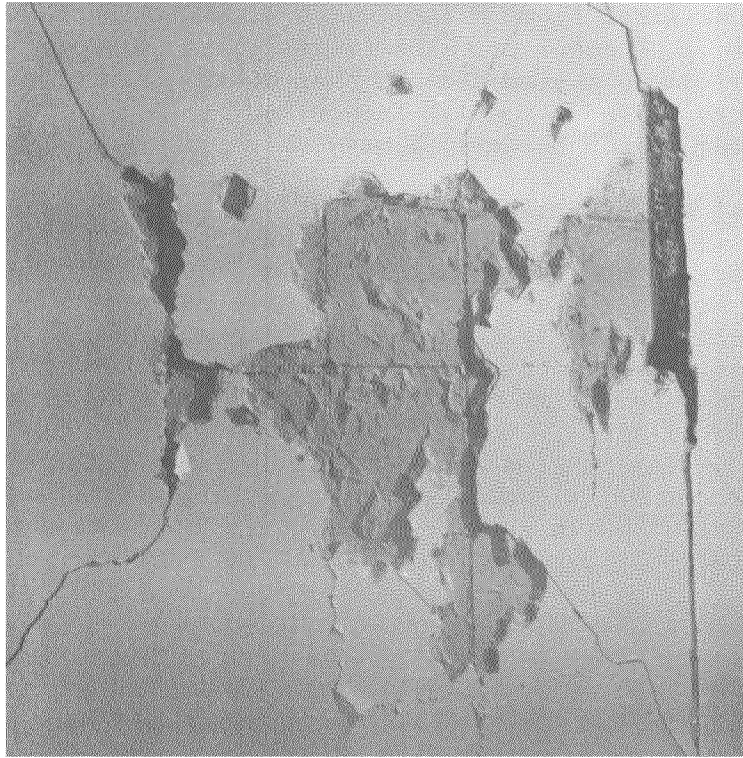
shear walls on the first floor. The cracks were mostly diagonal trending, as shown in Figs. 7.20 and 7.21. The cracks often followed the mortar lines, but occasionally passed through the concrete blocks themselves. Most of the cracks extended through the entire thickness of the wall. Extensive cracking of the headers of many doorways was also observed.

The cracking was noticeably more severe in some places than in others. In one such severely damaged portion, several damaged concrete blocks were chipped away with a hammer to expose the internal reinforcement. It was found in some cases that no grout was in place to bond the reinforcing steel to the concrete blocks, as shown in Figs. 7.22 and 7.23, resulting in an unexpectedly weak shear wall. Further investigation occasionally revealed such additional deficiencies as missing or misplaced steel, and inadequate laps and splices. In these severely damaged areas repairs consisted of complete removal of the concrete block shear walls, and replacement with new reinforced concrete shear walls. Sixteen walls required replacement. In other locations repairs will be accomplished by epoxy injection.

Fig. 7.20 Diagonal cracks in north-south shear wall in first story of Anacapa Residence Hall.

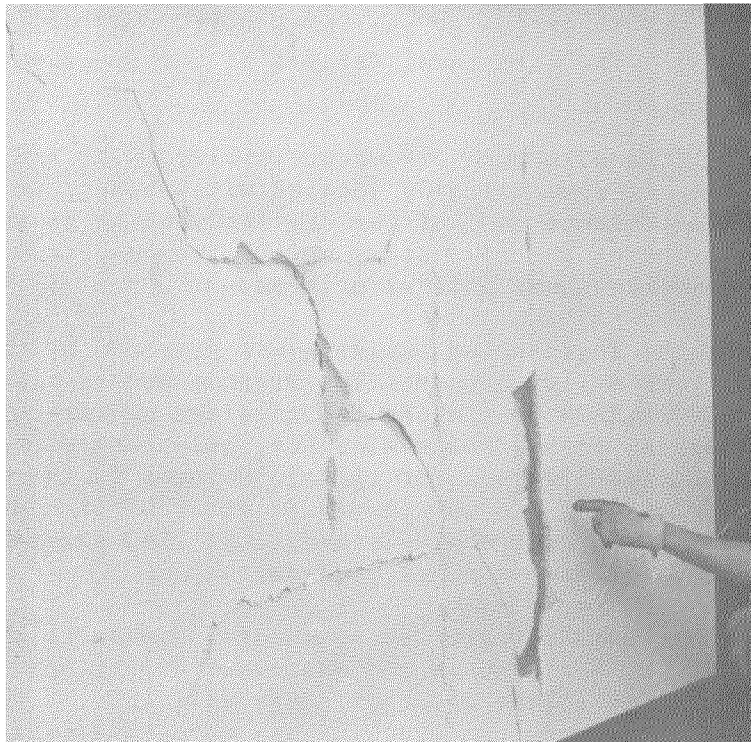
Fig. 7.21 More diagonal cracks in north-south shear walls in first story of Anacapa Residence Hall.
