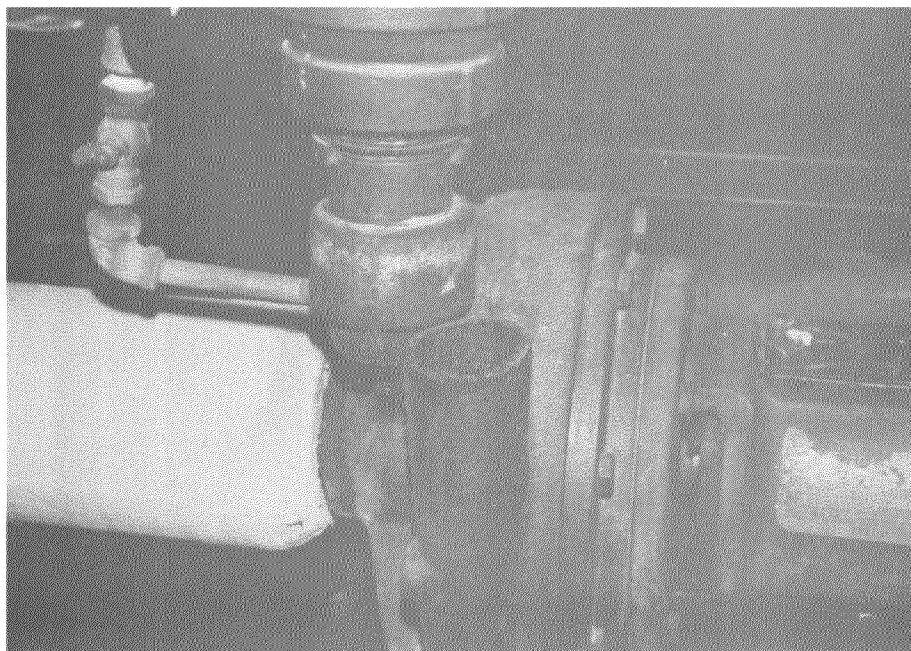
Fig. 8.18 Broken cast-iron valve at discharge connection of pump on top of six-story Ellison Hall, UCSB.

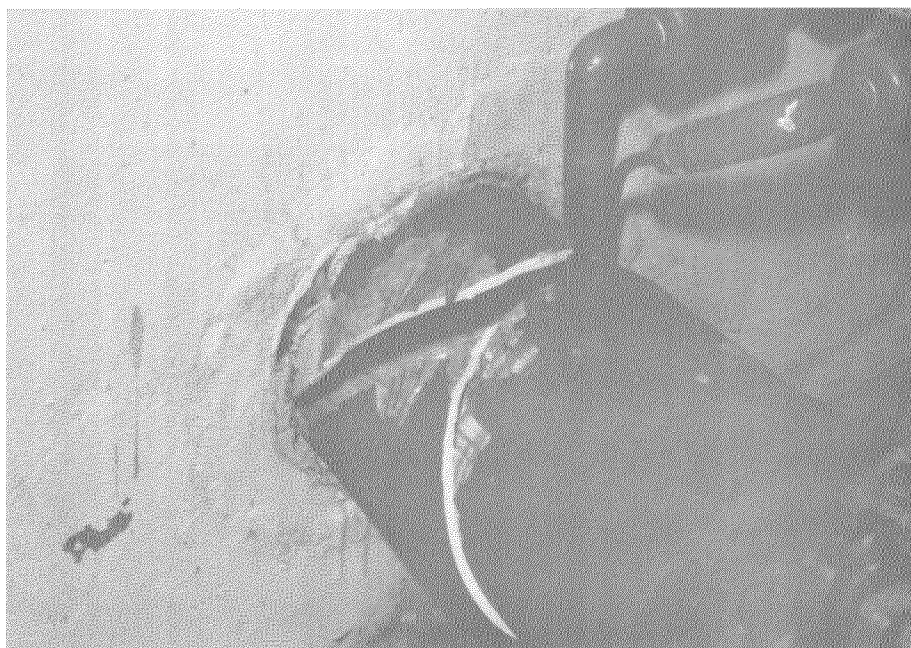
Fig. 8.19 Break in 8 inch sea water discharge pipe at wall penetration, UCSB Marine Research Facility.
