#### 8.5 Damage to Sliding Doors

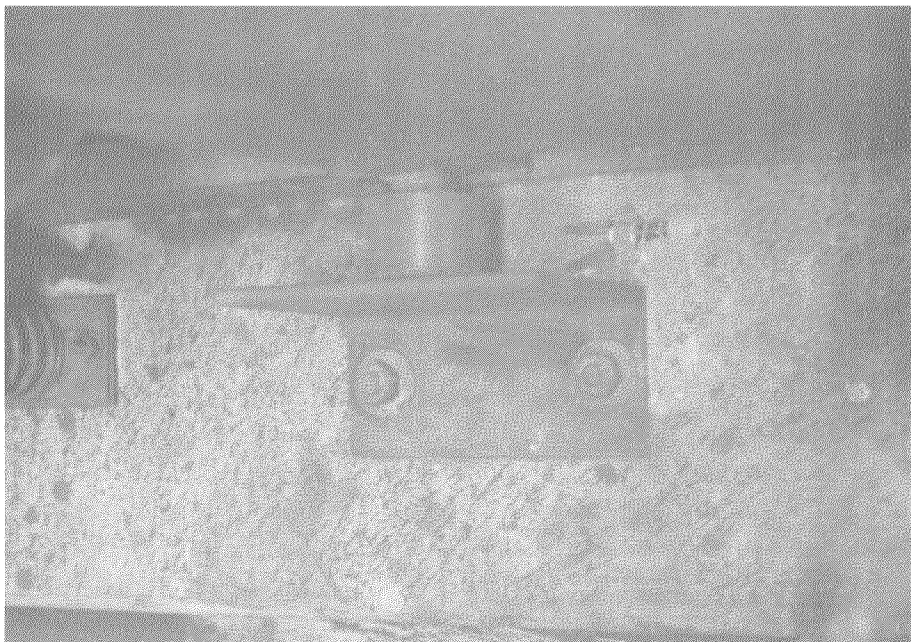
Fig. 8.21 Close up of commercially available seismic restraint on fan (Fig. 8.20).

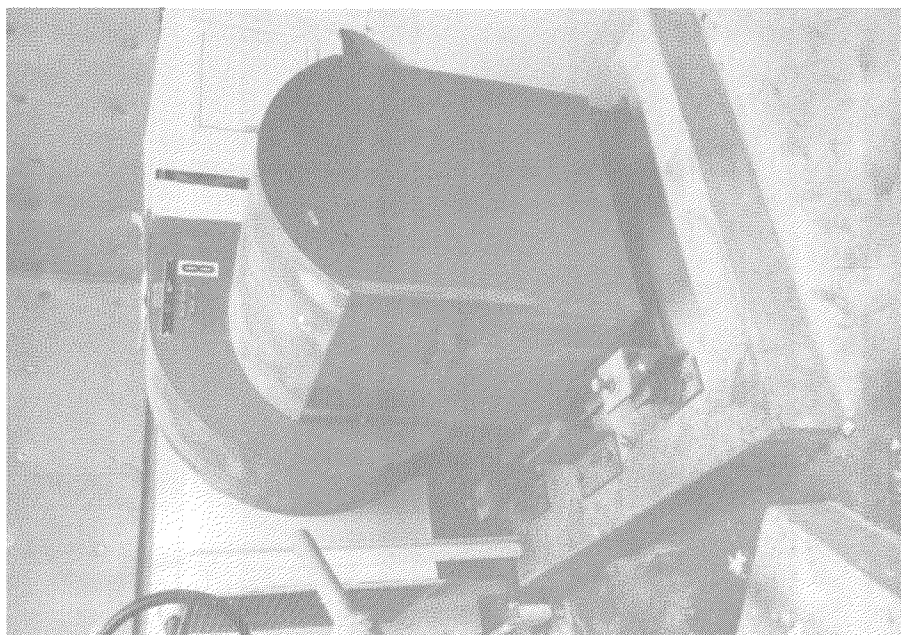
Fig. 8.20 Fan in basement of four-story Library IV Building, UCSB. Vibration supports were not damaged.

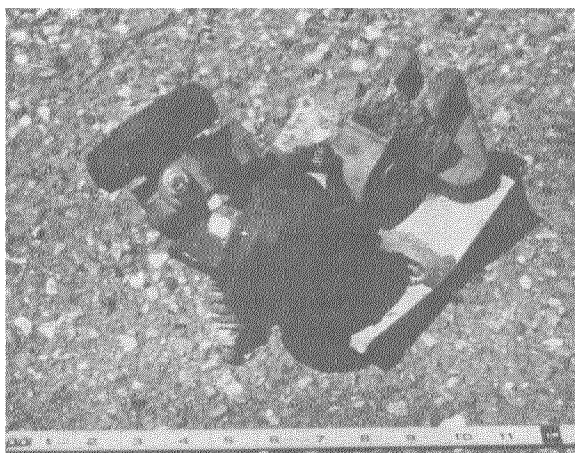
Fig. 8.22 Broken roller guide/shoe from electric traction elevator in five-story Engineering Building, UCSB.
