### 8.3 Equipment Damage

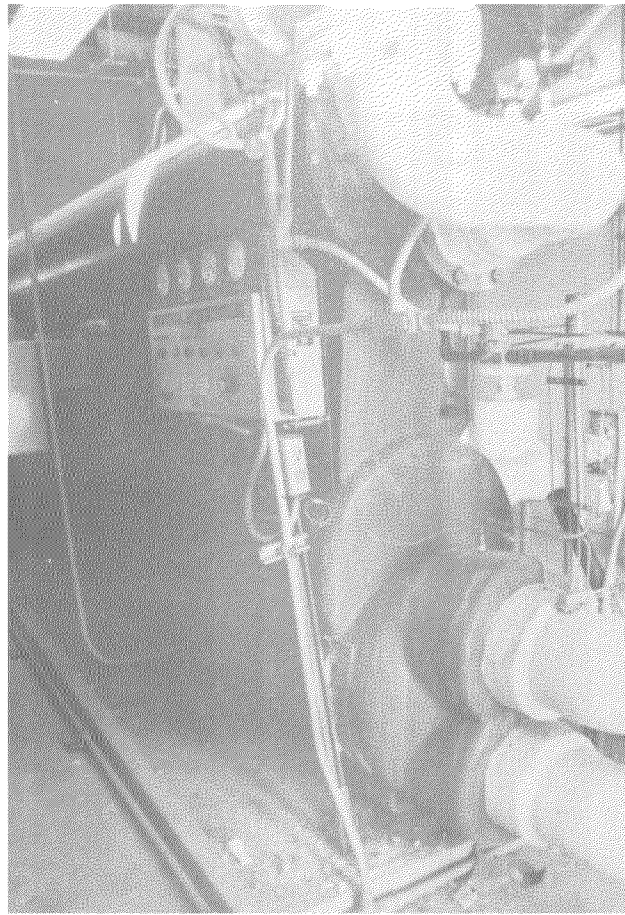
Fig. 8.8

Mechanical equipment on or near the roof tops of multistory buildings incurred considerable damage from building motion, particularly on the UCSB campus. In many instances, such equipment is spring mounted for vibration isolation purposes. When these supports did not provide sufficient lateral restraint, swaying motion of the buildings tended to knock the equipment off its supports as was amply evident from a survey of the damages. Figures 8.8 through 8.10 show an overall view and two close-ups of the collapsed supports under a 14,000-lb centrifugal water chiller on the top of the eight-story section of the UCSB campus Library (see Fig. 7.38). At the same location, several hot water pumps were wrenched from their anchor bolts, and in one instance, a pump's mounting base integrally cast with the pump motor case was simply broken off, as seen in Fig. 8.11. On the top of this and more than twenty other UCSB buildings, boilers and fans were shifted from their vibration isolation supports when inadequate lateral restraints were present, bolted down pumps were shorn loose, and the supports under cooling towers and were buckled and bent. In many cases the elevated concrete housekeeping pads on which the equipment rests were chipped and cracked. A typical example is shown in Figs. 8.12 and 8.13 which show an overall view of a boiler installation on top of six-story Ellison Hall, and a close-up of the damaged supports. A similarly sized boiler on top of six-story Phelps Hall, shown in Fig. 8.14, which has seismic restraints that conform with the current code and are of the type shown in the close-up in Fig. 8.15, received no damage. Such seismic restraints were the exception rather than the rule on the UCSB mechanical equipment surveyed. Equipment lighter in weight, such as fans, did not fare better. Figures 8.16 and 8.17 show a series of fans which fell off their supports on the roof of the Biological Science II building. Equipment control cabinets, electrical junction boxes and wiring were also dislodged and moved.

14,000 lb centrifugal water chiller on top of Library III Building at UCSB (see Fig. 7.38). Vibration isolation supports were damaged.

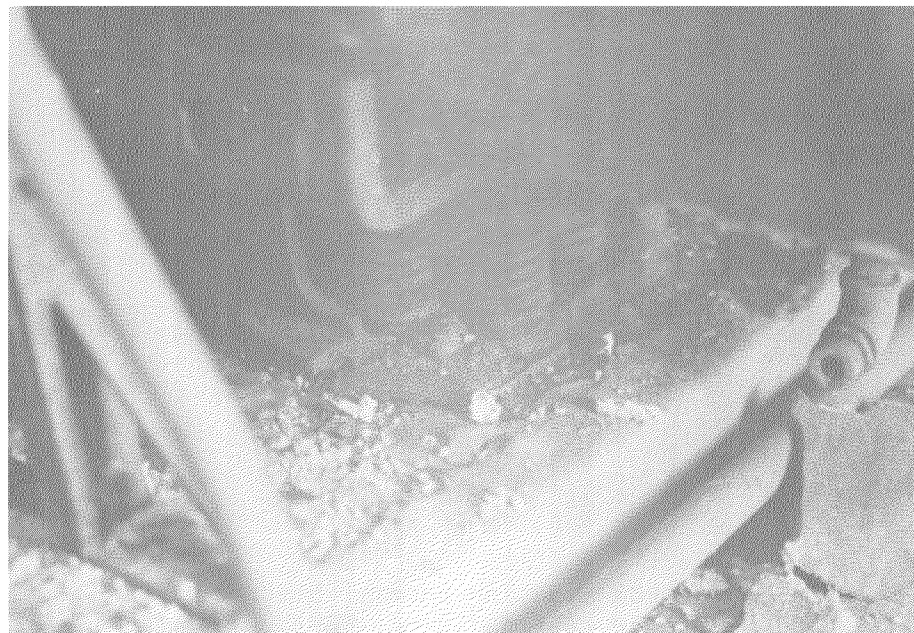
Fig. 8.9 Close up of damaged supports at front of chiller (Fig. 8.8).
