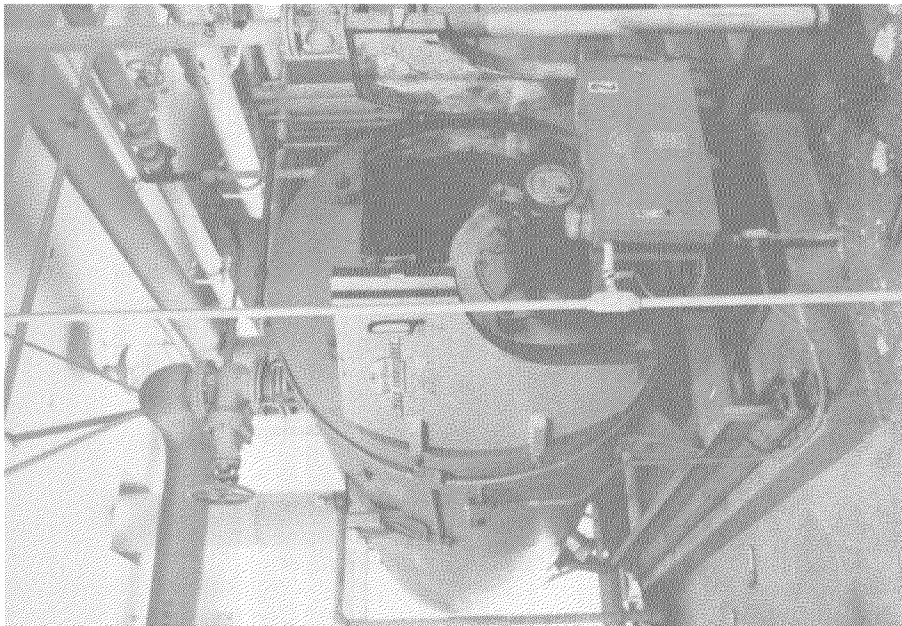
Fig. 8.12 Boiler on top of six-story Ellison Hall, UCSB. Vibration isolation supports were damaged.

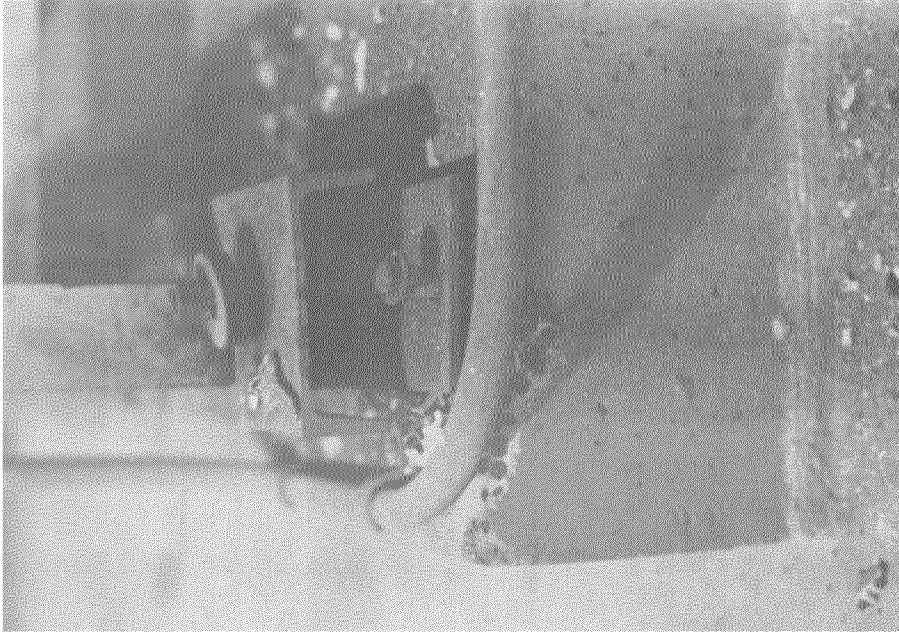
Fig. 8.13 Close up of damaged support on left side of boiler (Fig. 8.12).
